WBA6K31030FL26681

## Vehicle details

## Zustandsbericht

**Protocol number:** 35992719

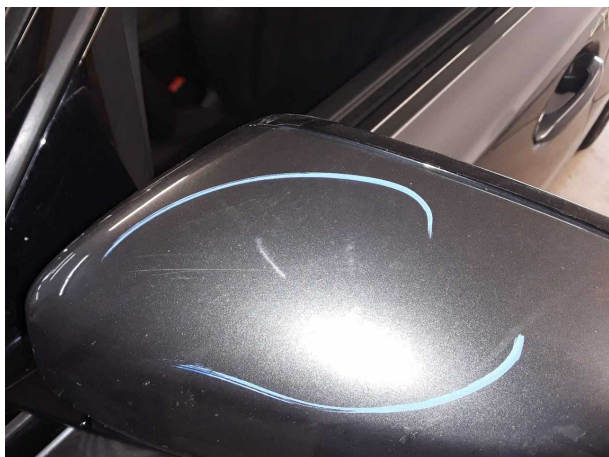
| No. | Component group | Description |
|---|---|---|
| 2 | Wing mirror - left side | Cap - Scratch(es) - Smart repair |

**Damage #2:** Wing mirror - left side: Cap - Scratch(es) - Smart repair

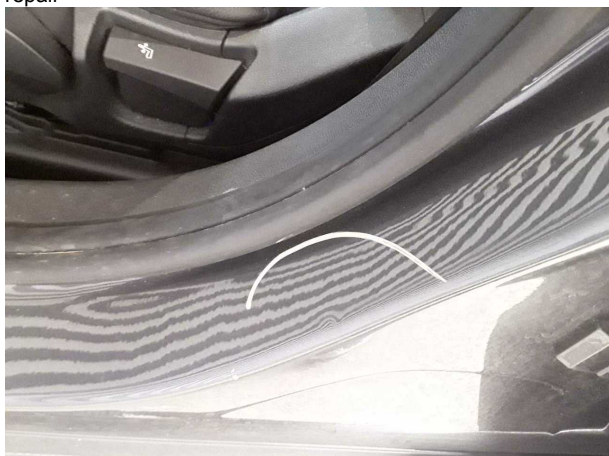
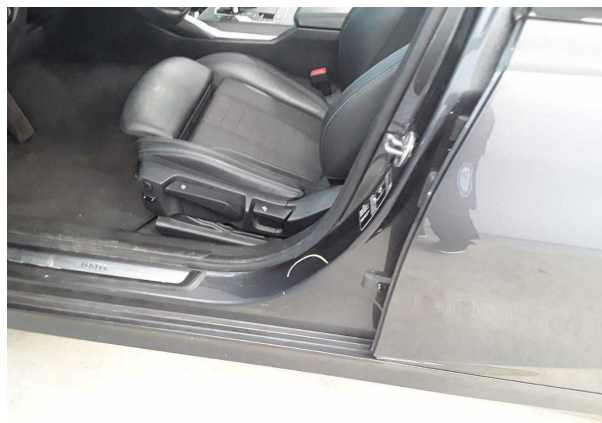
| No. | Component group | Description |
|---|---|---|
| 3 | Sill - left side | Sill - Dent(s) - Smooth repair work |

**Damage #3:** Sill - left side: Sill - Dent(s) - Smooth repair work

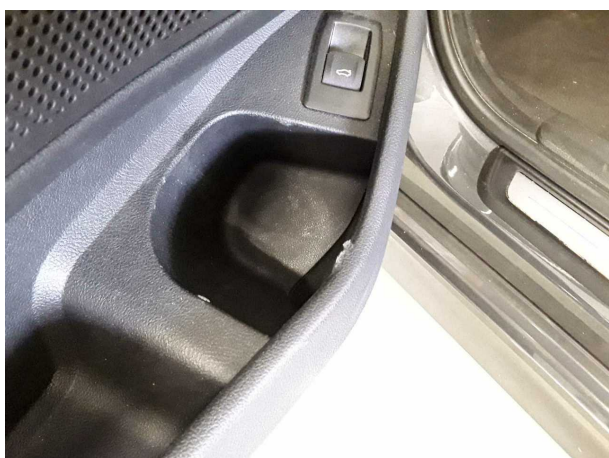
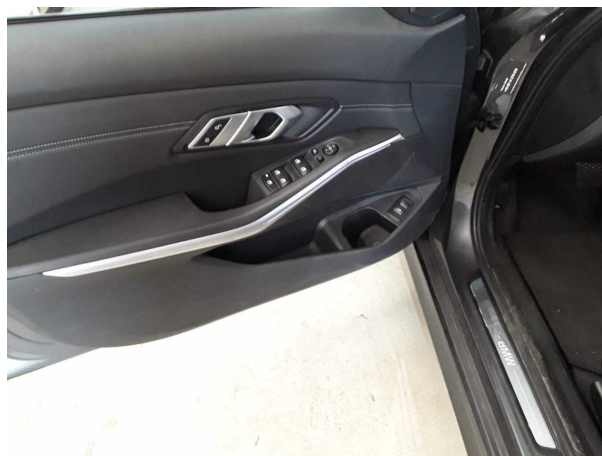
| No. | Component group | Description |
|---|---|---|
| 4 | Trim / covers | Door trim - front left side - Damaged - Loss in value |

**Damage #4:** Trim / covers: Door trim - front left side - Damaged - Loss in value

**Damage #4:** Trim / covers: Door trim - front left side - Damaged... - Loss in value

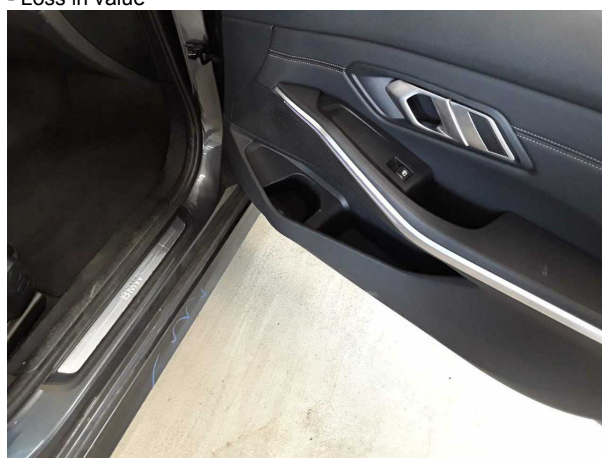
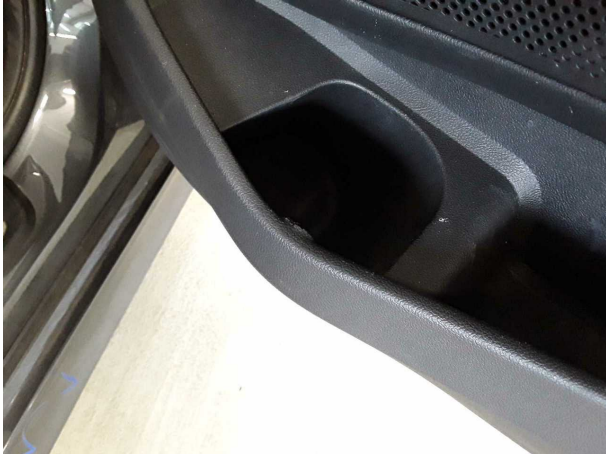
| No. | Component group | Description |
|---|---|---|
| 5 | Trim / covers | Door trim - front right side - Scratched - Loss in value |

**Damage #5:** Trim / covers: Door trim - front right side - Scratched - Loss in value

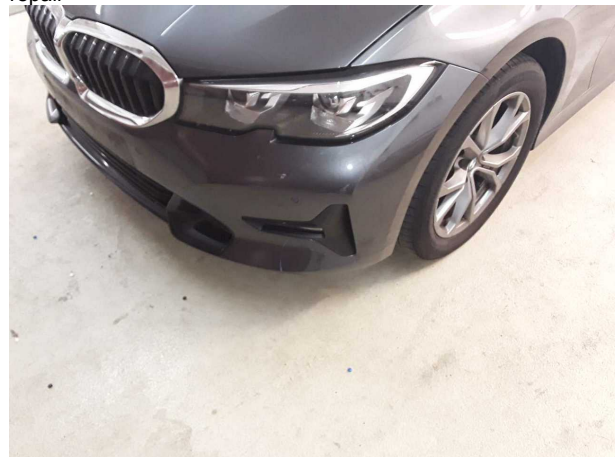
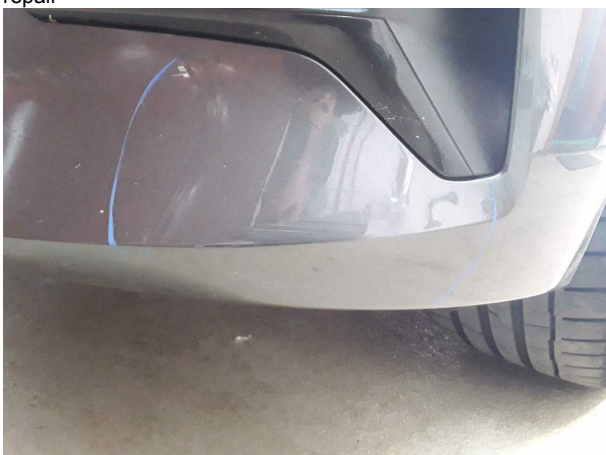
| No. | Component group | Description |
|---|---|---|
| 7 | Front bumper | Front bumper - Scratched - Smart repair |

**Damage #7:** Front bumper: Front bumper - Scratched - Smart repair

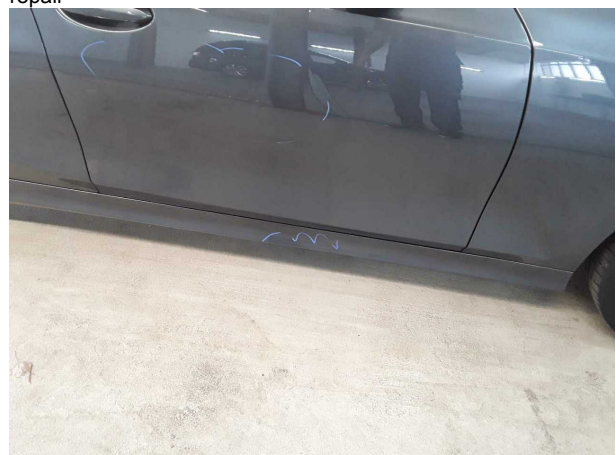
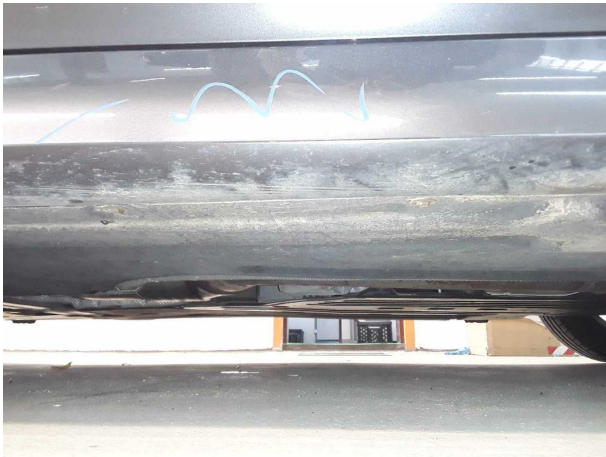
| No. | Component group | Description |
|---|---|---|
| 8 | Sill - right side | Trim - Scratched - Smart repair |

**Damage #8:** Sill - right side: Trim - Scratched - Smart repair

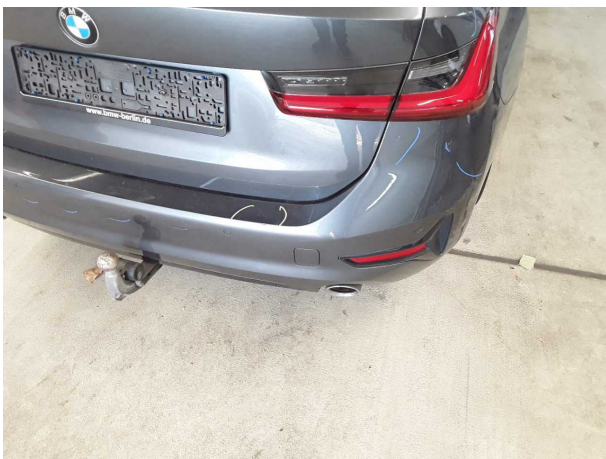
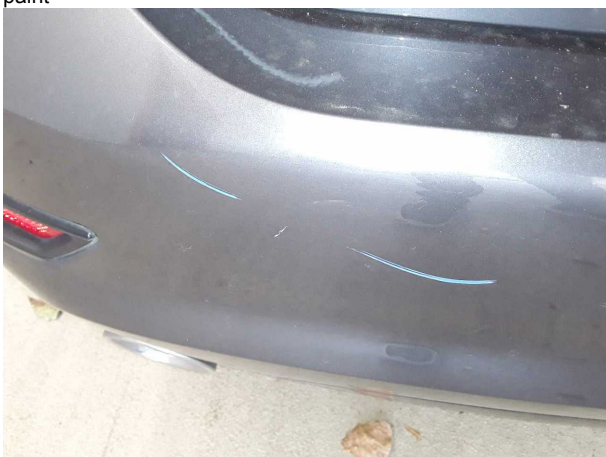
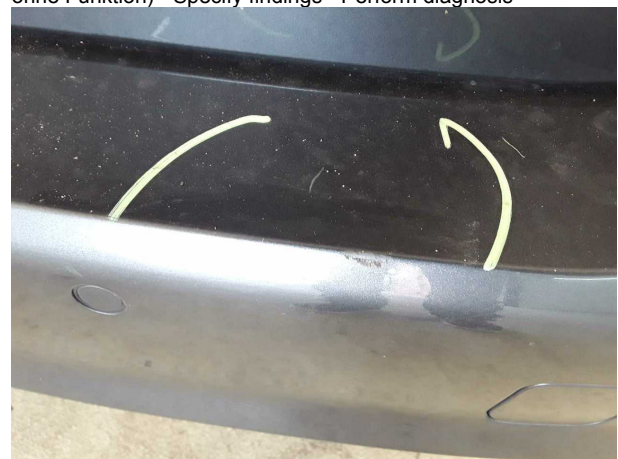
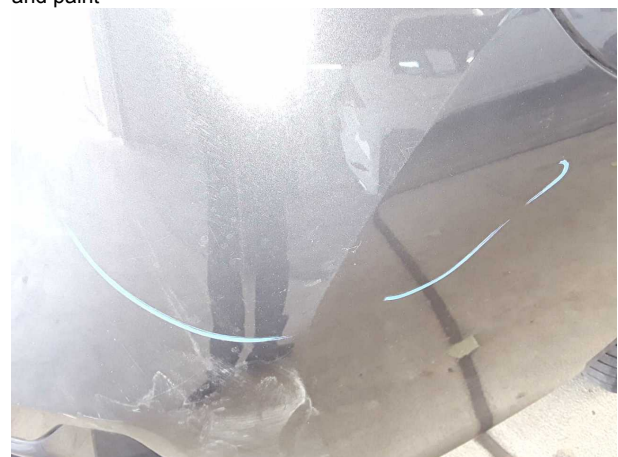
| No. | Component group | Description |
|---|---|---|
| 10 | Rear bumper | Rear bumper - Scratched - Repair and paint |

**Damage #10:** Rear bumper: Rear bumper - Scratched - Repair and paint

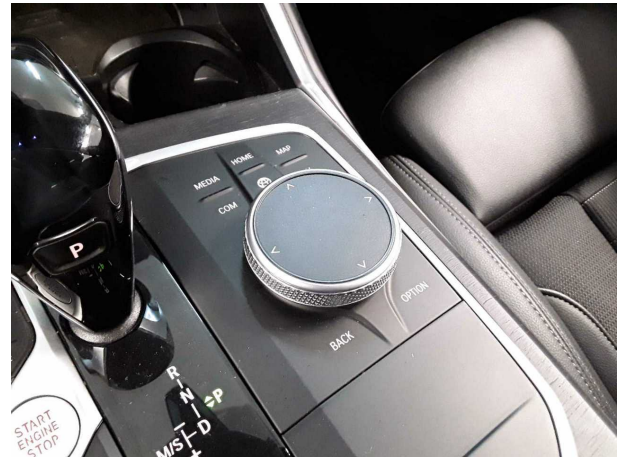
| No. | Component group | Description |
|---|---|---|
| 9 | Electronic systems | Electronic systems (IDrive ohne Funktion) - Specify findings - Perform diagnosis |

**Damage #9:** Electronic systems: Electronic systems (iDrive ohne Funktion) - Specify findings - Perform diagnosis

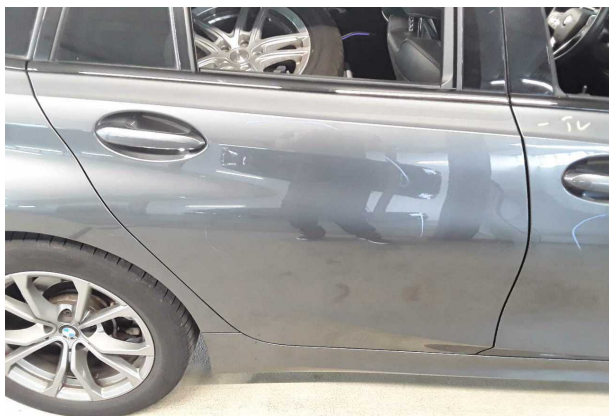
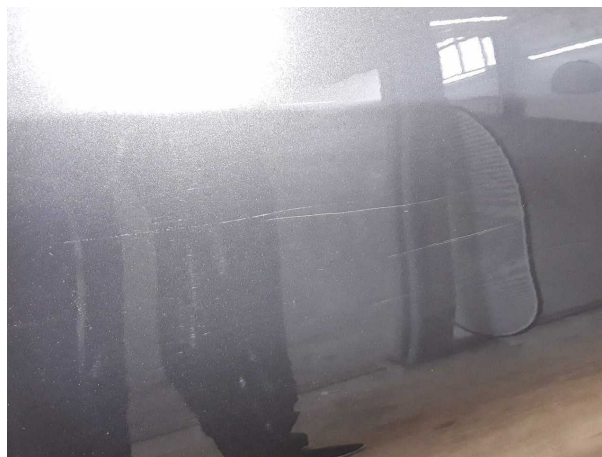
| No. | Component group | Description |
|---|---|---|
| 11 | Door - rear right side | Door - Scratched - Repair and paint |

**Damage #11:** Door - rear right side: Door - Scratched - Repair and paint

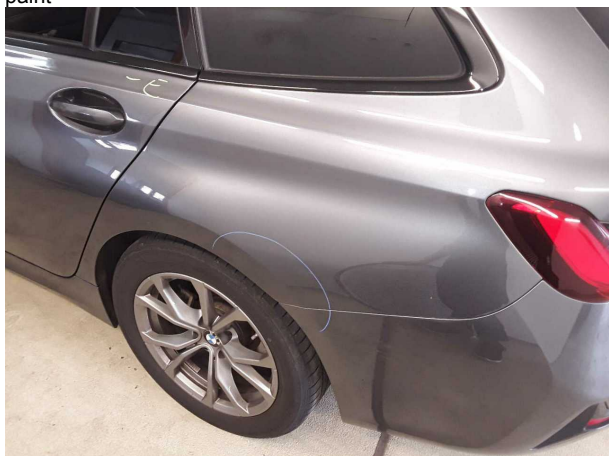
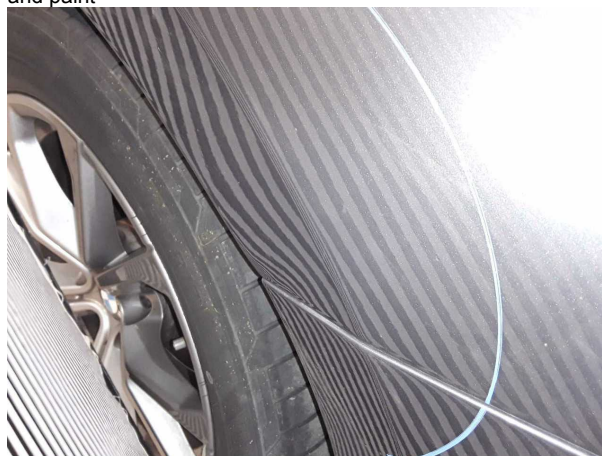
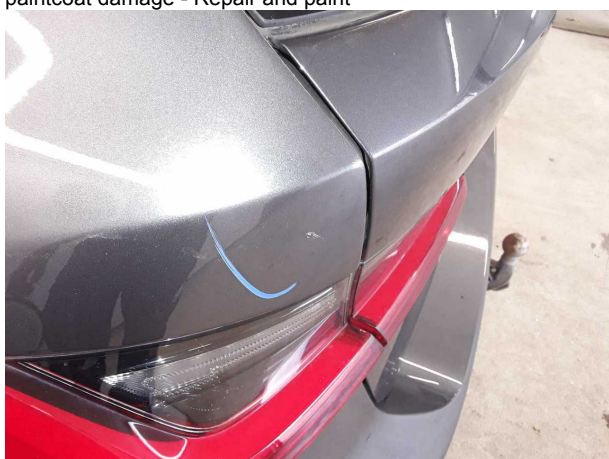
| No. | Component group | Description |
|---|---|---|
| 12 | Side panel - rear left side | Side panel - Dent / paintcoat damage - Repair and paint |

**Damage #12:** Side panel - rear left side: Side panel - Dent / paintcoat damage - Repair and paint

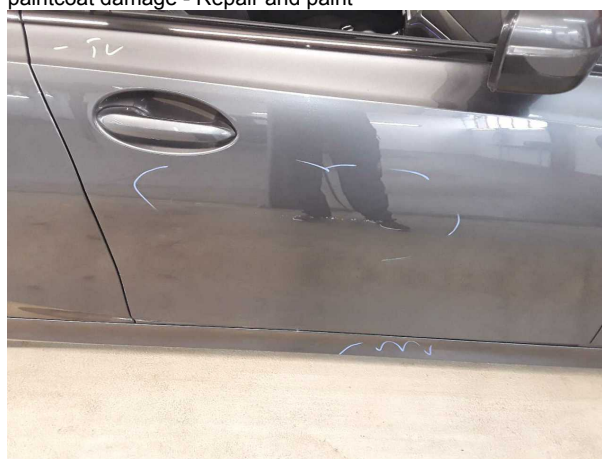
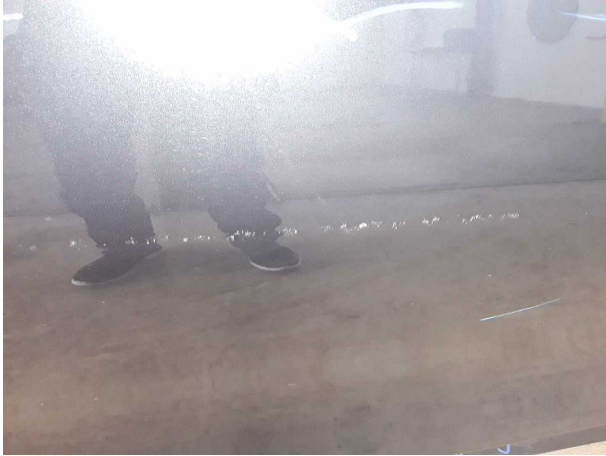
| No. | Component group | Description |
|---|---|---|
| 13 | Door - front right side | Door - Scratched - Repair and paint |

**Damage #13:** Door - front right side: Door - Scratched - Repair and paint
