**WAUZZZF4L2100722**

## Zustandsbericht

Inspection date: 25 Mar 2025  
**Protocol number: 39003972**

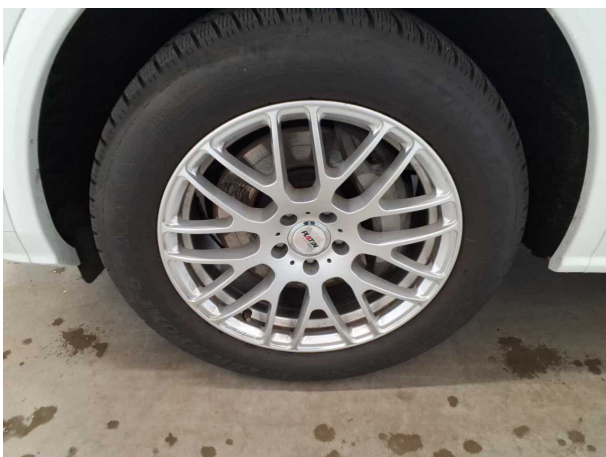
**Figure 17: Mounted tyres**

The wear and tear condition and possible damages to the tyres are considered in the value.

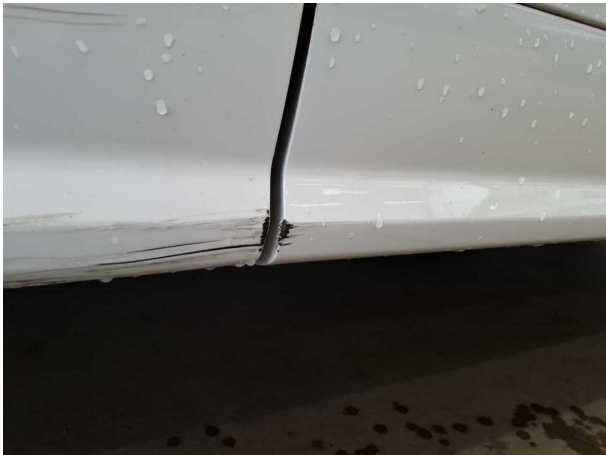
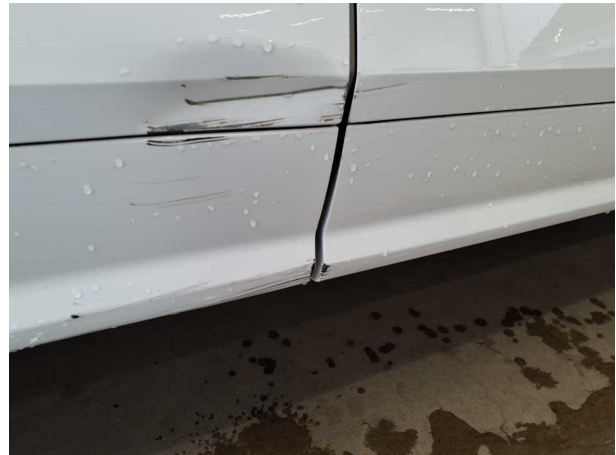
| No. | Component group | Description |
|---|---|---|
| 1 | Door - front right side | Brightware - lower - Scratched - Replace |

**Damage #1:** Door - front right side: Brightware - lower - Scratched - Replace

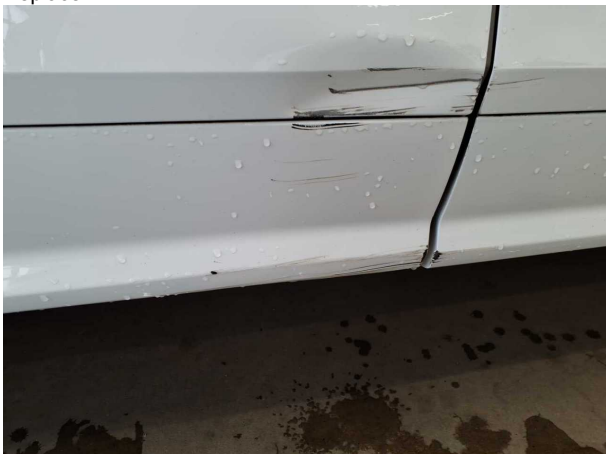
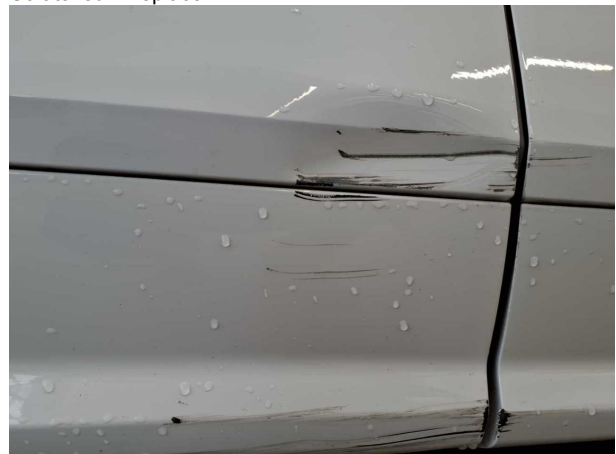
| No. | Component group | Description |
|---|---|---|
| 2 | Door - rear right side | Brightware - lower - Scratched - Replace |

**Damage #2:** Door - rear right side: Brightware - lower - Scratched - Replace

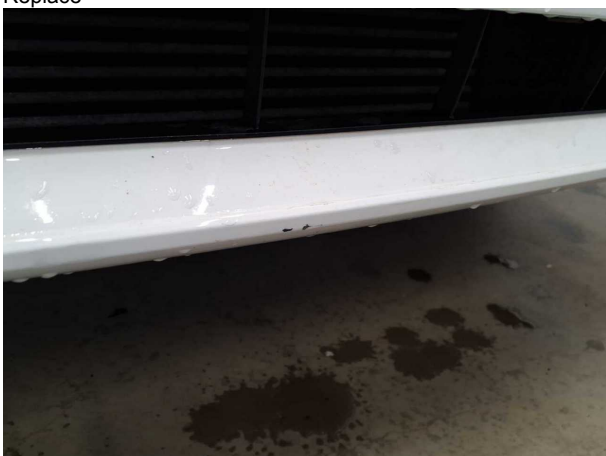
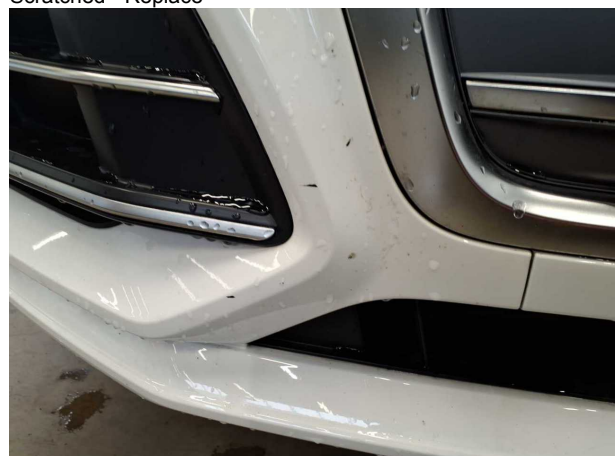
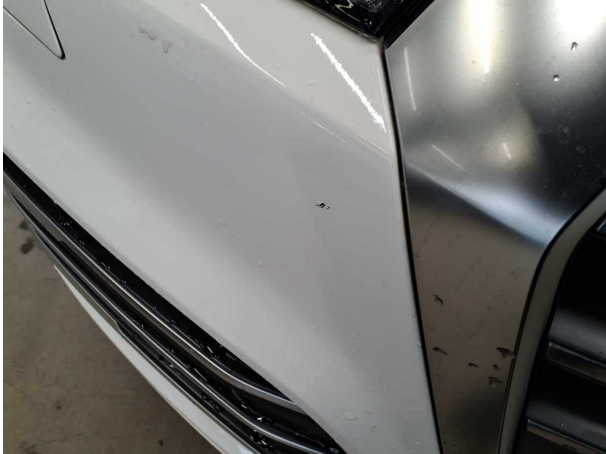
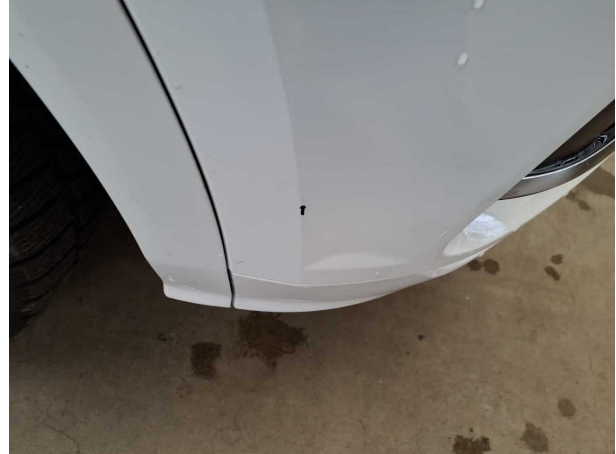
| No. | Component group | Description |
|---|---|---|
| 3 | Front bumper | Front bumper - Scratched - Paint |

**Damage #3:** Front bumper: Front bumper - Scratched - Paint

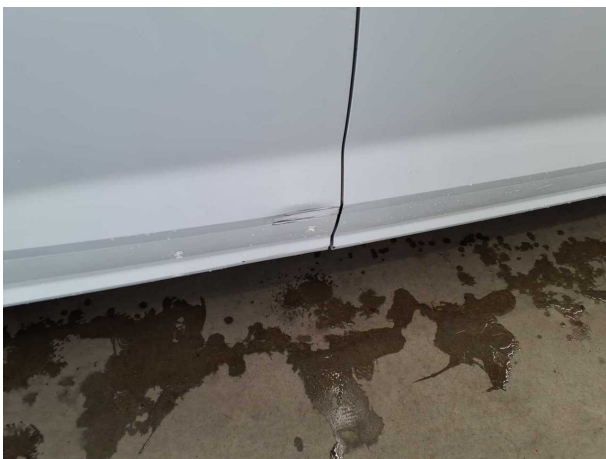
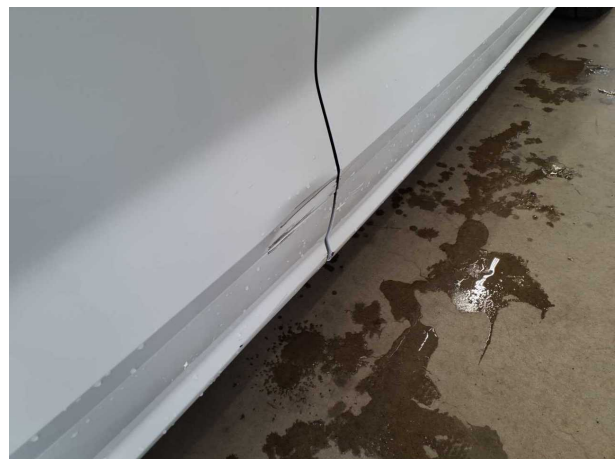
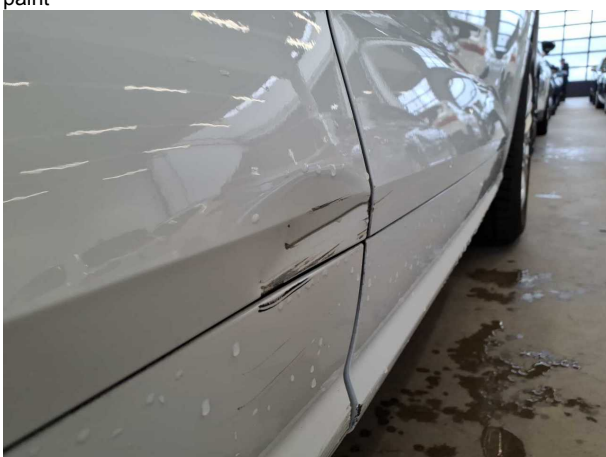
| No. | Component group | Description |
|---|---|---|
| 4 | Door - rear right side | Door - Scratched - Repair and paint |

**Damage #4:** Door - rear right side: Door - Scratched - Repair and paint

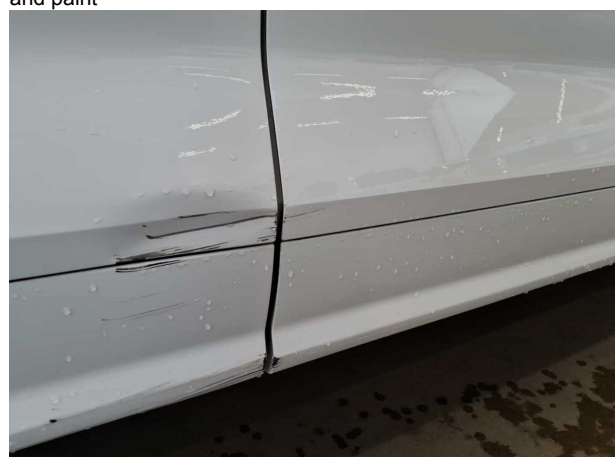
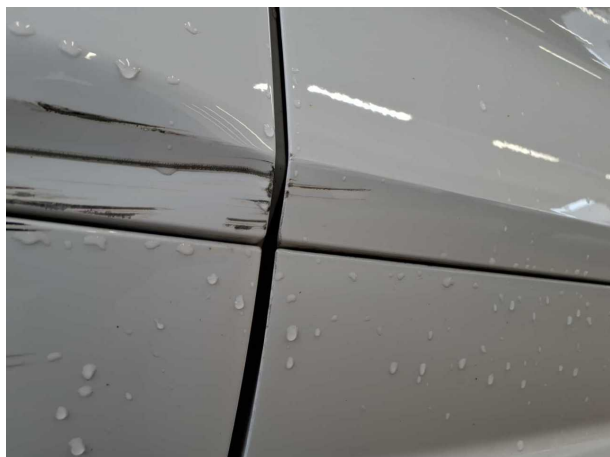
| No. | Component group | Description |
|---|---|---|
| 5 | Door - front right side | Door - Scratched - Repair and paint |

**Damage #5:** Door - front right side: Door - Scratched - Repair and paint
