**WBA31AJ040CG48163**

## Zustandsbericht

Inspection date: 21 Feb 2025  
**Protocol number: 38537792**

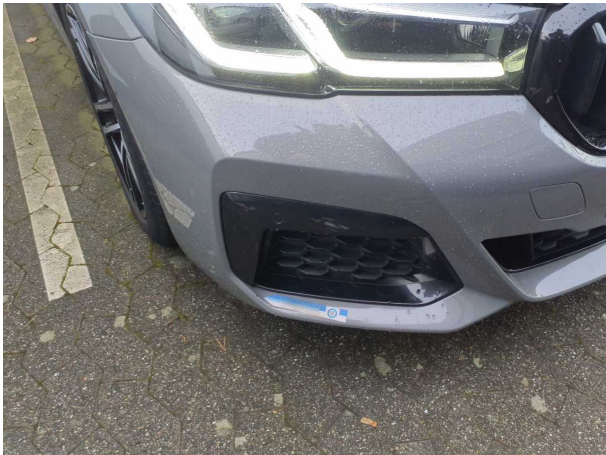
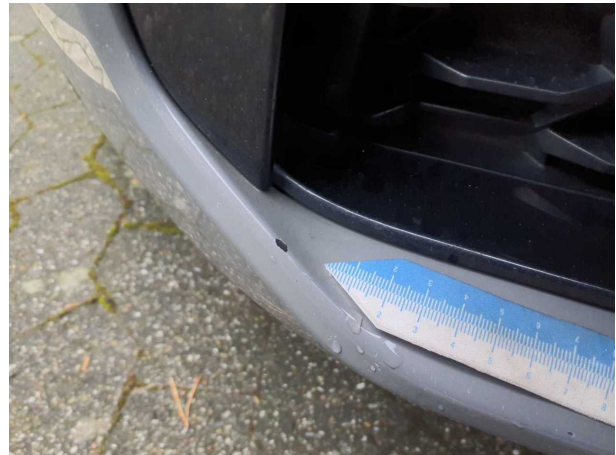
**Damage #1:** Front bumper: Front bumper - Scratched - Cover / polish

| No. | Component group | Description |
|---|---|---|
| 1 | Front bumper | Front bumper - Scratched - Cover / polish |

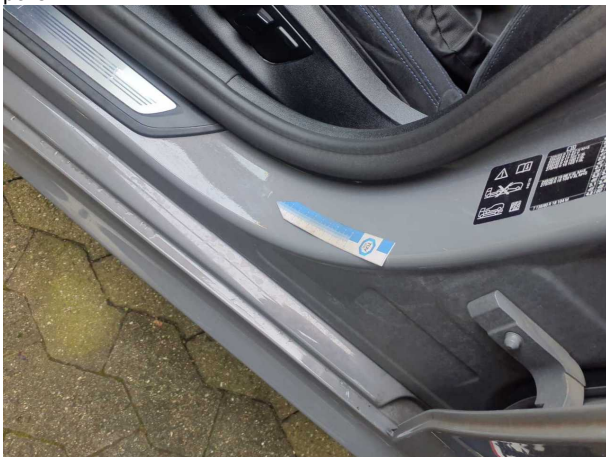
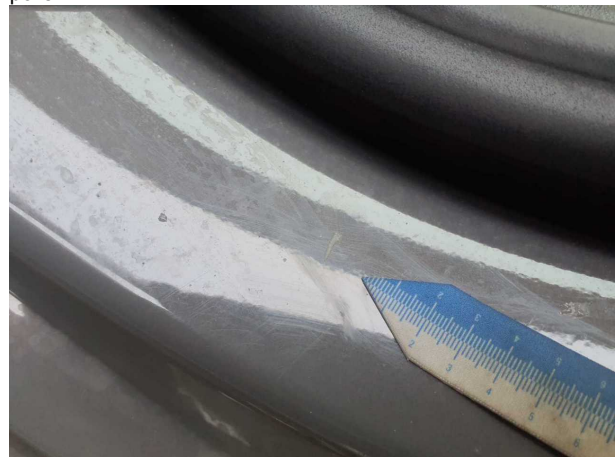
**Damage #2:** Sill - left side: Sill - Scratched - Smart repair

| No. | Component group | Description |
|---|---|---|
| 2 | Sill - left side | Sill - Scratched - Smart repair |

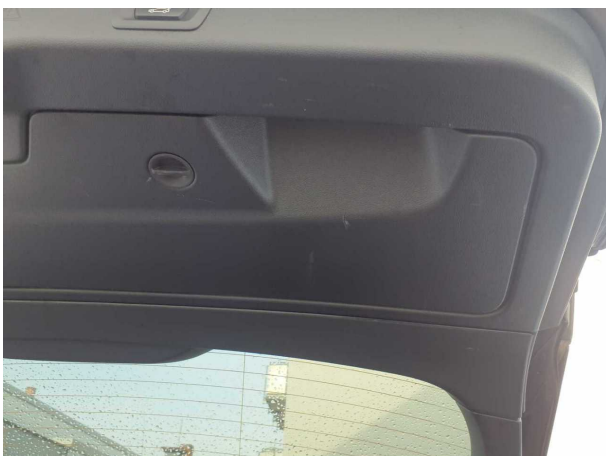
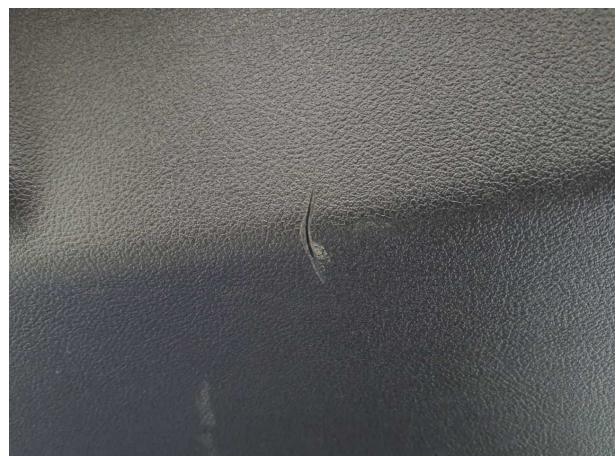
**Damage #3:** Trim / covers: Boot lid - interior trim - Scratched - Replace

| No. | Component group | Description |
|---|---|---|
| 3 | Trim / covers | Boot lid - interior trim - Scratched - Replace |

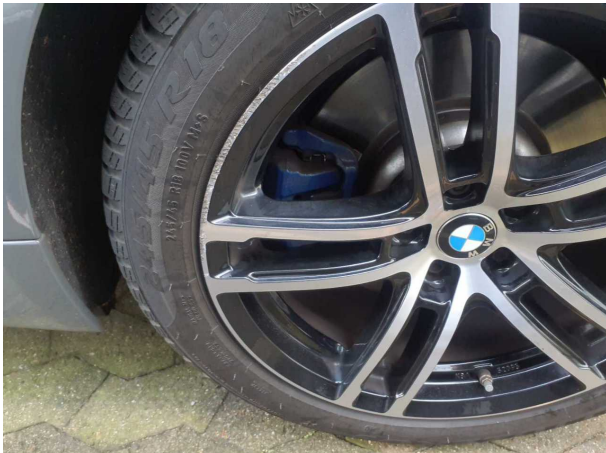
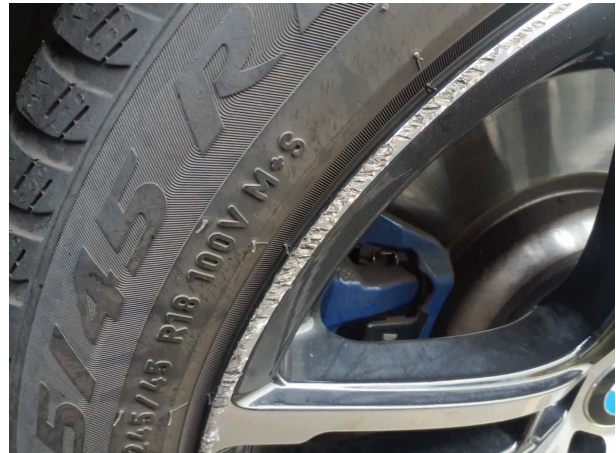
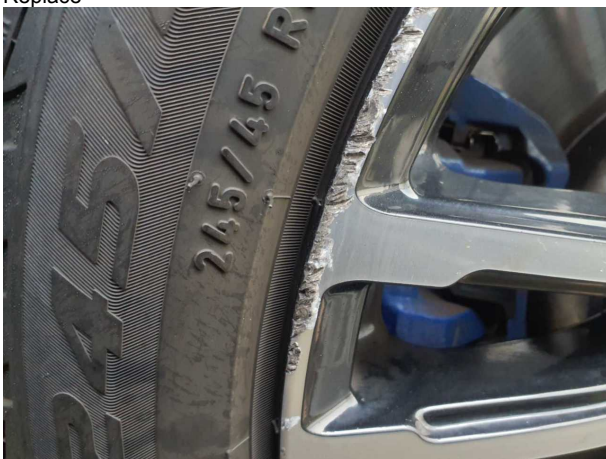
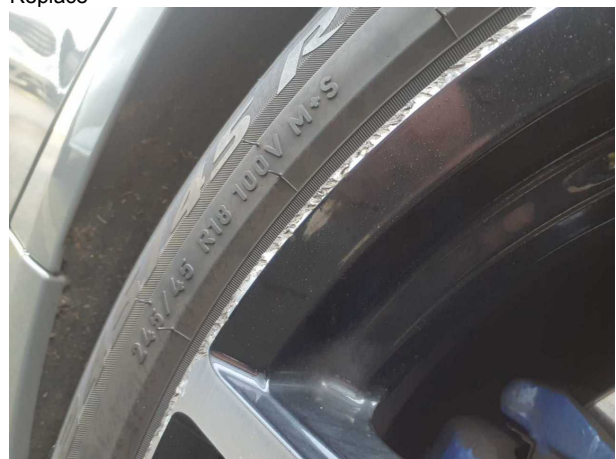
**Damage #4:** Wheel / tyres: Alloy rim - rear left side - Damaged - Replace

**Damage #4:** Wheel / tyres: Alloy rim - rear left side - Damage... Replace

| No. | Component group | Description |
|---|---|---|
| 4 | Wheel / tyres | Alloy rim - rear left side - Damaged - Replace |

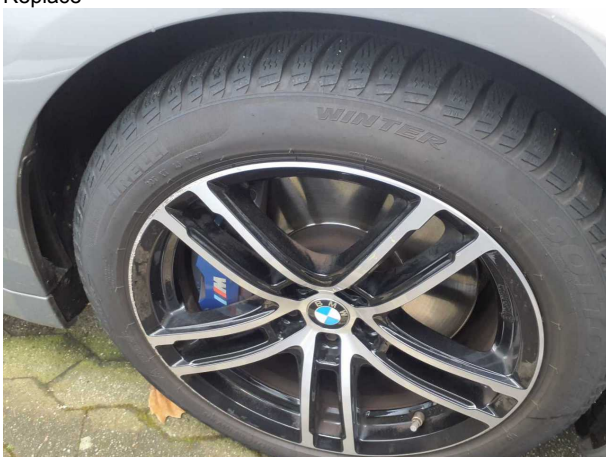
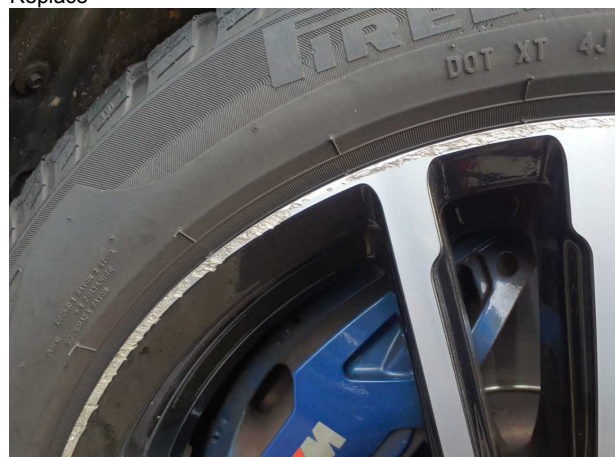
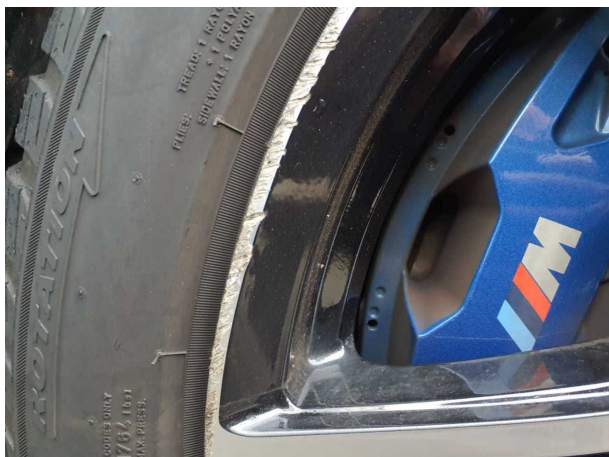
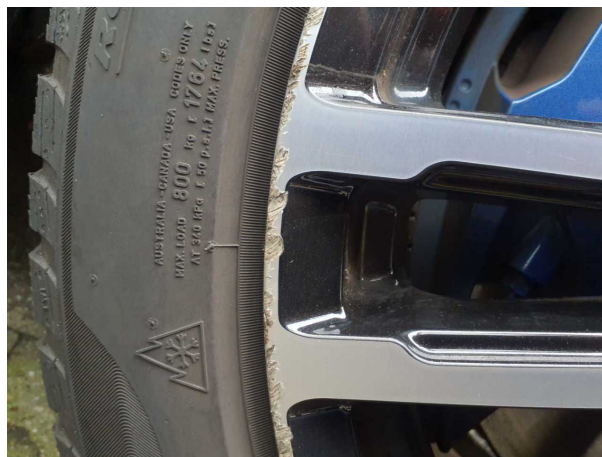
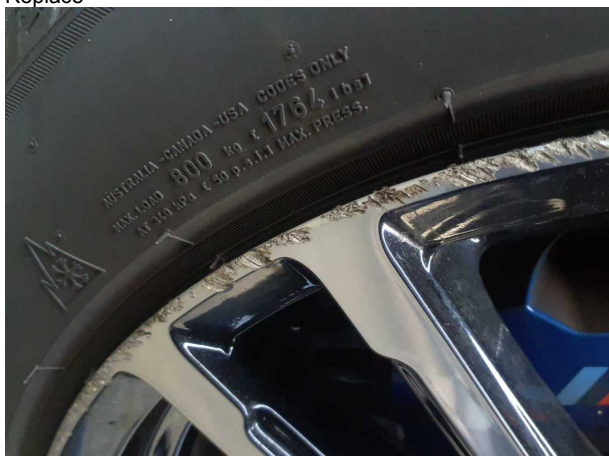
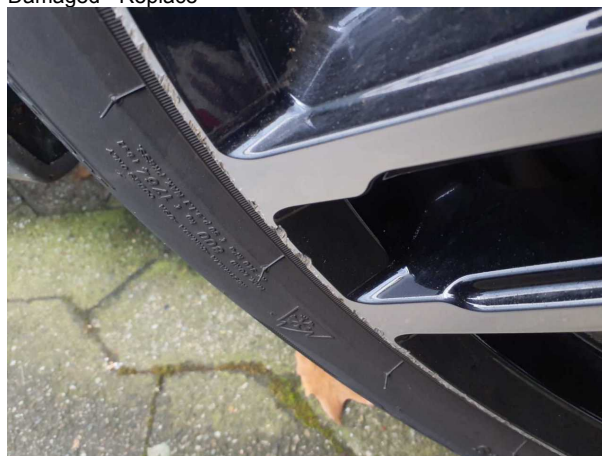
**Damage #5:** Wheel / tyres: Alloy rim - front right side - Damaged - Replace

| No. | Component group | Description |
|---|---|---|
| 5 | Wheel / tyres | Alloy rim - front right side - Damaged - Replace |

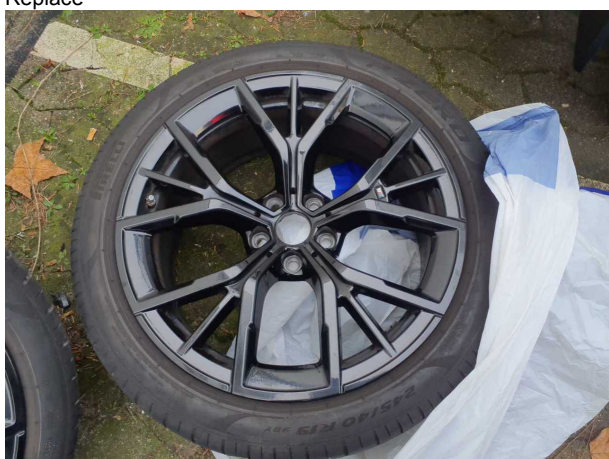
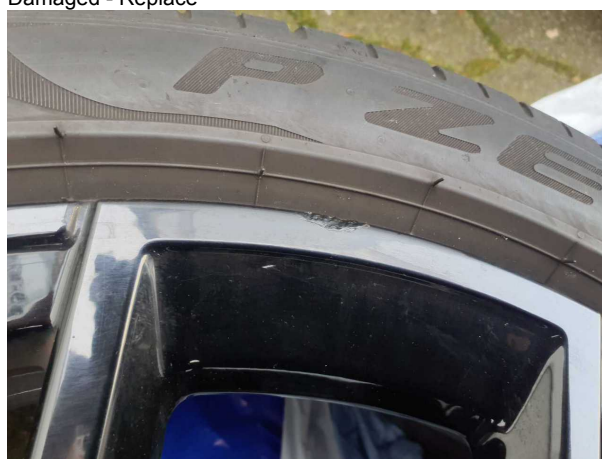
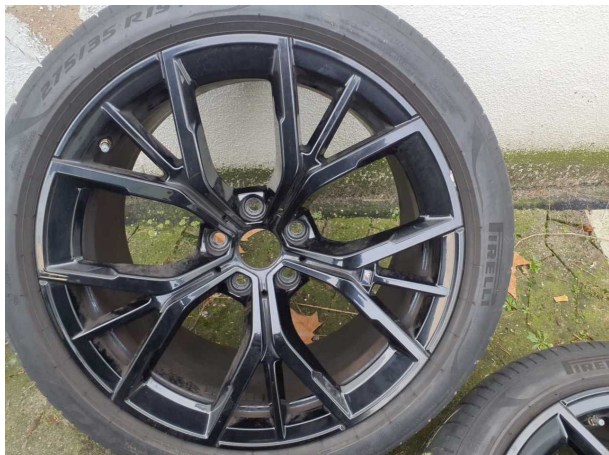
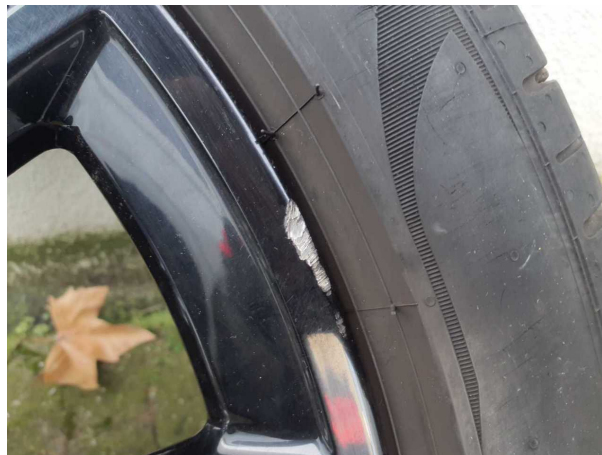
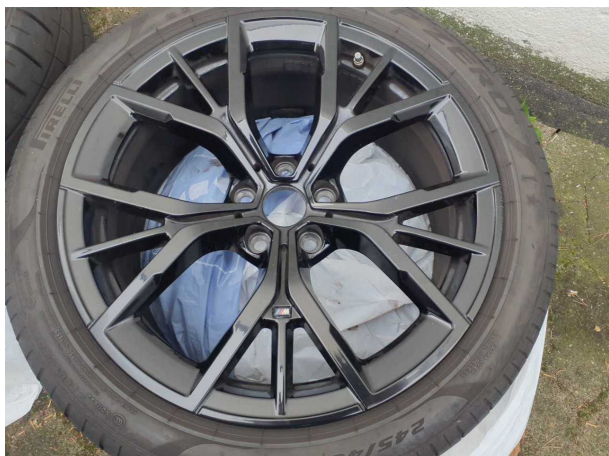
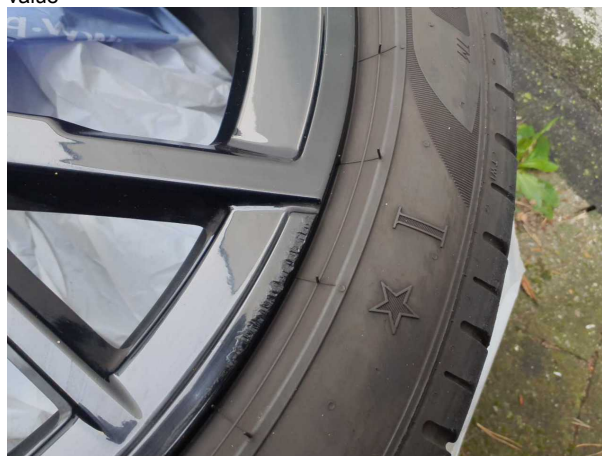
**Damage #6:** 2nd wheel set: 3 alloy rims - Scratched - Loss in value

| No. | Component group | Description |
|---|---|---|
| 6 | 2nd wheel set | 3 alloy rims - Scratched - Loss in value |

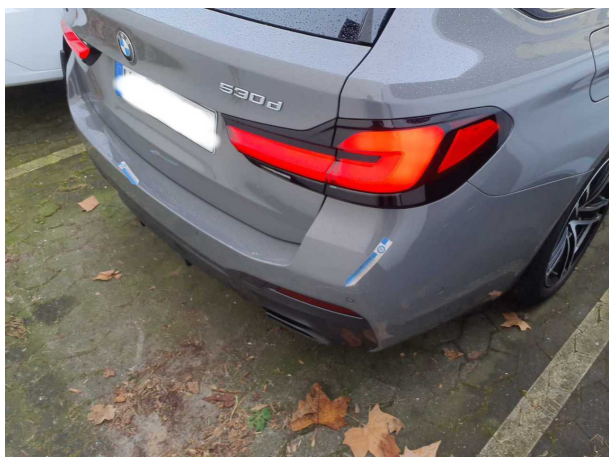
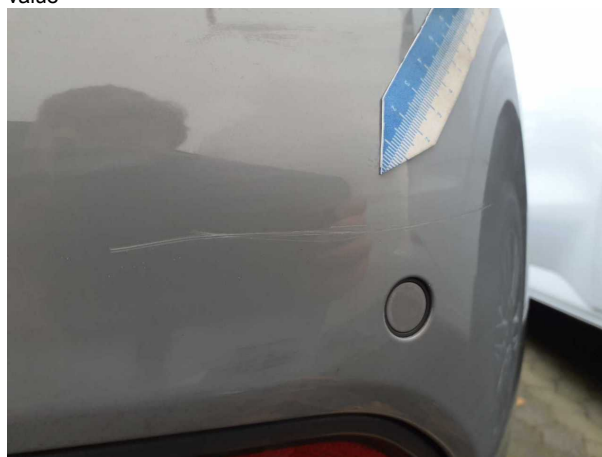
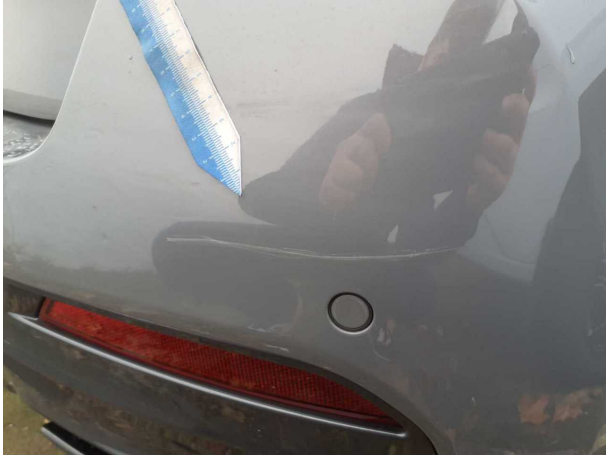
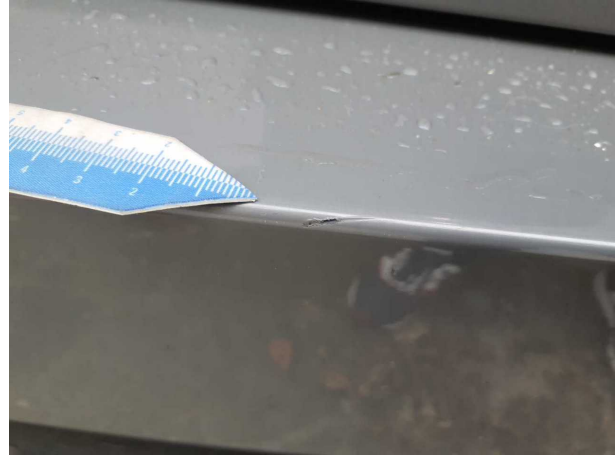
**Damage #7:** Rear bumper: Rear bumper - Scratched - Paint

| No. | Component group | Description |
|---|---|---|
| 7 | Rear bumper | Rear bumper - Scratched - Paint |
