**WAUZZZF55PA019486**

## Zustandsbericht

**TÜV SÜD Auto Plus GmbH**  
Gutenbergstr. 13  
70771 Leinfelden-Echterdingen

**Protocol number:** 39097450

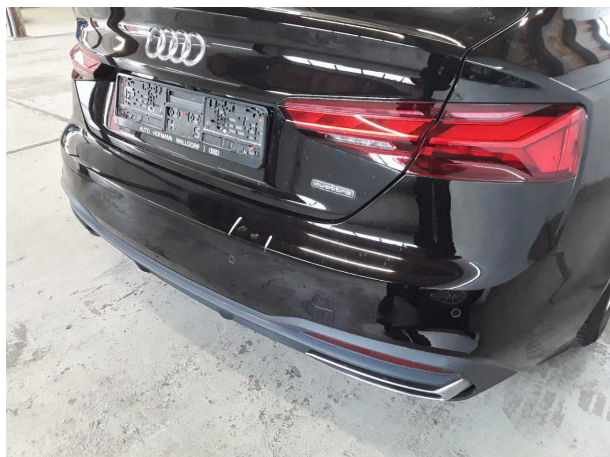
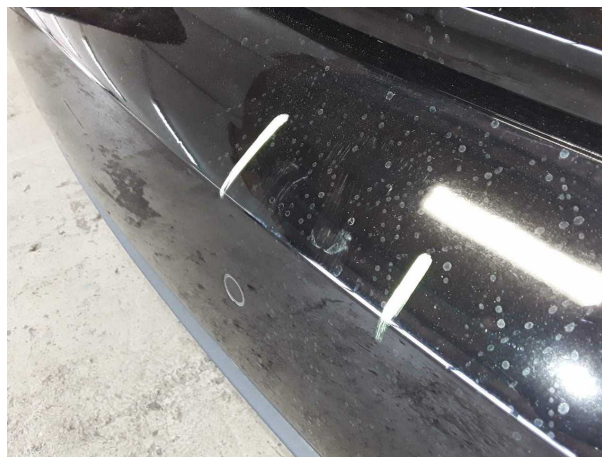
| No. | Component group | Description |
|---|---|---|
| 1 | Rear bumper | Rear bumper - Scratched - Cover / polish |

**Damage #1:** Rear bumper: Rear bumper - Scratched - Cover / polish

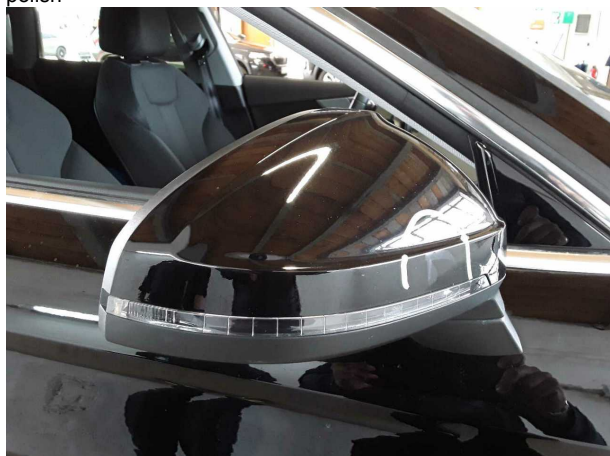
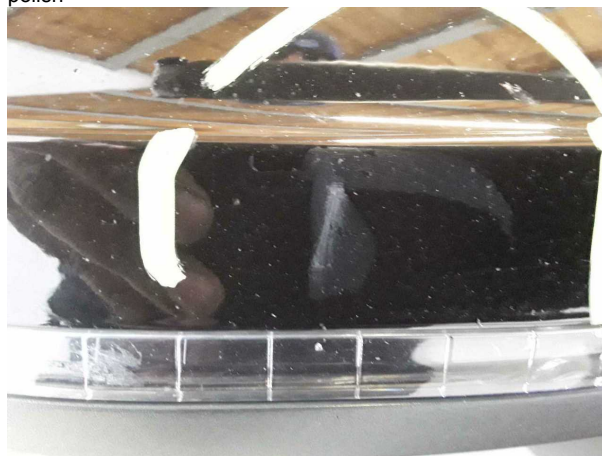
| No. | Component group | Description |
|---|---|---|
| 2 | Wing mirror - right side | Cap - Scratched - Smart repair |

**Damage #2:** Wing mirror - right side: Cap - Scratched - Smart repair

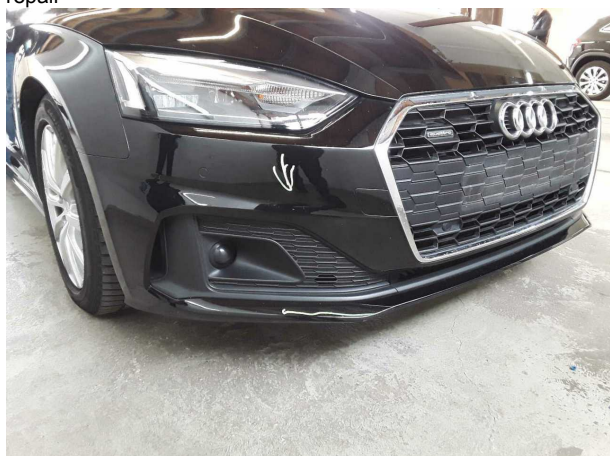
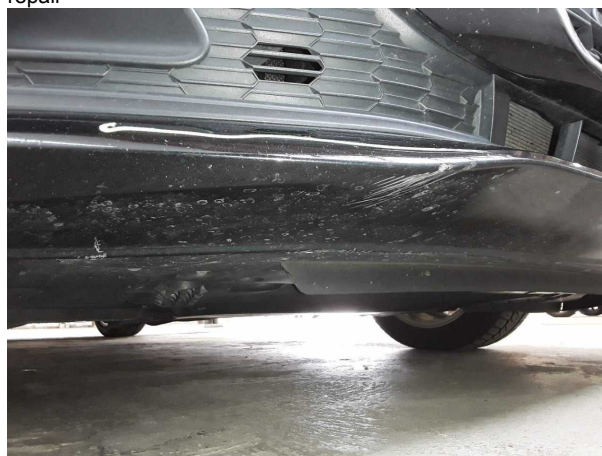
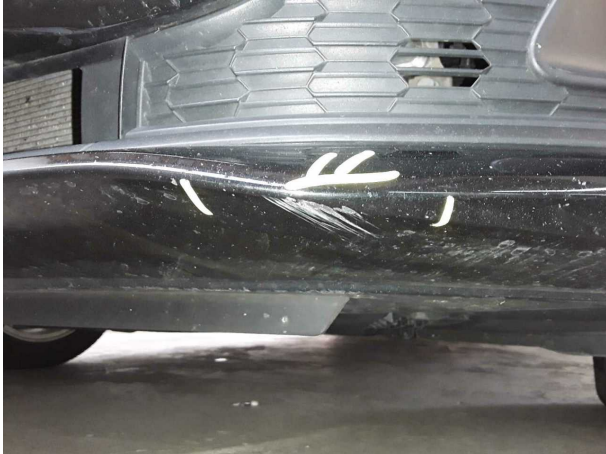
| No. | Component group | Description |
|---|---|---|
| 3 | Front bumper | Front bumper - Scratched - Smart repair |

**Damage #3:** Front bumper: Front bumper - Scratched - Smart repair

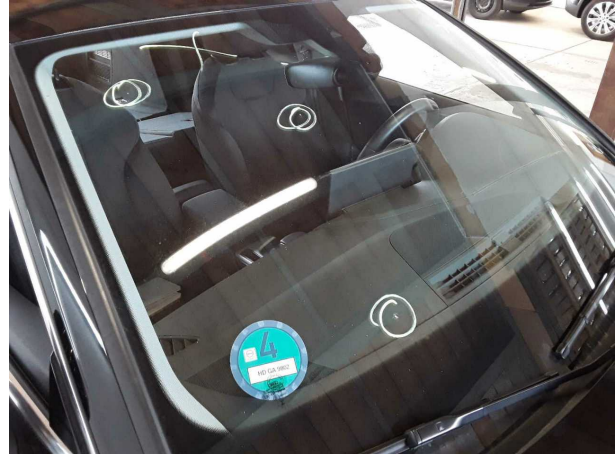
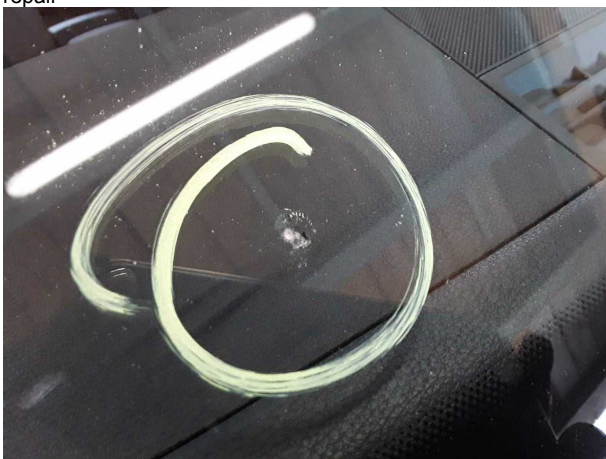
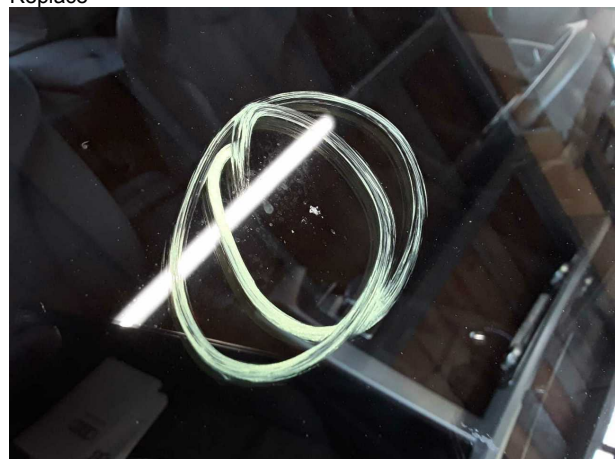
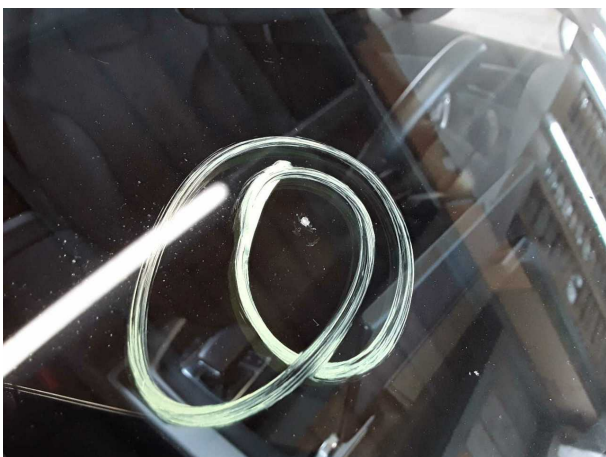
| No. | Component group | Description |
|---|---|---|
| 4 | Vehicle glazing | Windscreen - Stone chips - Replace |

**Damage #4:** Vehicle glazing: Windscreen - Stone chips - Replace
