WBA31BN070CG90391

## Zustandsbericht

Inspection date: 28 Mar 2025  
**Protocol number:** 39078421  
Delivery date: 28 Mar 2025

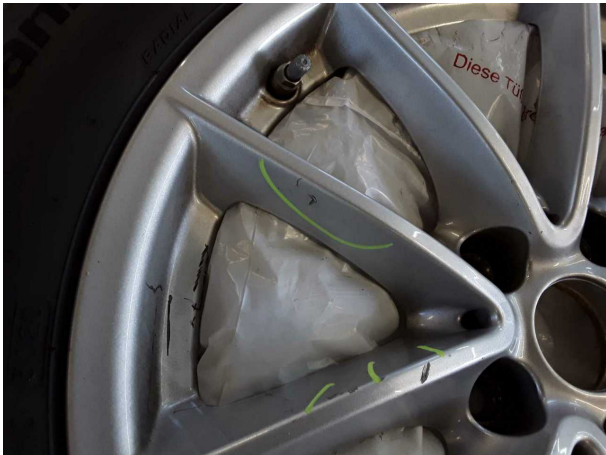
| No. | Component group | Description |
|---|---|---|
| 1 | 2nd wheel set | 1 alloy rim - Scratched - Loss in value |

**Damage #1:** 2nd wheel set: 1 alloy rim - Scratched - Loss in value

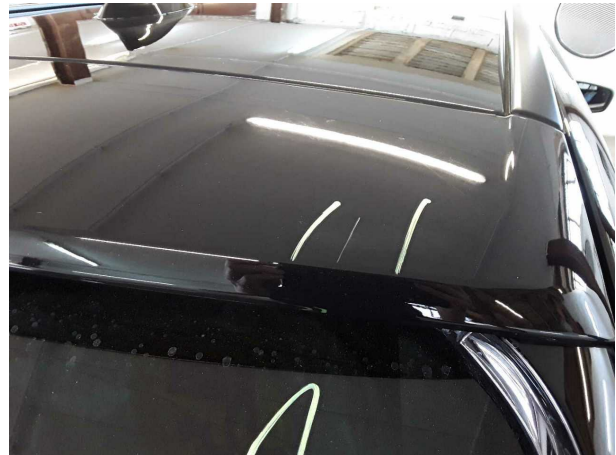
| No. | Component group | Description |
|---|---|---|
| 2 | Boot lid / rear door | Rear spoiler - Scratched - Smart repair |

**Damage #2:** Boot lid / rear door: Rear spoiler - Scratched - Smart repair

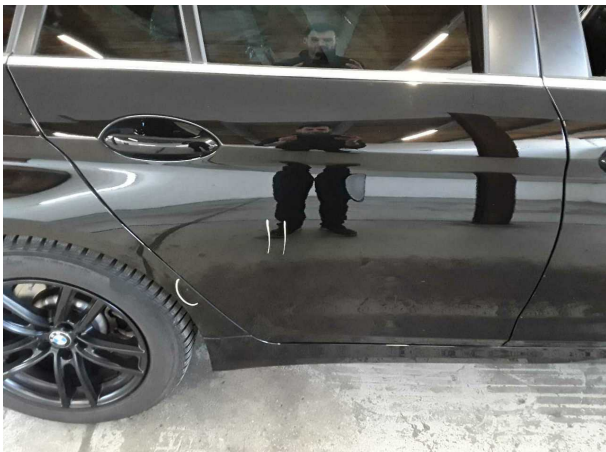
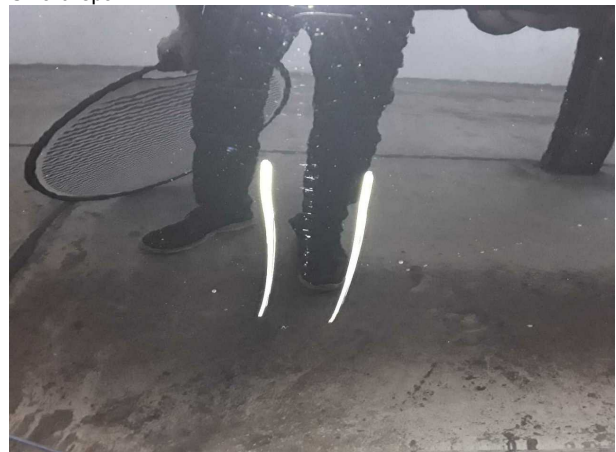
| No. | Component group | Description |
|---|---|---|
| 4 | Door - rear right side | Door - Scratch(es) - Repair and paint |

**Damage #4:** Door - rear right side: Door - Scratch(es) - Repair and paint

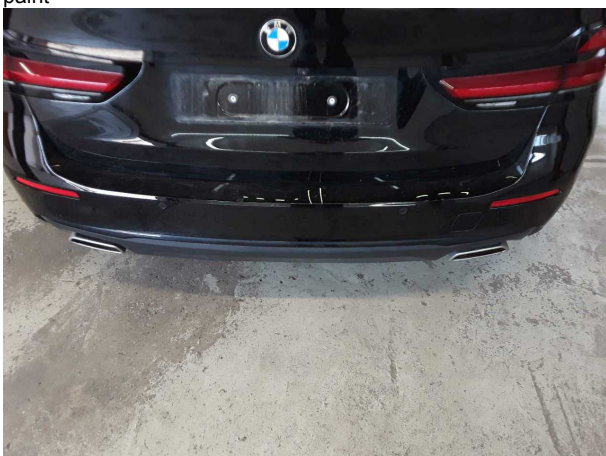
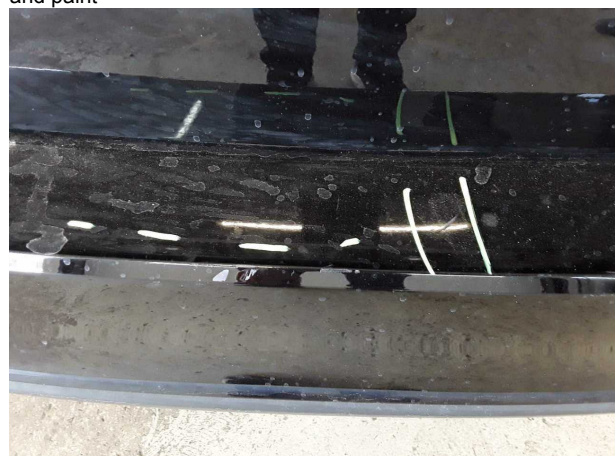
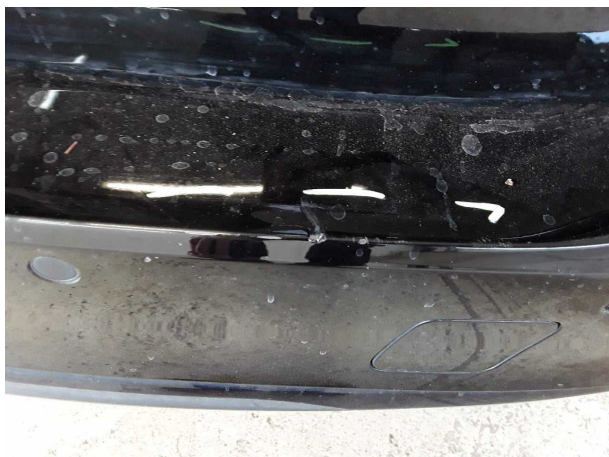
| No. | Component group | Description |
|---|---|---|
| 5 | Rear bumper | Rear bumper - Scratched - Repair and paint |

**Damage #5:** Rear bumper: Rear bumper - Scratched - Repair and paint

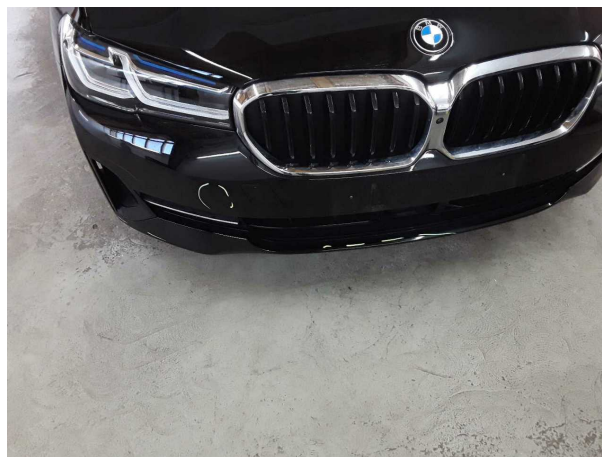
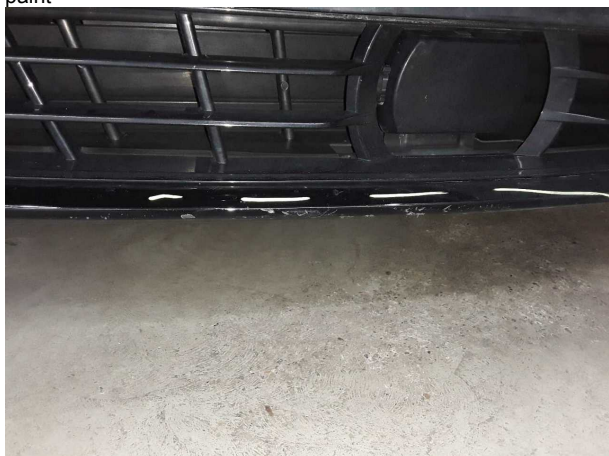
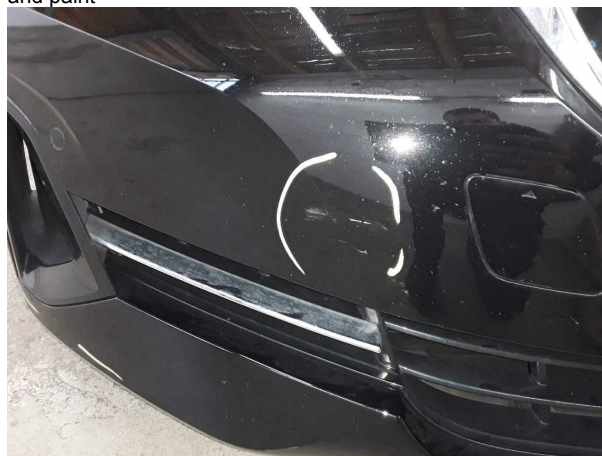
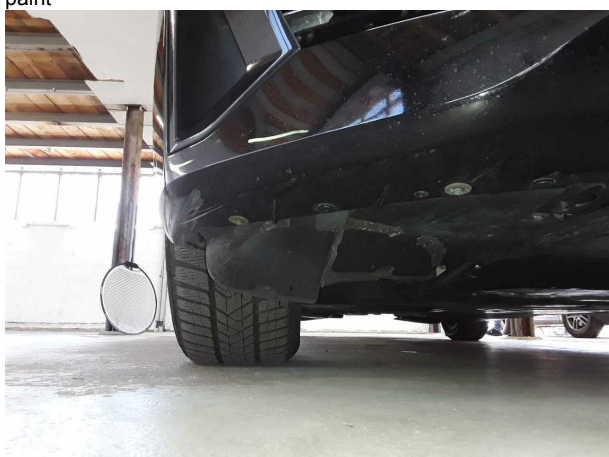
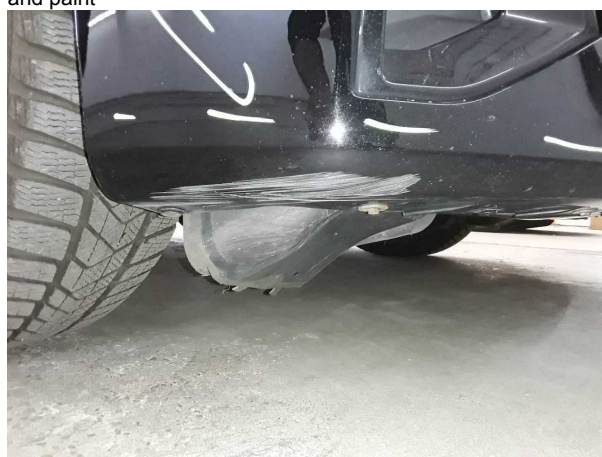
| No. | Component group | Description |
|---|---|---|
| 6 | Front bumper | Front bumper - Scratched - Repair and paint |

**Damage #6:** Front bumper: Front bumper - Scratched - Repair and paint

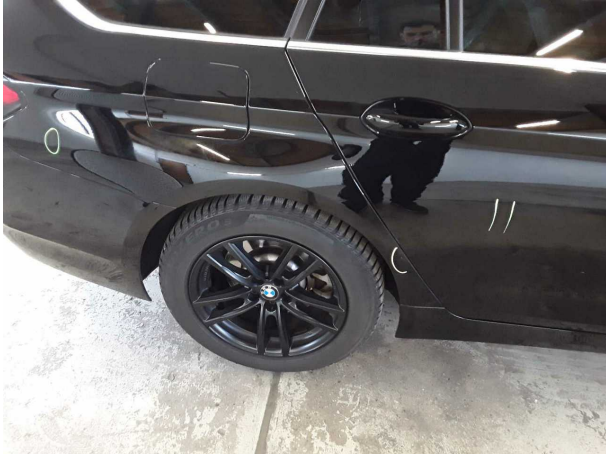
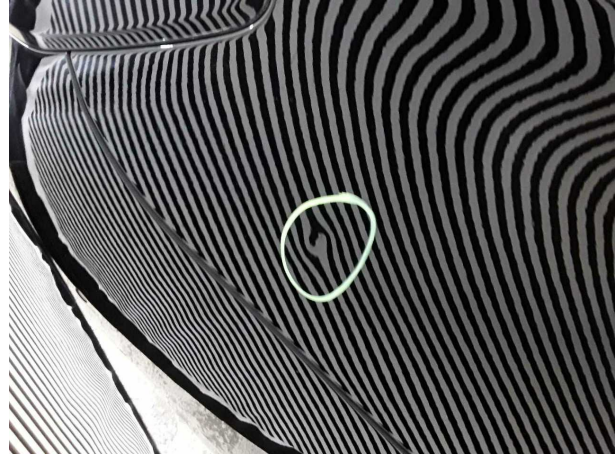
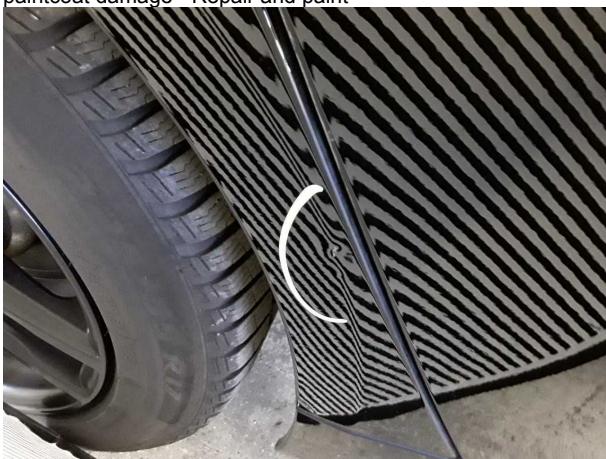
| No. | Component group | Description |
|---|---|---|
| 7 | Side panel - rear right side | Side panel - Dent / paintcoat damage - Repair and paint |

**Damage #7:** Side panel - rear right side: Side panel - Dent / paintcoat damage - Repair and paint
