WF0PXXGCHPMJ31100

## Zustandsbericht

Inspection date: 3 Apr 2025

**Protocol number:** 39162307

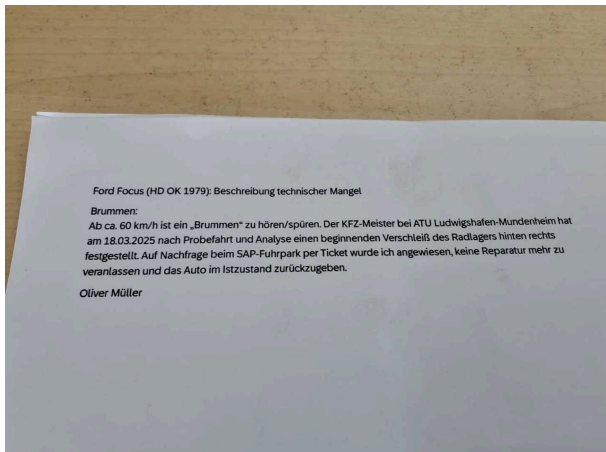
| No. | Component group | Description |
|---|---|---|
| 3 | Rear axle | Wheel bearing - right side - Specify findings - Perform diagnosis |

**Damage #3:** Rear axle: Wheel bearing - right side - Specify findin...  
- Perform diagnosis

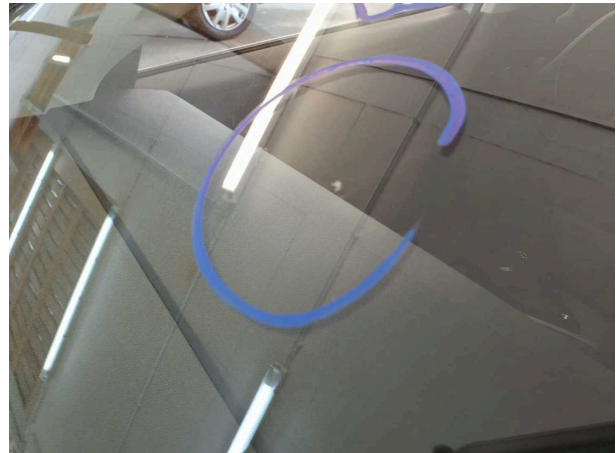
| No. | Component group | Description |
|---|---|---|
| 4 | Vehicle glazing | Windscreen - Stone chips - Replace |

**Damage #4:** Vehicle glazing: Windscreen - Stone chips -  
Replace

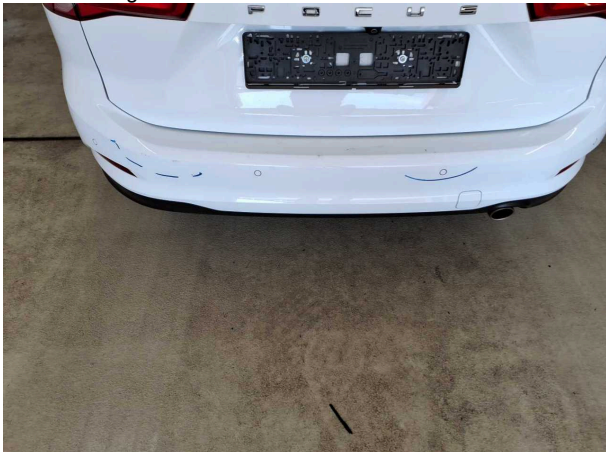
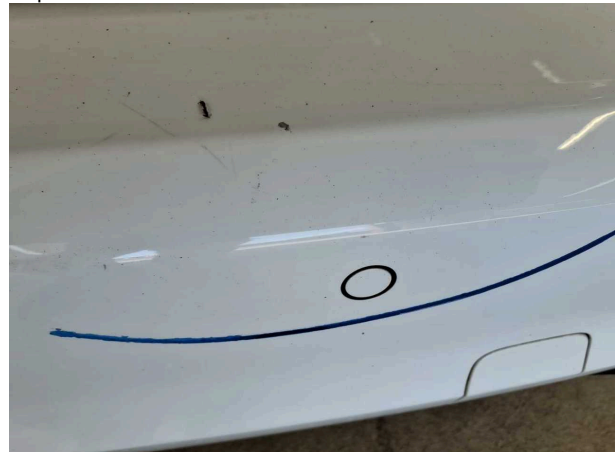
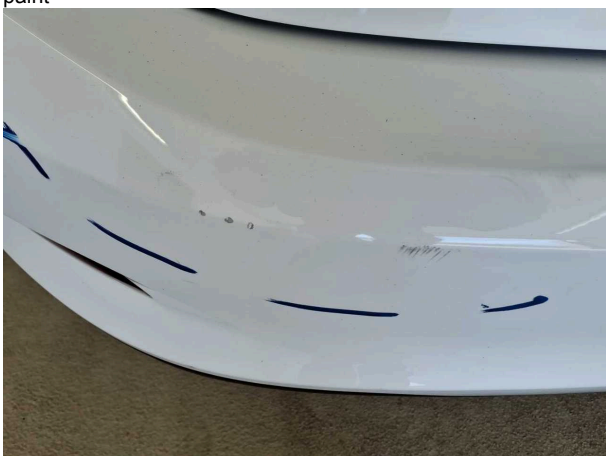
| No. | Component group | Description |
|---|---|---|
| 5 | Rear bumper | Rear bumper - Scratched - Repair and paint |

**Damage #5:** Rear bumper: Rear bumper - Scratched - Repair and  
paint

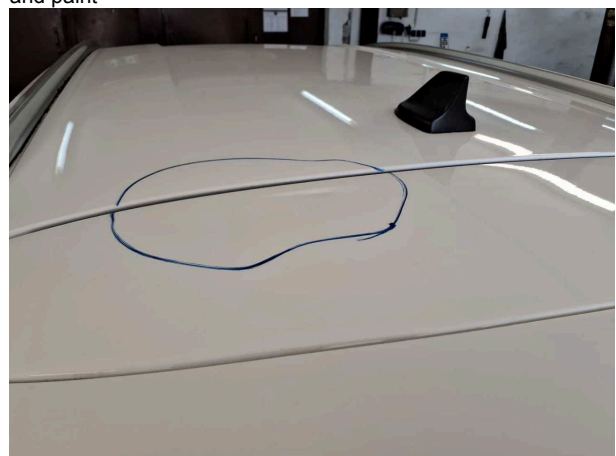
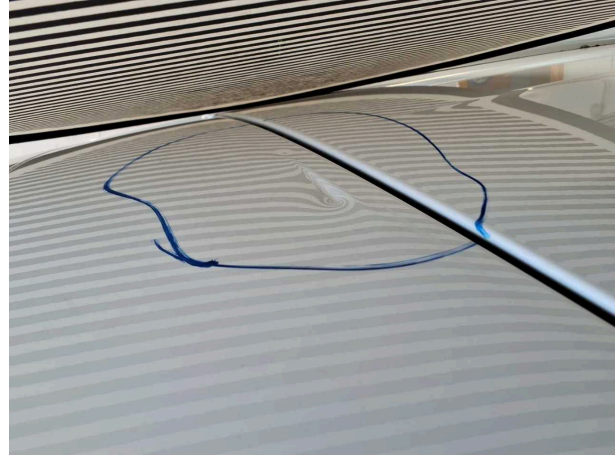
| No. | Component group | Description |
|---|---|---|
| 6 | Boot lid / rear door | Rear spoiler - Dent / paintcoat damage - Replace |

**Damage #6:** Boot lid / rear door: Rear spoiler - Dent / paintcoat  
damage - Replace

**Damage #6:** Boot lid / rear door: Rear spoiler - Dent / paintcoat damage - Replace
