WBA6Y310007F30916

## Zustandsbericht

Inspection date: 9 Apr 2025

**Protocol number:** 39254630

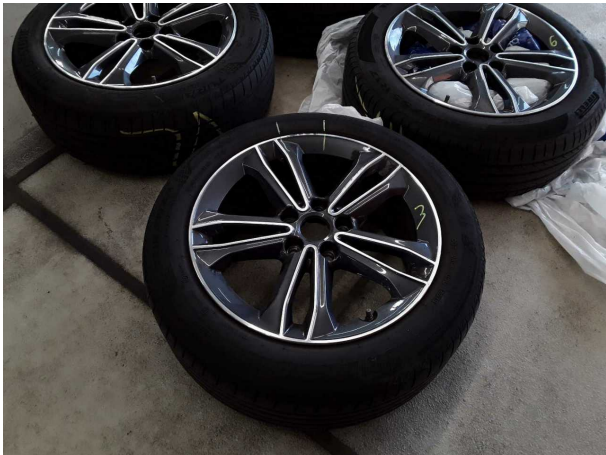
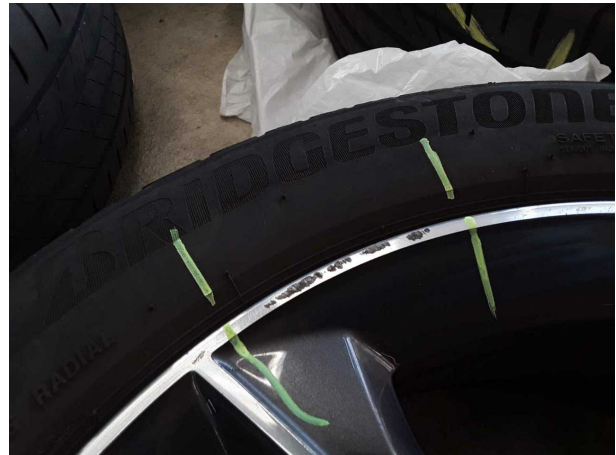
| No. | Component group | Description |
|---|---|---|
| 1 | 2nd wheel set | 1 alloy rim - Scratched - Loss in value |

**Damage #1:** 2nd wheel set: 1 alloy rim - Scratched - Loss in value

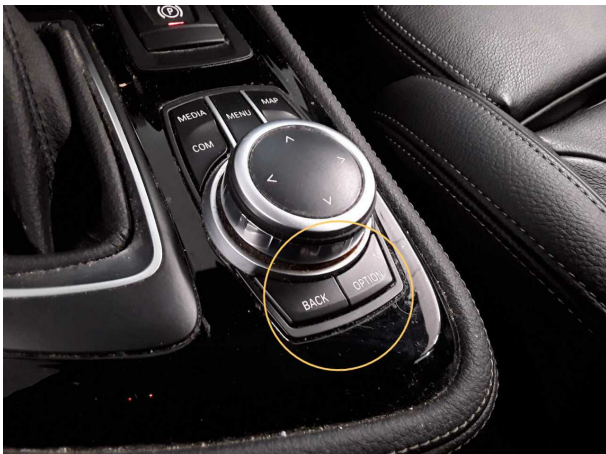
| No. | Component group | Description |
|---|---|---|
| 2 | Electrical system | Switch (Fest) - Specify findings - Perform diagnosis |

**Damage #2:** Electrical system: Switch (Fest) - Specify findings - Perform diagnosis

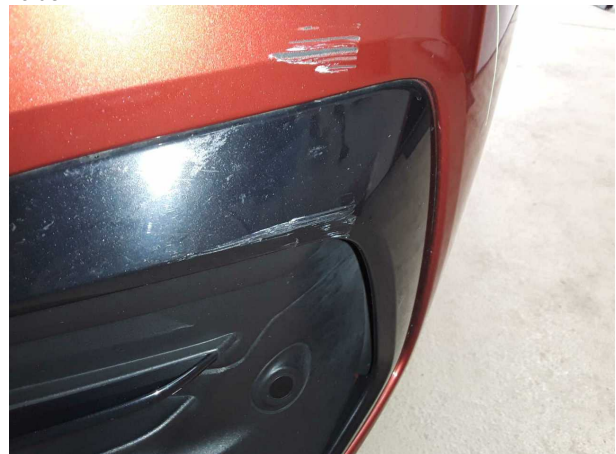
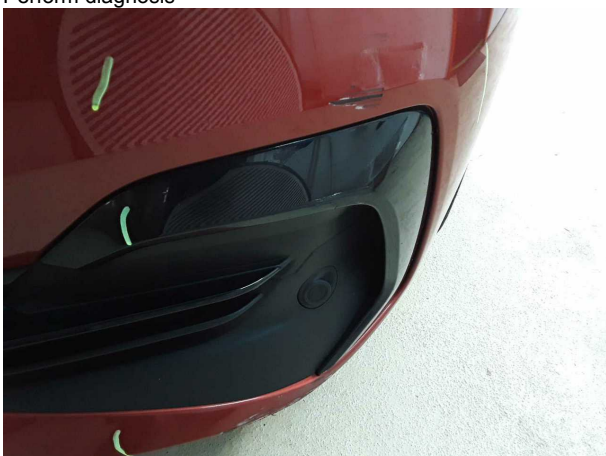
| No. | Component group | Description |
|---|---|---|
| 3 | Front bumper | Spoiler - Scratched - Replace |

**Damage #3:** Front bumper: Spoiler - Scratched - Replace

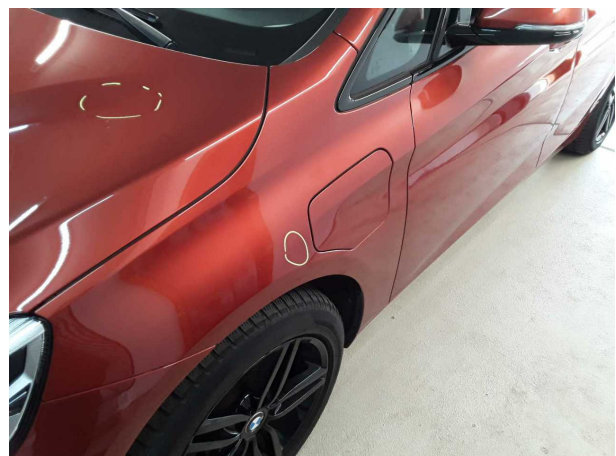
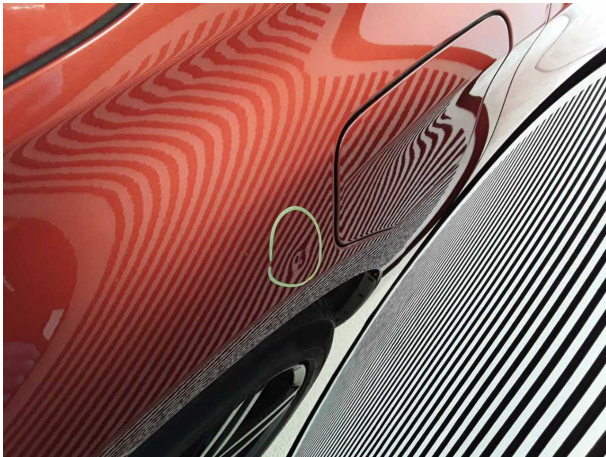
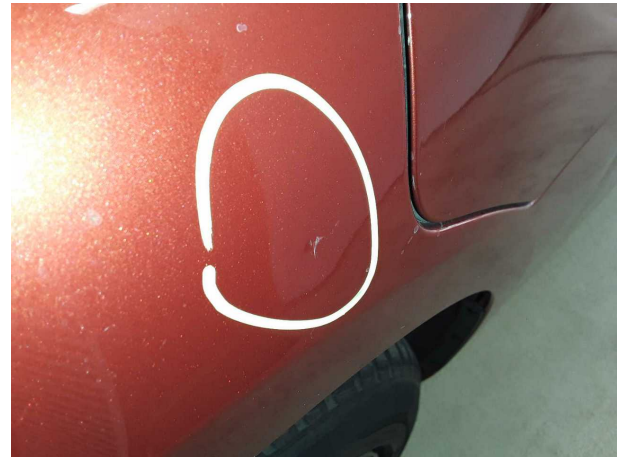
| No. | Component group | Description |
|---|---|---|
| 4 | Mudguard - left side | Mudguard - left side - Dent / paintcoat damage - Repair and paint |

**Damage #4:** Mudguard - left side: Mudguard - left side - Dent / paintcoat damage - Repair and paint

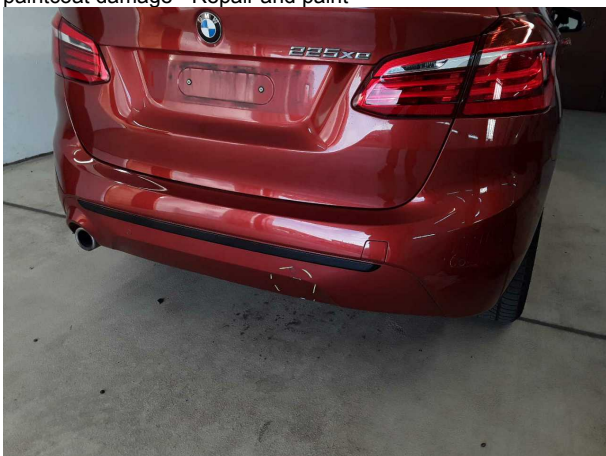
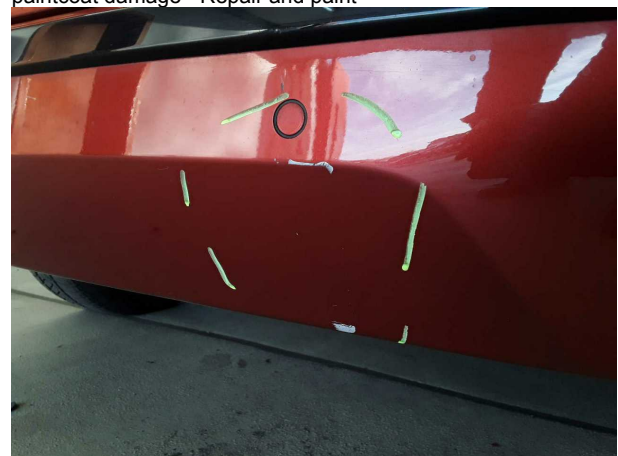
| No. | Component group | Description |
|---|---|---|
| 5 | Rear bumper | Rear bumper - Scratched - Repair and paint |

**Damage #5:** Rear bumper: Rear bumper - Scratched - Repair and paint

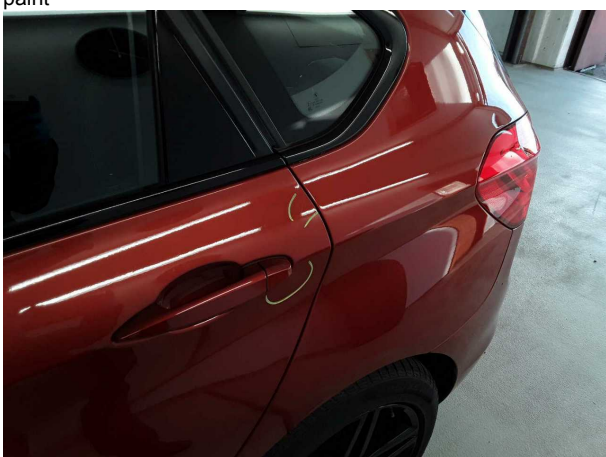
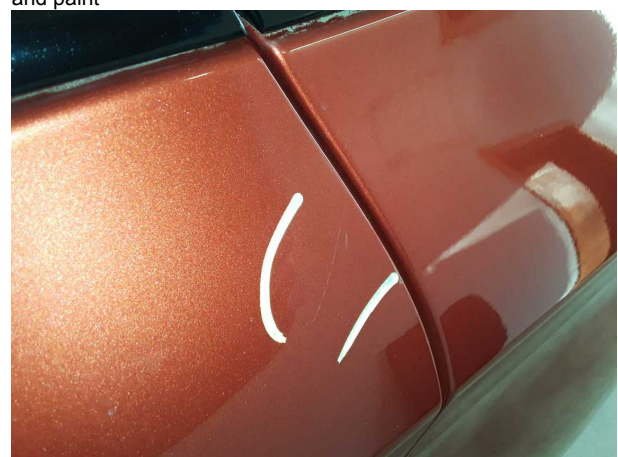
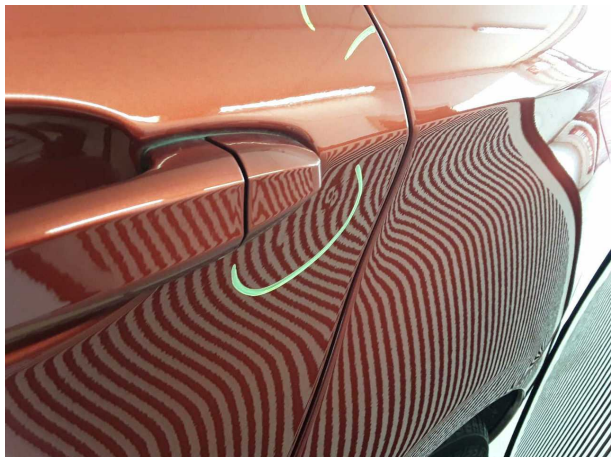
| No. | Component group | Description |
|---|---|---|
| 6 | Door - rear left side | Door - Dent / paintcoat damage - Repair and paint |

**Damage #6:** Door - rear left side: Door - Dent / paintcoat damage - Repair and paint

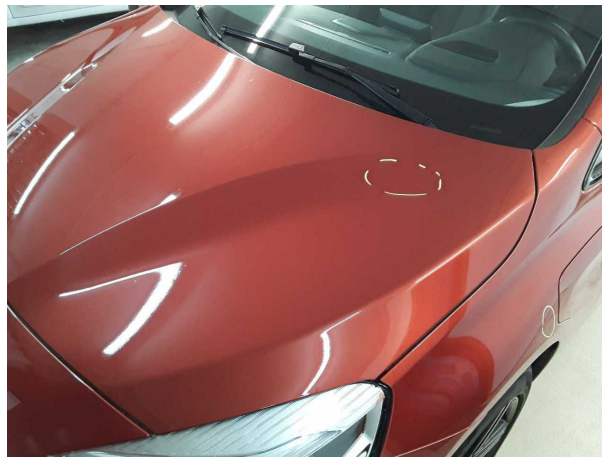
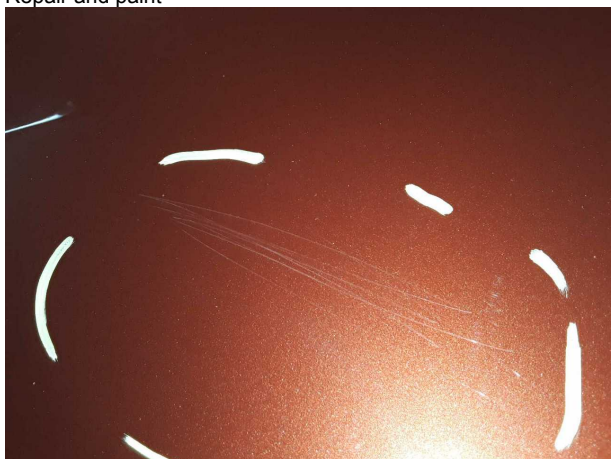
| No. | Component group | Description |
|---|---|---|
| 7 | Bonnet | Bonnet - Scratched - Paint |

**Damage #7:** Bonnet: Bonnet - Scratched - Paint

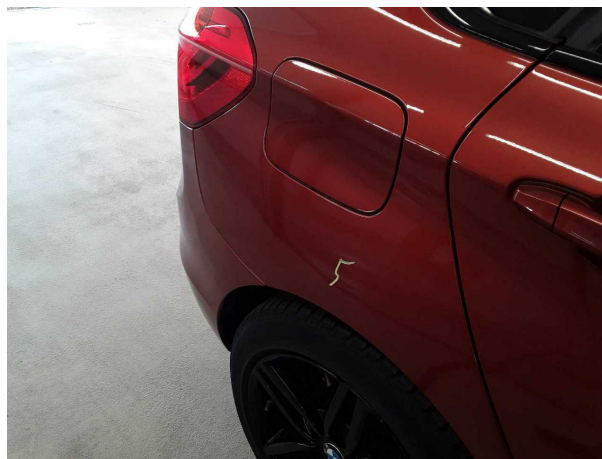
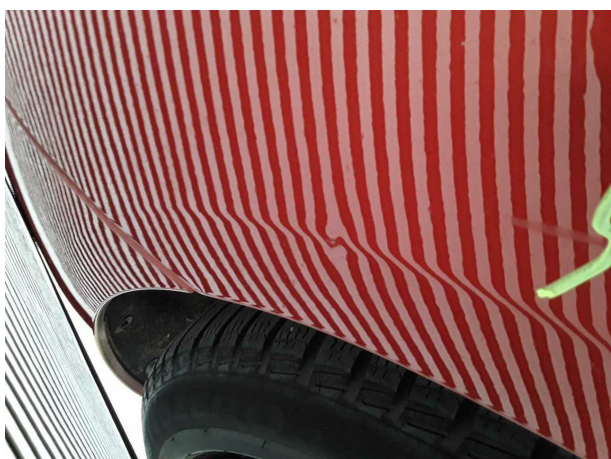
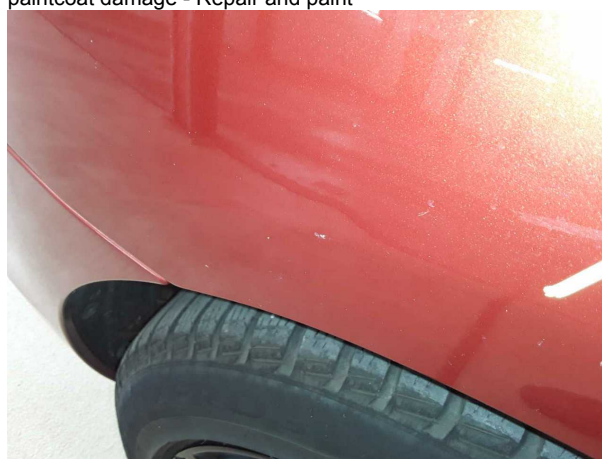
| No. | Component group | Description |
|---|---|---|
| 8 | Side panel - rear right side | Side panel - Dent / paintcoat damage - Repair and paint |

**Damage #8:** Side panel - rear right side: Side panel - Dent / paintcoat damage - Repair and paint

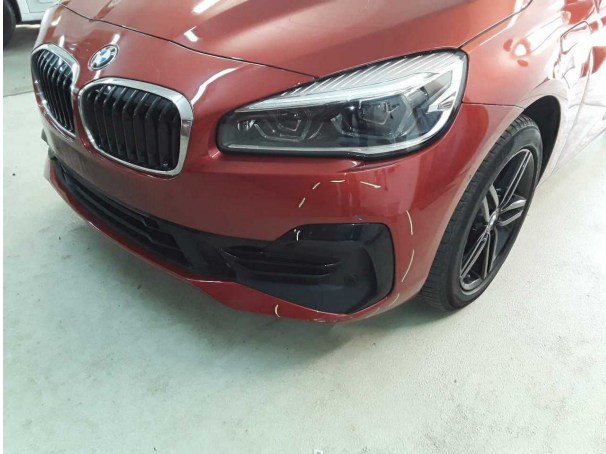
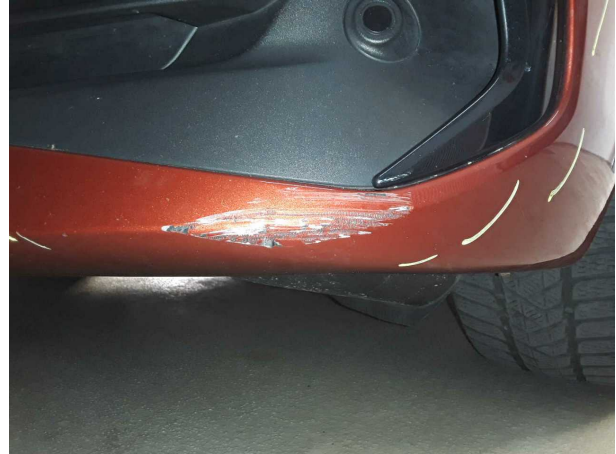
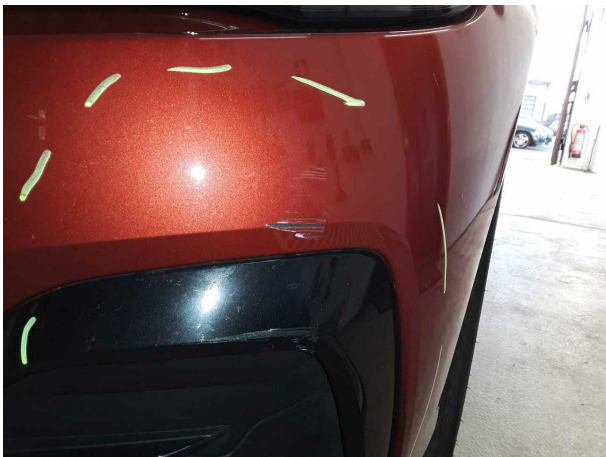
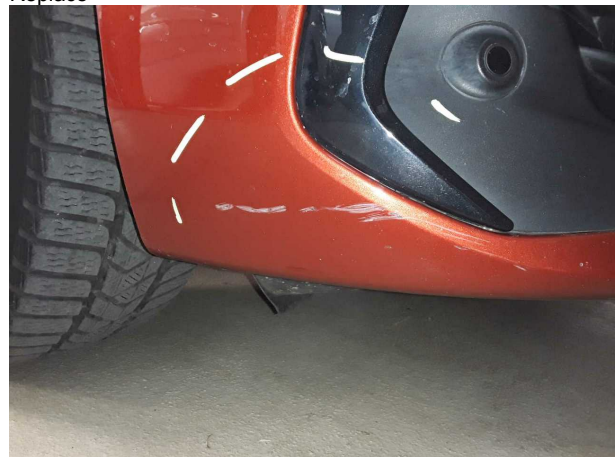
| No. | Component group | Description |
|---|---|---|
| 9 | Front bumper | Front bumper - Scratched - Replace |

**Damage #9:** Front bumper: Front bumper - Scratched - Replace
