WBA6K51060FL21700

## Zustandsbericht

Inspection date: 7 Apr 2025

**Protocol number:** 39204073

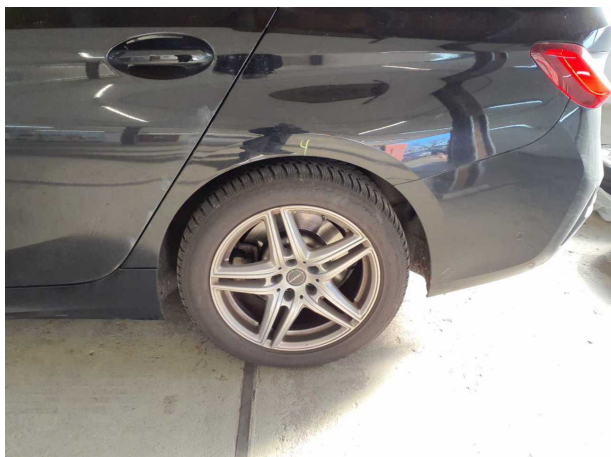
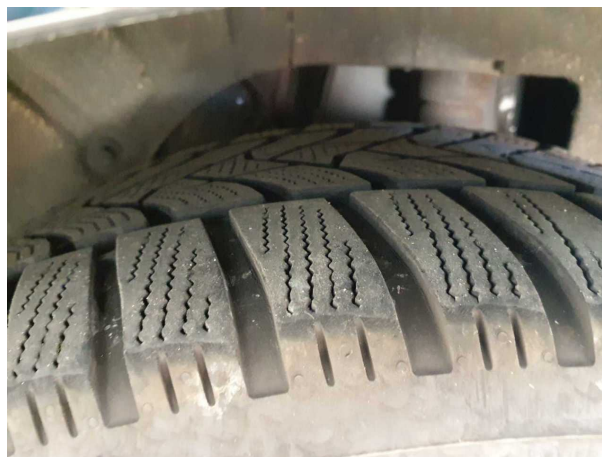
| No. | Component group | Description |
|---|---|---|
| 1 | Wheel / tyres | Tyre - right - Worn - No deduction |

**Damage #1:** Wheel / tyres: Tyre - right - Worn - No deduction

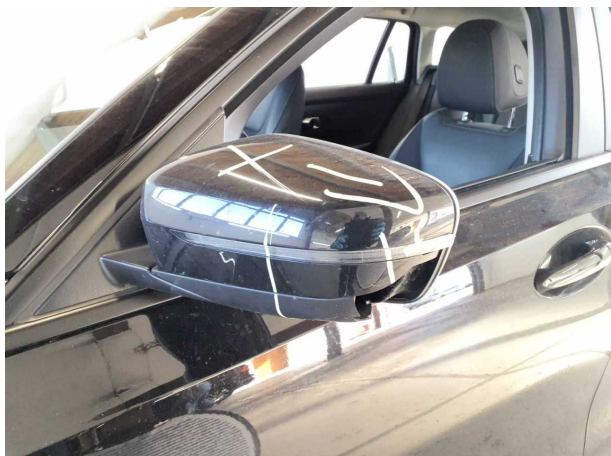
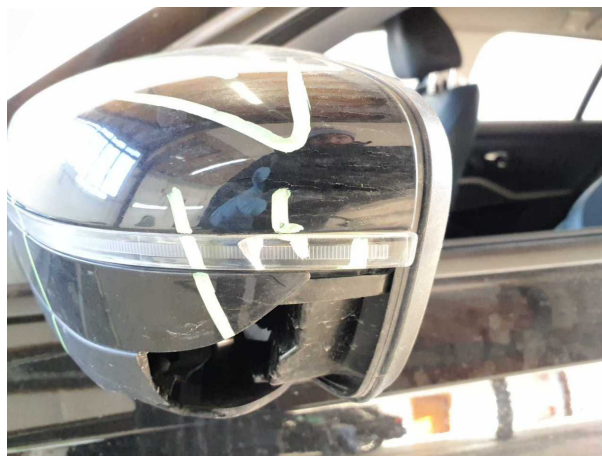
| No. | Component group | Description |
|---|---|---|
| 2 | Indicator - front | Mirror - left side - Scratched - Replace |

**Damage #2:** Indicator - front: Mirror - left side - Scratched - Replace

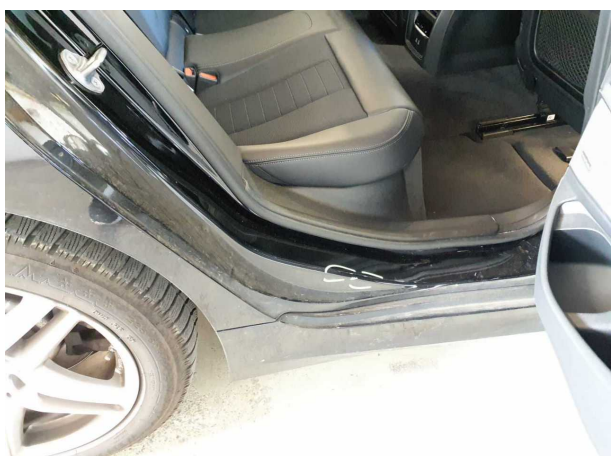
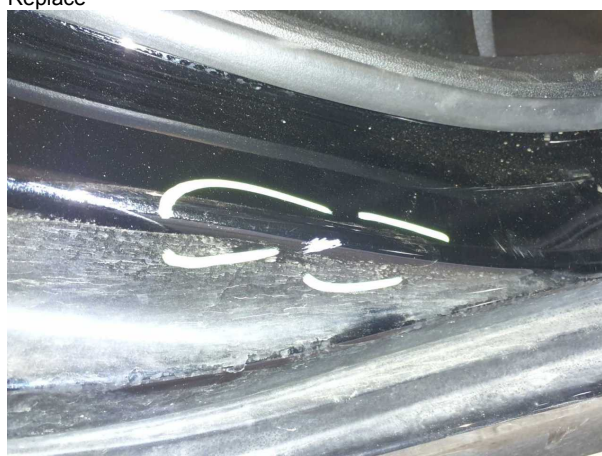
| No. | Component group | Description |
|---|---|---|
| 3 | Side panel - rear right side | Sill - Scratched - Smart repair |

**Damage #3:** Side panel - rear right side: Sill - Scratched - Smart repair

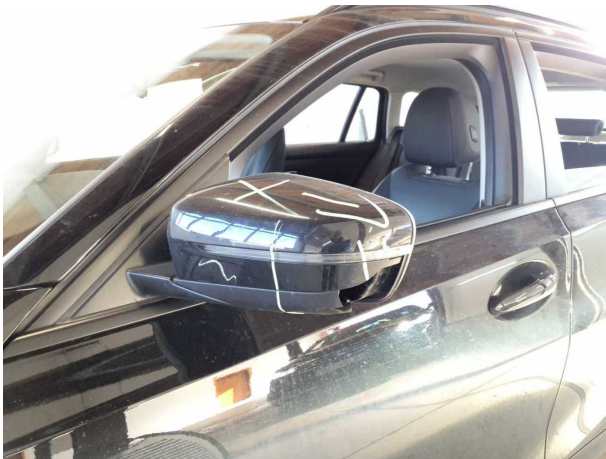
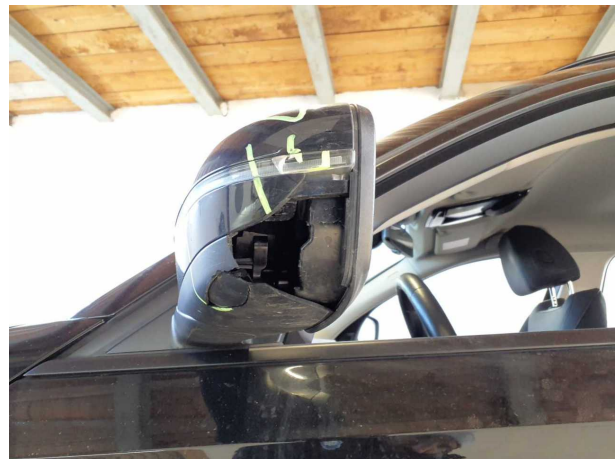
| No. | Component group | Description |
|---|---|---|
| 4 | Wing mirror - left side | Wing mirror - Damaged - Replace |

**Damage #4:** Wing mirror - left side: Wing mirror - Damaged - Replace

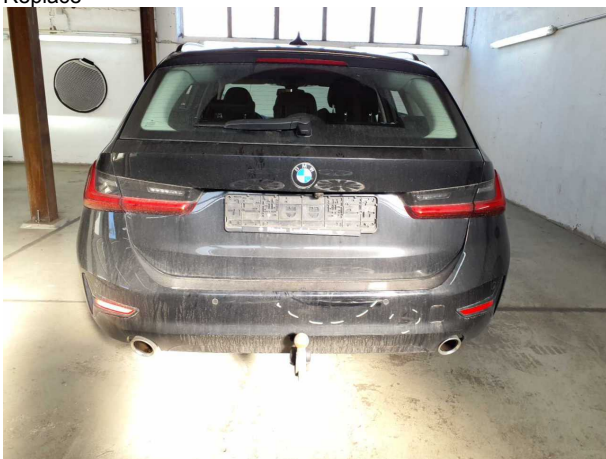
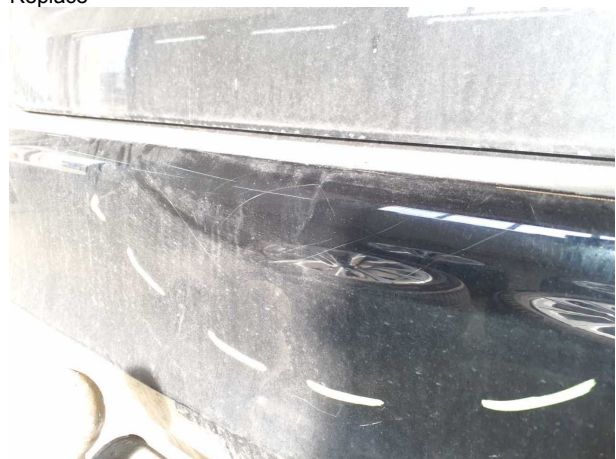
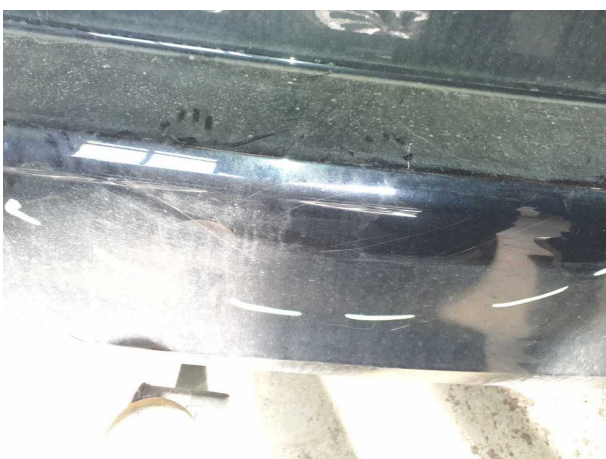
| No. | Component group | Description |
|---|---|---|
| 5 | Rear bumper | Rear bumper - Scratched - Paint |

**Damage #5:** Rear bumper: Rear bumper - Scratched - Paint

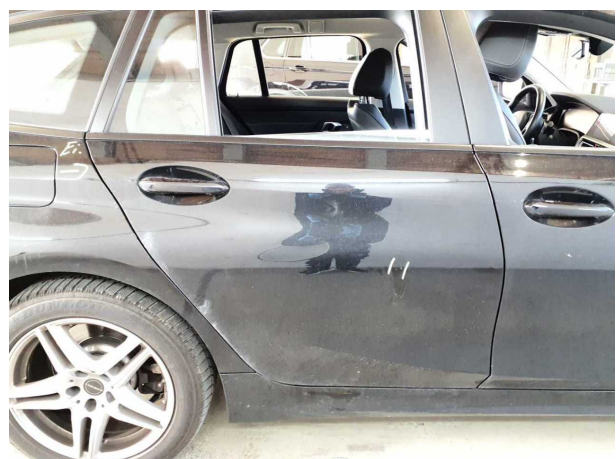
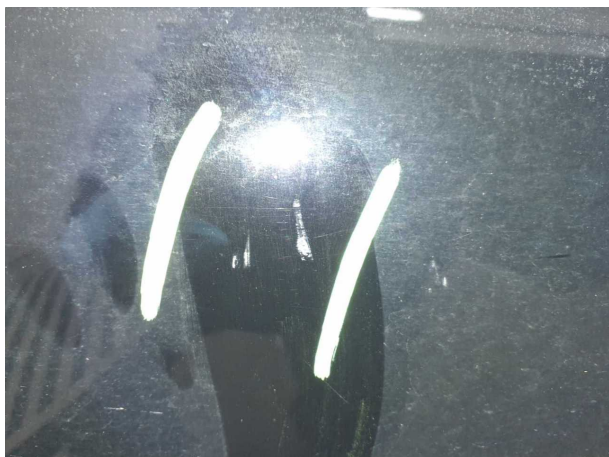
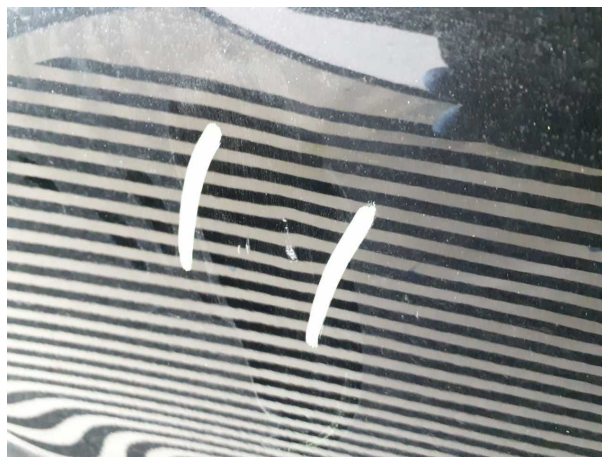
| No. | Component group | Description |
|---|---|---|
| 6 | Door - rear right side | Door - Dent / paintcoat damage - Repair and paint |

**Damage #6:** Door - rear right side: Door - Dent / paintcoat damage - Repair and paint

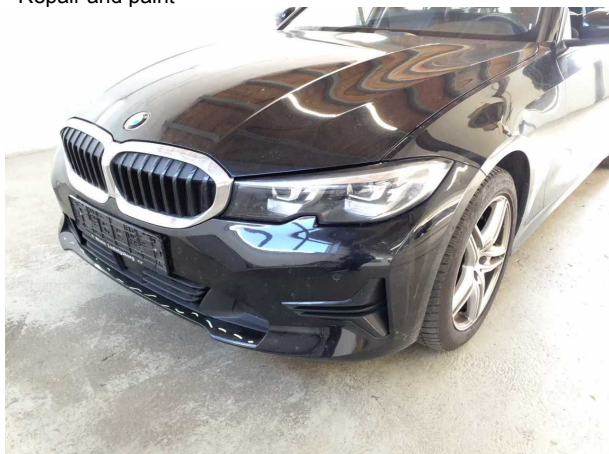
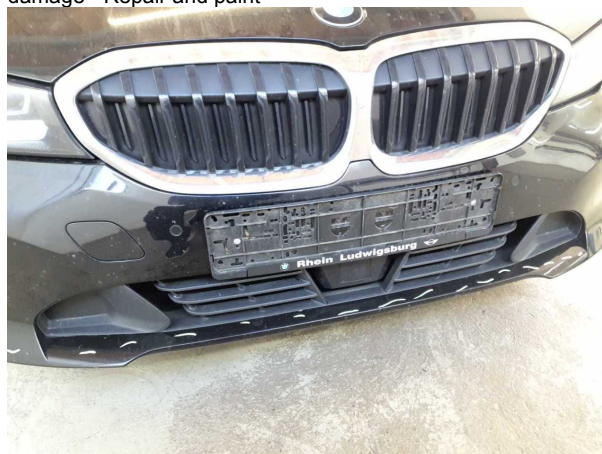
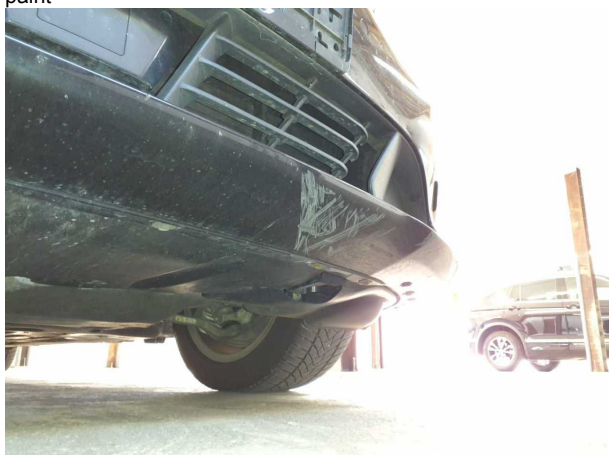
| No. | Component group | Description |
|---|---|---|
| 7 | Front bumper | Front bumper - Scratched - Repair and paint |

| No. | Location |
|---|---|
| 1 | Bumper front, Professionally carried out |

**Damage #7:** Front bumper: Front bumper - Scratched - Repair and paint

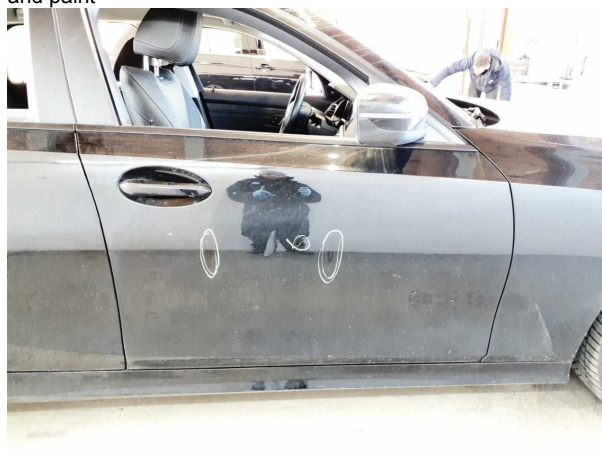
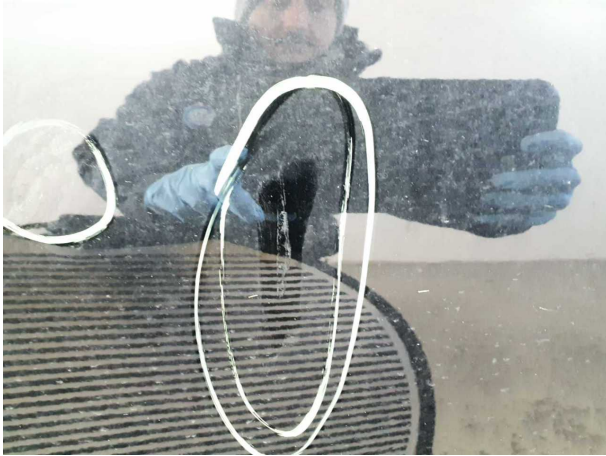
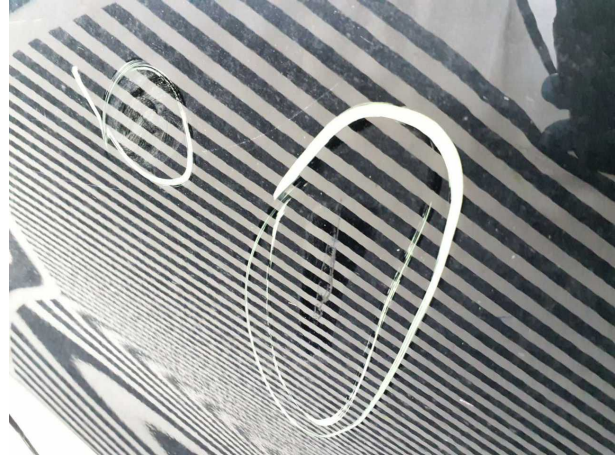
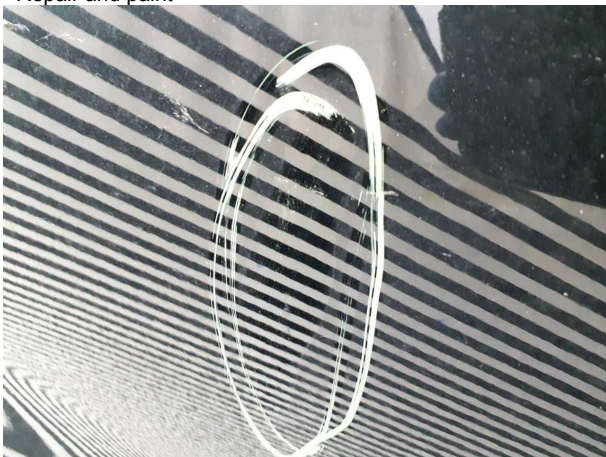
| No. | Component group | Description |
|---|---|---|
| 8 | Door - front right side | Door - Dent / paintcoat damage - Repair and paint |

**Damage #8:** Door - front right side: Door - Dent / paintcoat damage - Repair and paint

**Damage #8:** Door - front right side: Door - Dent / paintcoat damage  
- Repair and paint

**Damage #8:** Door - front right side: Door - Dent / paintcoat  
damage - Repair and paint
