**WAUZZZF48PA052103**

## Zustandsbericht

Inspection date: 23 Apr 2025  
**Protocol number: 39454847**

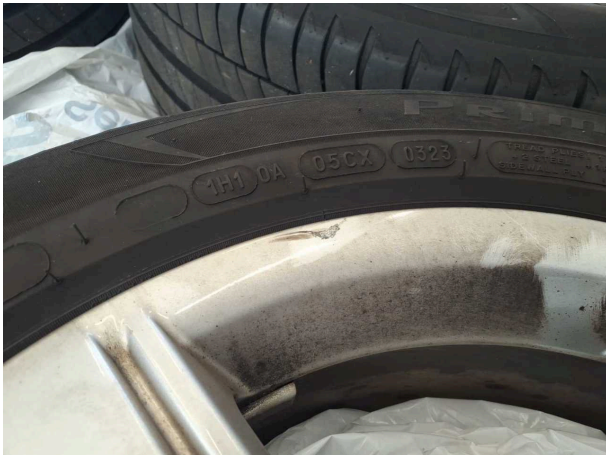
| No. | Component group | Description |
|---|---|---|
| 1 | 2nd wheel set | 1 alloy rim - Scratched - Loss in value |

**Damage #1:** 2nd wheel set: 1 alloy rim - Scratched - Loss in value

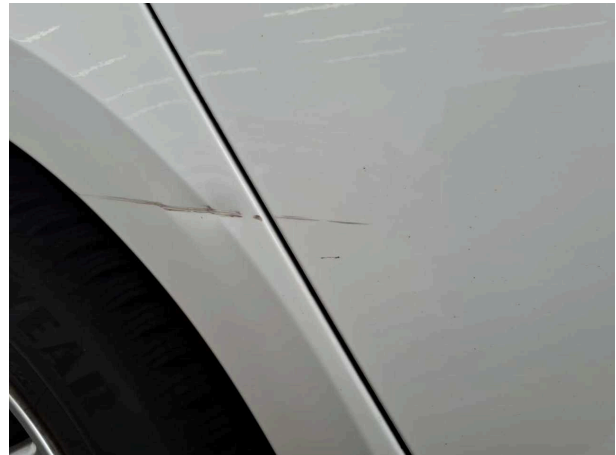
| No. | Component group | Description |
|---|---|---|
| 2 | Door - rear right side | Door - Scratched - Smart repair |

**Damage #2:** Door - rear right side: Door - Scratched - Smart repair

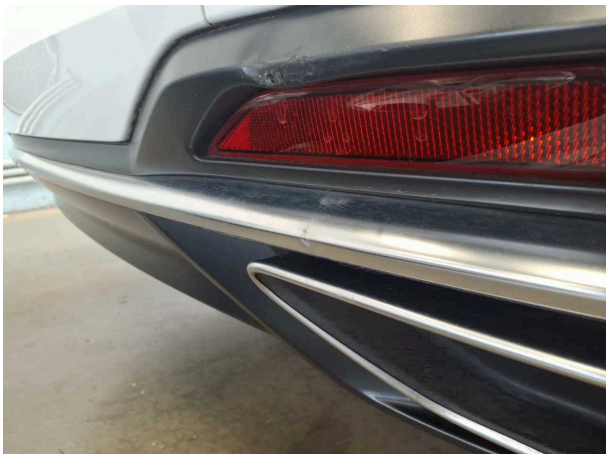
| No. | Component group | Description |
|---|---|---|
| 3 | Rear bumper | Protection strip - centre - Scratched - Replace |

**Damage #3:** Rear bumper: Protection strip - centre - Scratched - Replace

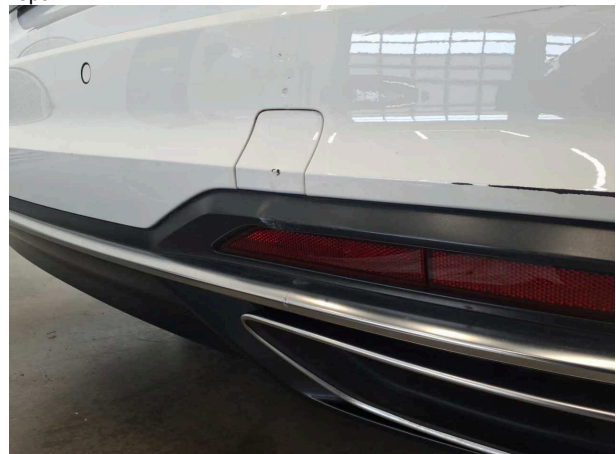
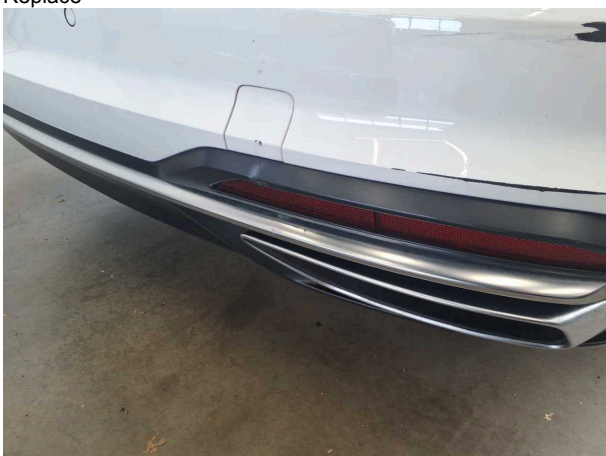
| No. | Component group | Description |
|---|---|---|
| 4 | Rear bumper | Spoiler - Deformed - Replace |

**Damage #4:** Rear bumper: Spoiler - Deformed - Replace

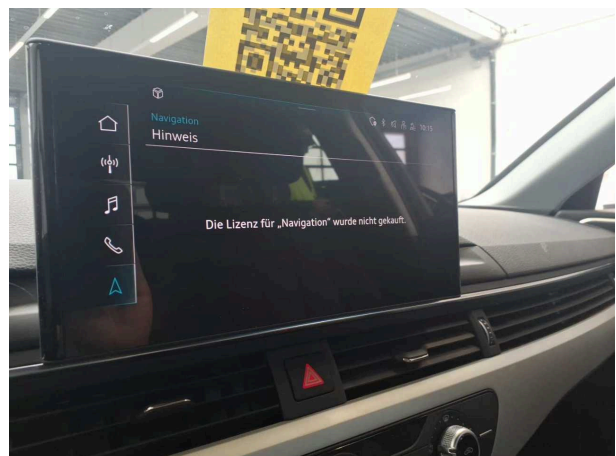
| No. | Component group | Description |
|---|---|---|
| 5 | Multimedia system | Navigation system - Non-operational - Set / adjust |

**Damage #5:** Multimedia system: Navigation system - Non-operational - Set / adjust

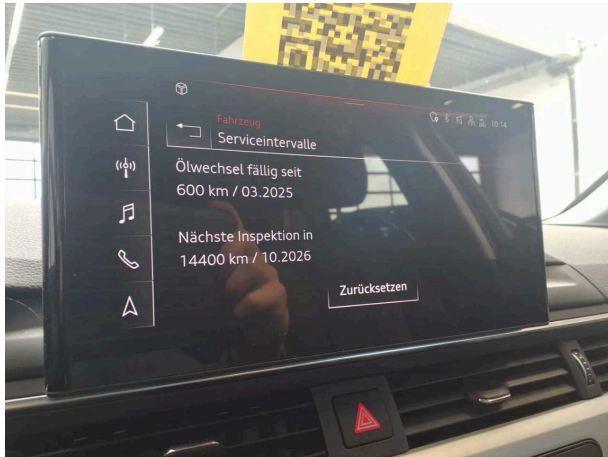
| No. | Component group | Description |
|---|---|---|
| 6 | Misc. | Inspection / maintenance - Due - Perform |

**Damage #6:** Misc.: Inspection / maintenance - Due - Perform

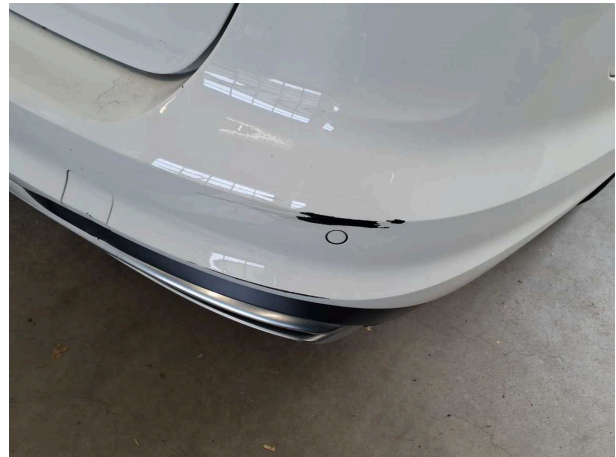
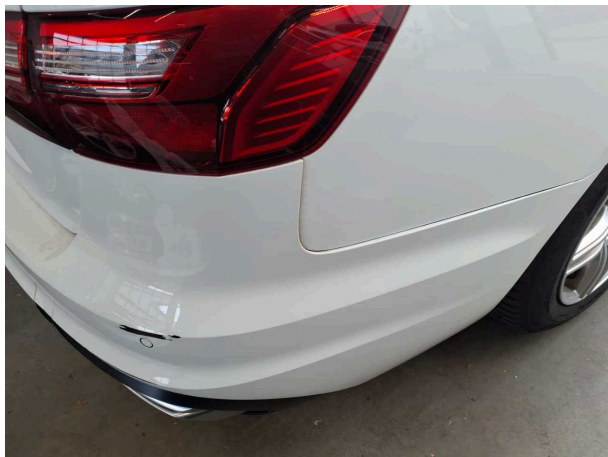
| No. | Component group | Description |
|---|---|---|
| 7 | Rear bumper | Rear bumper (Leichte Verformung, schadenserweiterung möglich) - Scratched - Repair and paint |

**Damage #7:** Rear bumper: Rear bumper (Leichte Verformung, schadenserweiterung möglich) - Scratched - Repair and paint

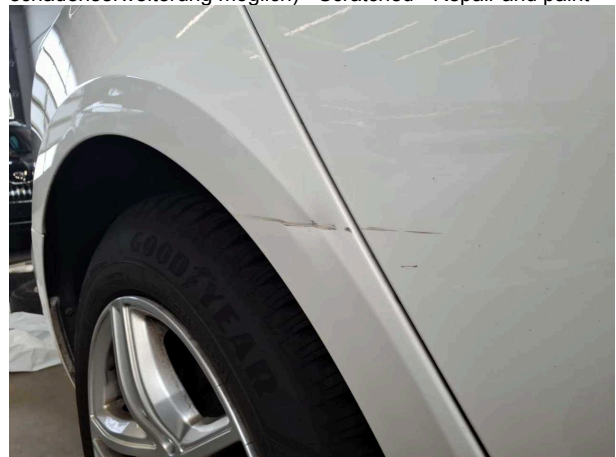
| No. | Component group | Description |
|---|---|---|
| 8 | Side panel - rear right side | Side panel - Scratched - Repair and paint |

**Damage #8:** Side panel - rear right side: Side panel - Scratch... - Repair and paint
