**WBA7K310005R39920**

## Vehicle details

## Zustandsbericht

Inspection date: 15 Apr 2025  
**Protocol number:** 39326580  
Delivery date: 15 Apr 2025

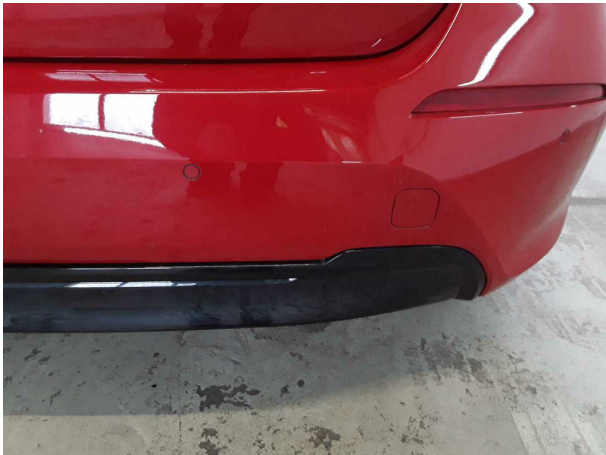
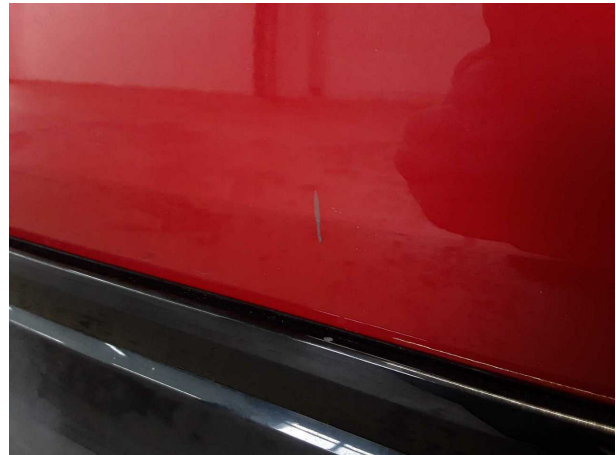
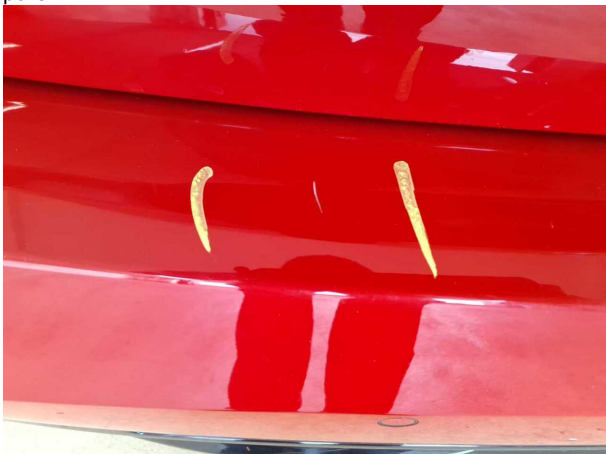
| No. | Component group | Description |
|---|---|---|
| 1 | Rear bumper | Rear bumper - Paint defect - Cover / polish |

**Damage #1:** Rear bumper: Rear bumper - Paint defect - Cover / polish

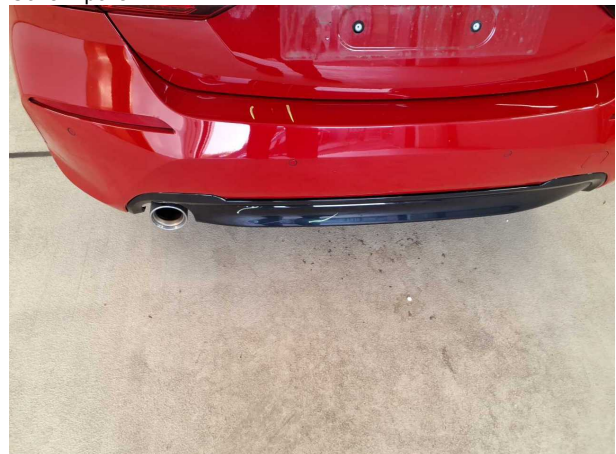
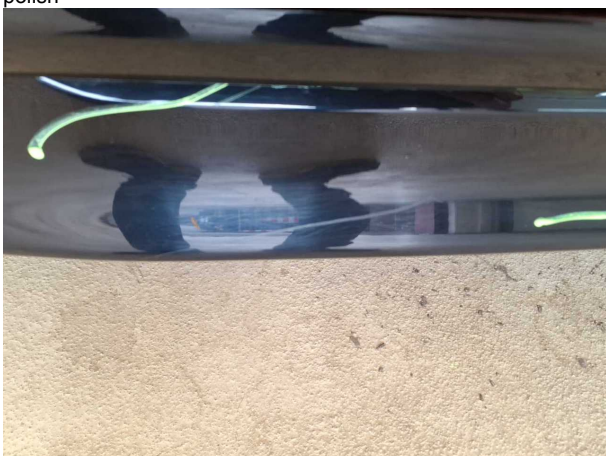
| No. | Component group | Description |
|---|---|---|
| 2 | Rear bumper | Spoiler - Scratched - Loss in value |

**Damage #2:** Rear bumper: Spoiler - Scratched - Loss in value

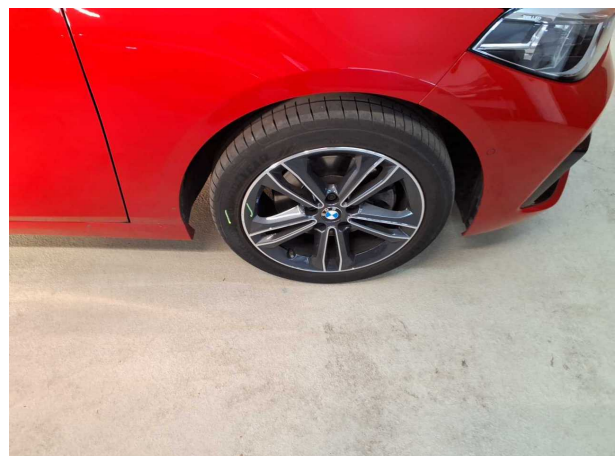
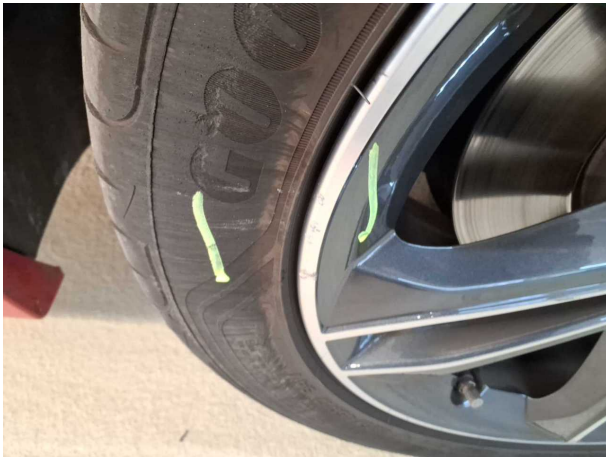
| No. | Component group | Description |
|---|---|---|
| 3 | Wheel / tyres | Alloy rim - front right side - Scratched - Loss in value |

**Damage #3:** Wheel / tyres: Alloy rim - front right side - Scratched - Loss in value

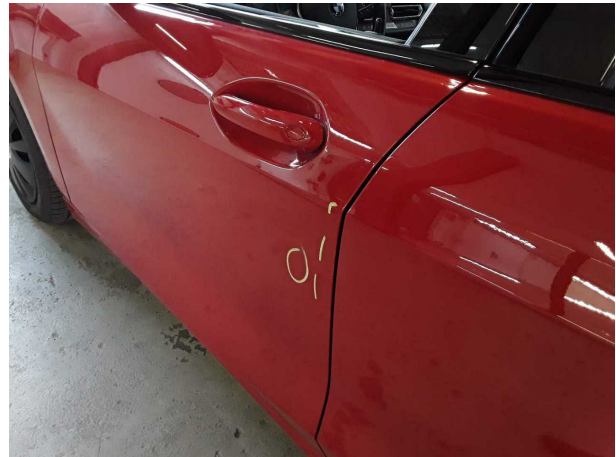
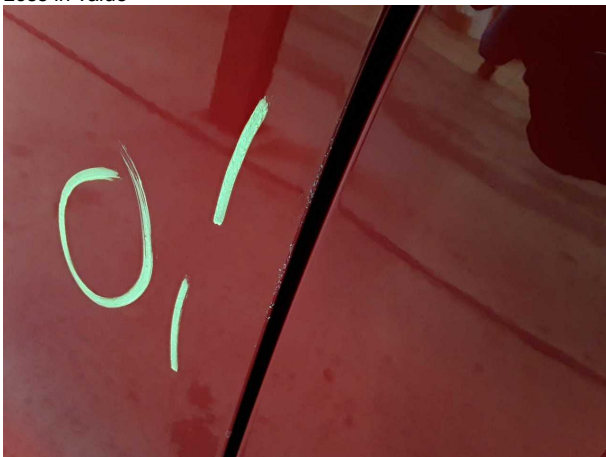
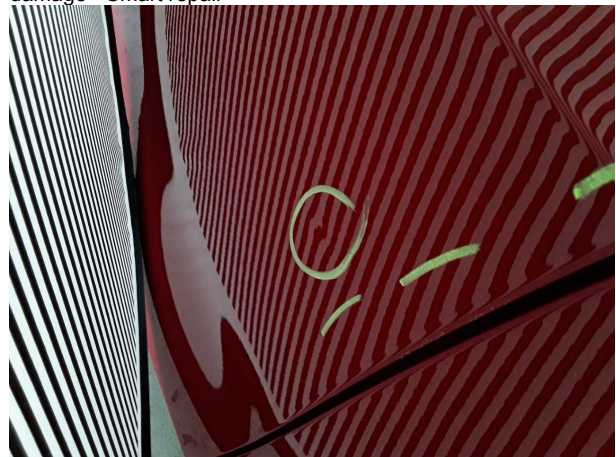
| No. | Component group | Description |
|---|---|---|
| 4 | Door - front left side | Door - Dent / paintcoat damage - Smart repair |

**Damage #4:** Door - front left side: Door - Dent / paintcoat damage - Smart repair

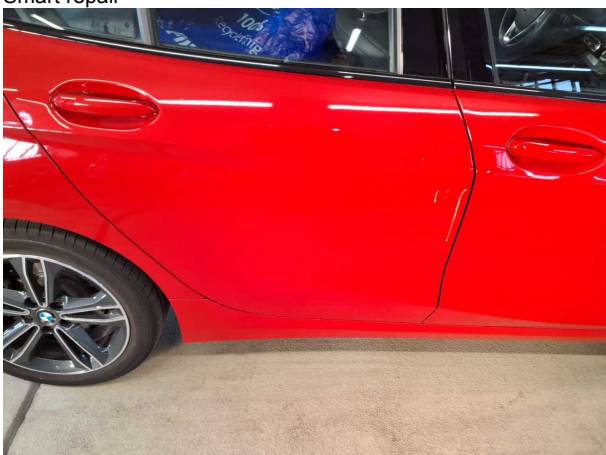
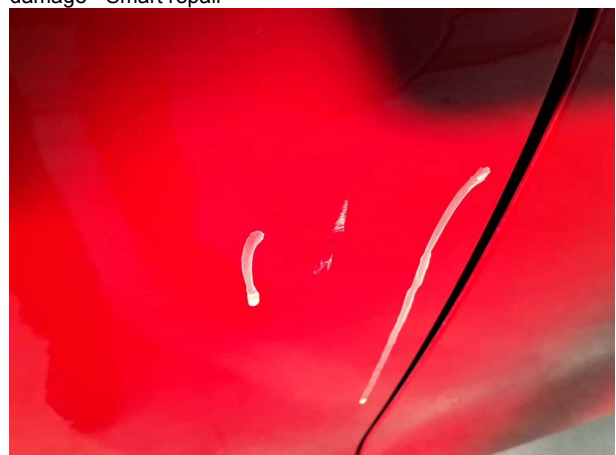
| No. | Component group | Description |
|---|---|---|
| 5 | Door - rear right side | Door - Scratched - Repair and paint |

**Damage #5:** Door - rear right side: Door - Scratched - Repair and paint
