**WAUZZZF49MA009692**

## Zustandsbericht

**TÜV SÜD Auto Plus GmbH**  
Gutenbergstr. 13  
70771 Leinfelden-Echterdingen

Inspection date: 16 Apr 2025  
**Protocol number: 39477871**

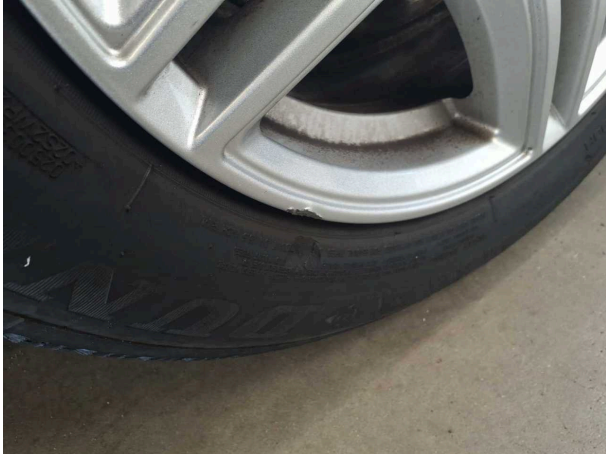
| No. | Component group | Description |
|---|---|---|
| 1 | Wheel / tyres | Alloy rim - rear right side - Scratched - No deduction |

**Damage #1:** Wheel / tyres: Alloy rim - rear right side - Scratched - No deduction

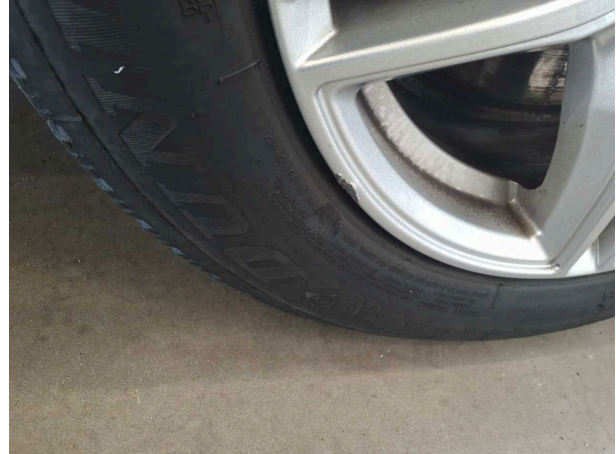
| No. | Component group | Description |
|---|---|---|
| 2 | Wheel / tyres | Tyre - rear right side - Damaged - No deduction |

**Damage #2:** Wheel / tyres: Tyre - rear right side - Damaged - No deduction

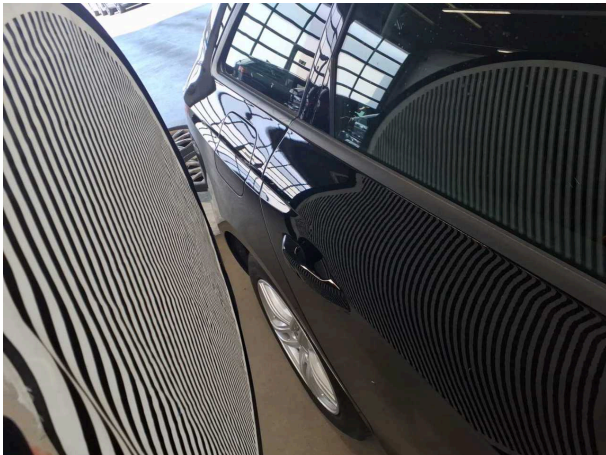
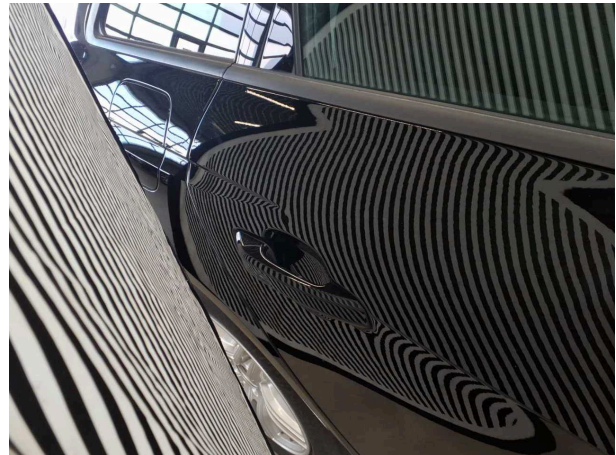
| No. | Component group | Description |
|---|---|---|
| 3 | Door - rear right side | Door - dent(s) - Smooth repair work |

**Damage #3:** Door - rear right side: Door - dent(s) - Smooth repair work

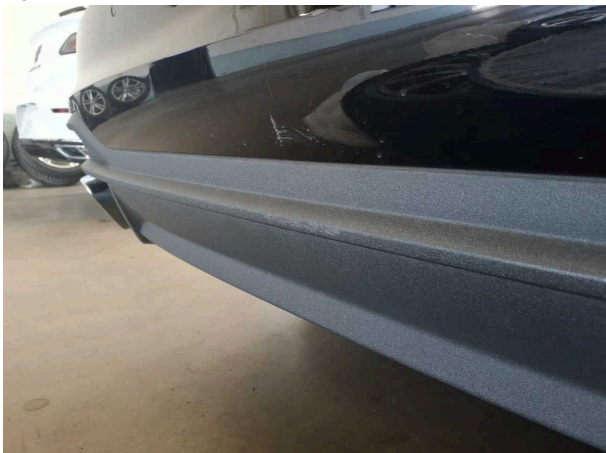
| No. | Component group | Description |
|---|---|---|
| 4 | Rear bumper | Spoiler - Abrasion - Replace |

**Damage #4:** Rear bumper: Spoiler - Abrasion - Replace

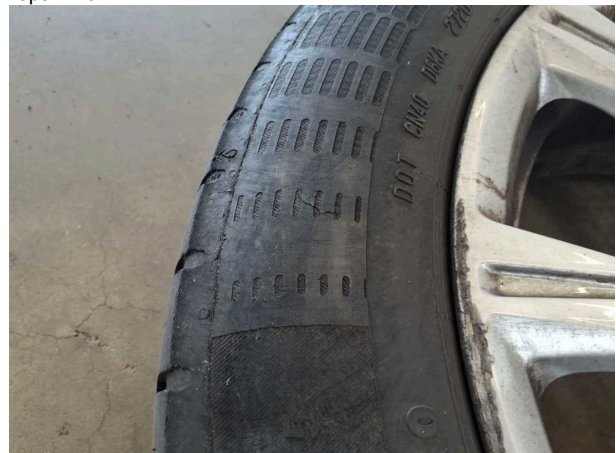
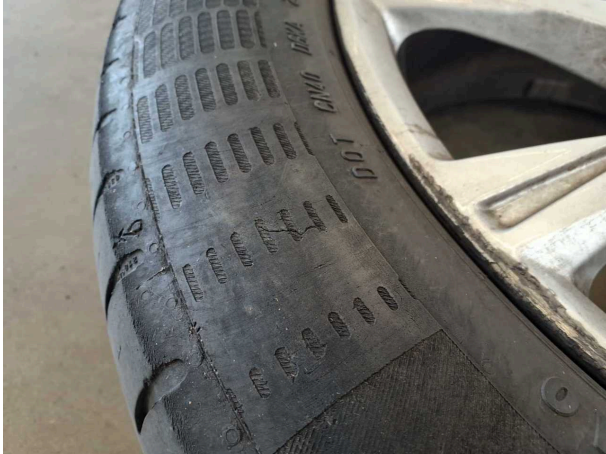
| No. | Component group | Description |
|---|---|---|
| 5 | 2nd wheel set | 1 tyre - Damaged - Replace |

**Damage #5:** 2nd wheel set: 1 tyre - Damaged - Replace

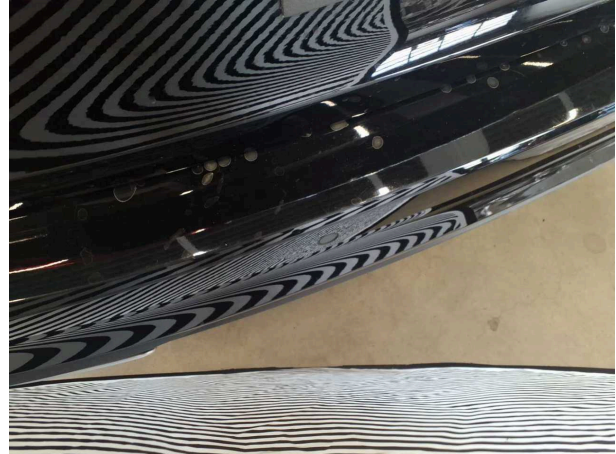
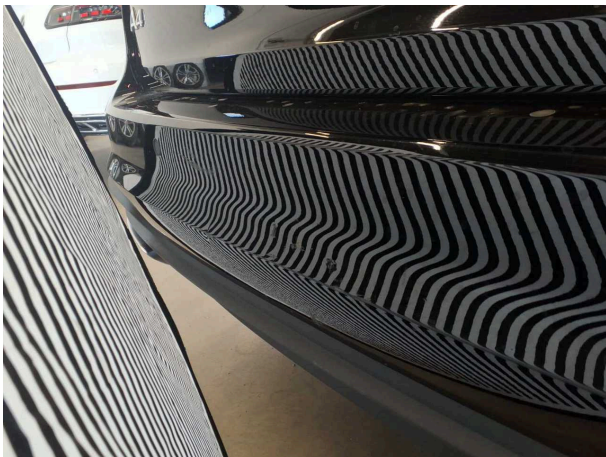
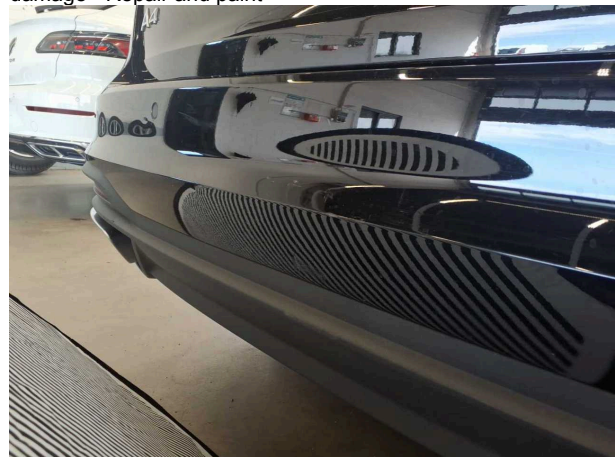
| No. | Component group | Description |
|---|---|---|
| 6 | Rear bumper | Rear bumper - Dent / paintcoat damage - Repair and paint |

**Damage #6:** Rear bumper: Rear bumper - Dent / paintcoat damage - Repair and paint

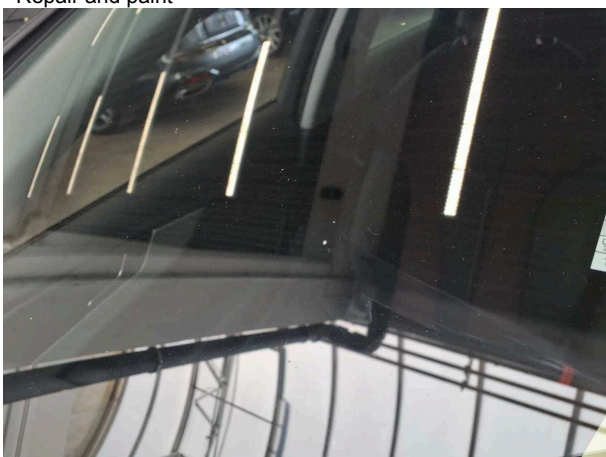
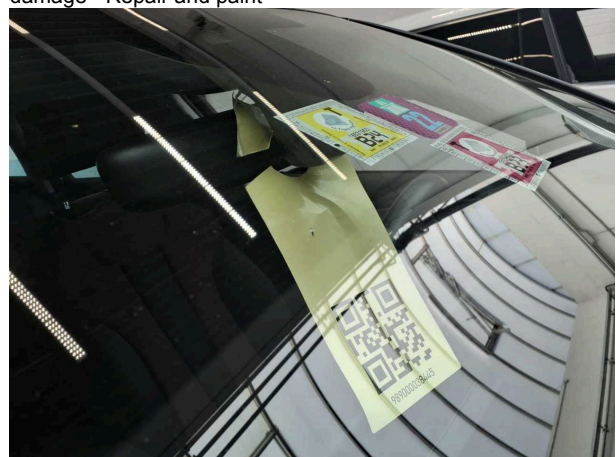
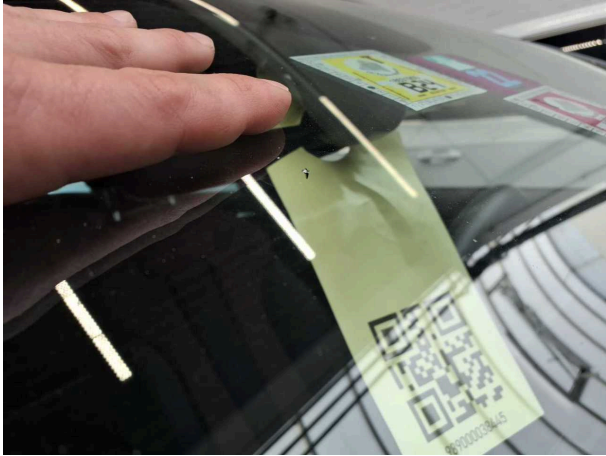
| No. | Component group | Description |
|---|---|---|
| 7 | Vehicle glazing | Windscreen with rain sensor - Damaged - Replace |

**Damage #7:** Vehicle glazing: Windscreen with rain sensor - Damaged - Replace

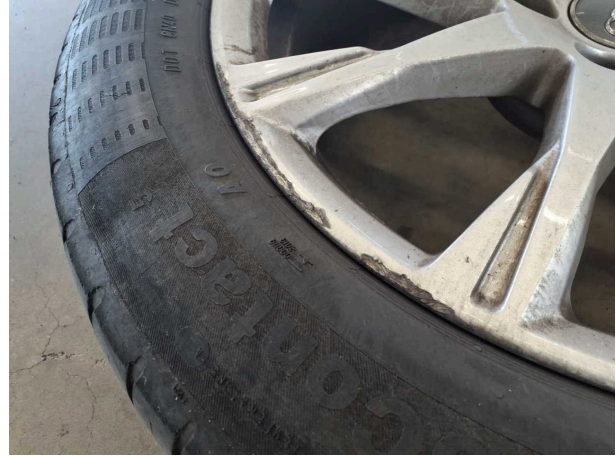
| No. | Component group | Description |
|---|---|---|
| 8 | 2nd wheel set | 1 alloy rim - Scratched - Replace |

**Damage #8:** 2nd wheel set: 1 alloy rim - Scratched - Replace

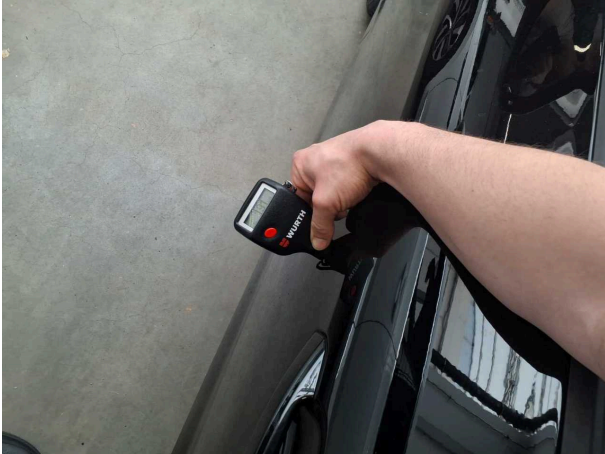
| No. | Location |
|---|---|
| 1 | Door - front left side, Professionally carried out, Invoice of repair done Non-existent |

**Repainting 1:** Door - front left side
