**WAUZZZF29MN074372**

## Zustandsbericht

**Protocol number:** 39197616

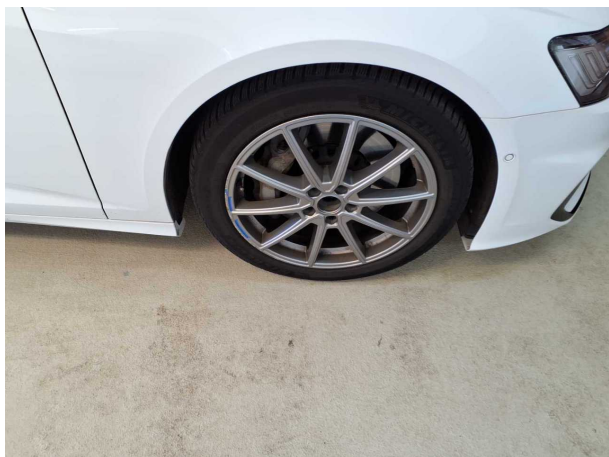
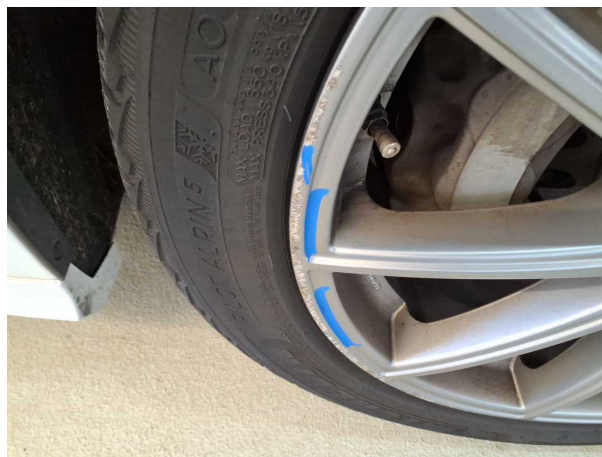
| No. | Component group | Description |
|---|---|---|
| 2 | Wheel / tyres | Alloy rim - front right side - Scratched - No deduction |

**Damage #2:** Wheel / tyres: Alloy rim - front right side - Scratched - No deduction

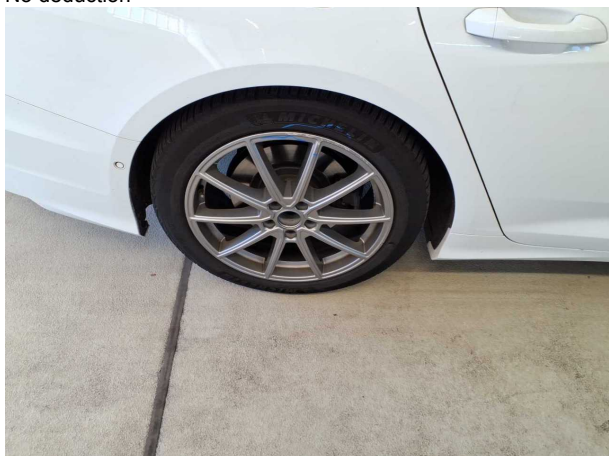
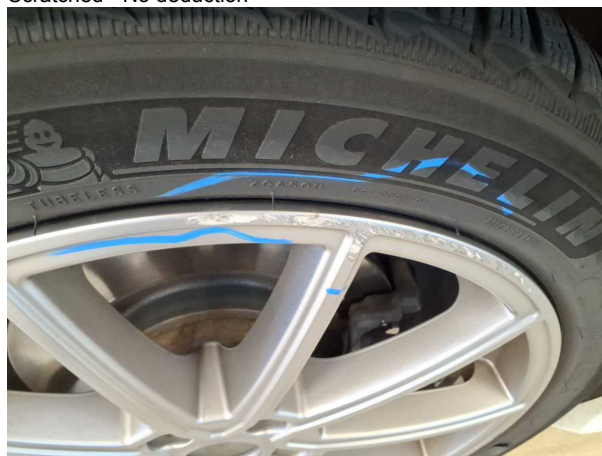
| No. | Component group | Description |
|---|---|---|
| 3 | Wheel / tyres | Alloy rim - rear right side - Scratched - No deduction |

**Damage #3:** Wheel / tyres: Alloy rim - rear right side - Scratched - No deduction

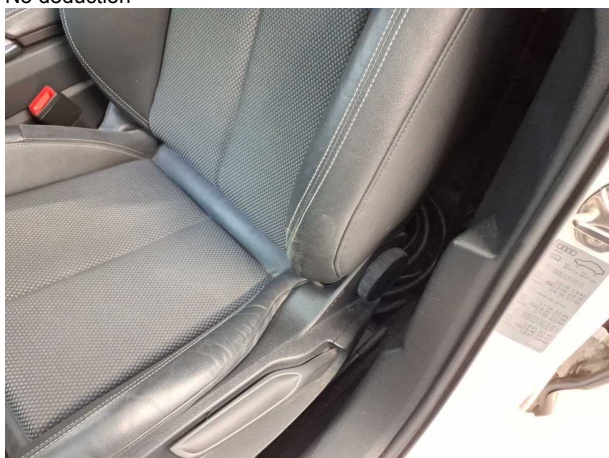
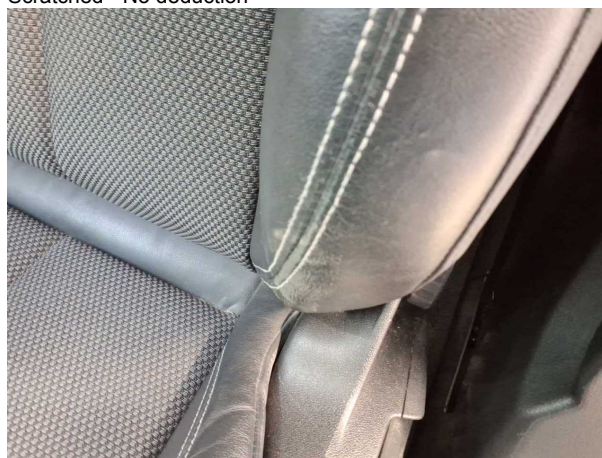
| No. | Component group | Description |
|---|---|---|
| 4 | Seat - front | Backrest cover - left side - Abrasion - Loss in value |

**Damage #4:** Seat - front: Backrest cover - left side - Abrasion - Loss in value

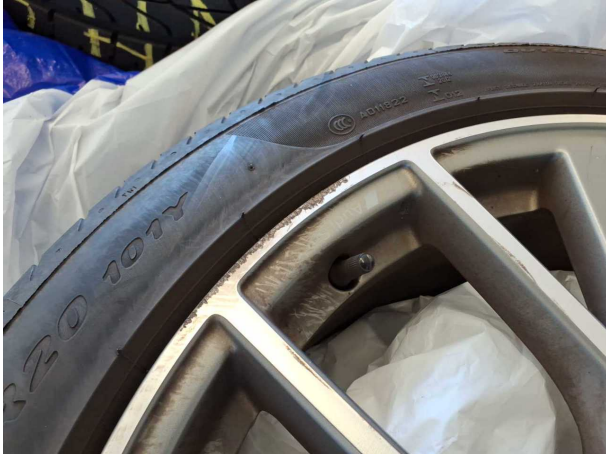
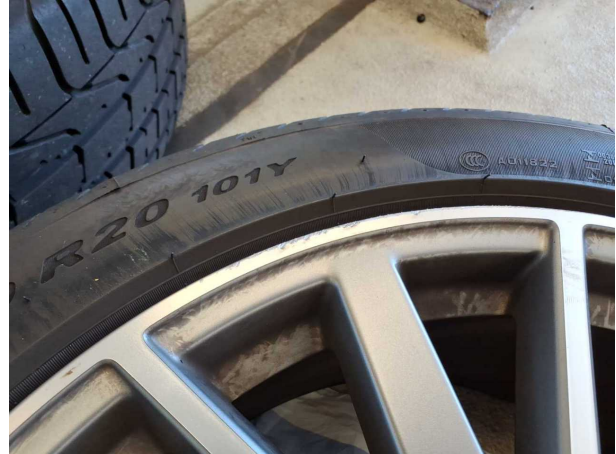
| No. | Component group | Description |
|---|---|---|
| 5 | 2nd wheel set | 2 alloy rims - Scratched - Loss in value |

**Damage #5:** 2nd wheel set: 2 alloy rims - Scratched - Loss in value

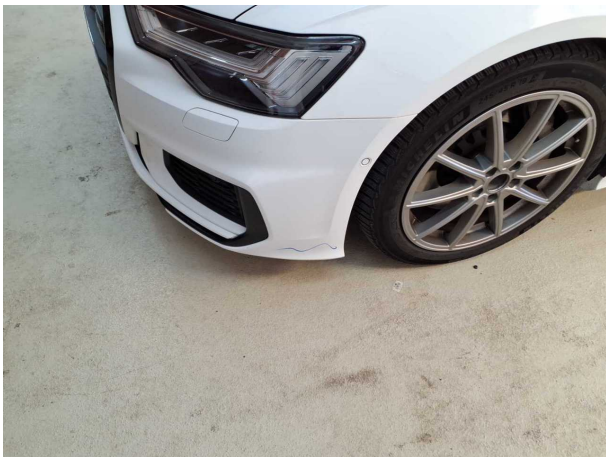
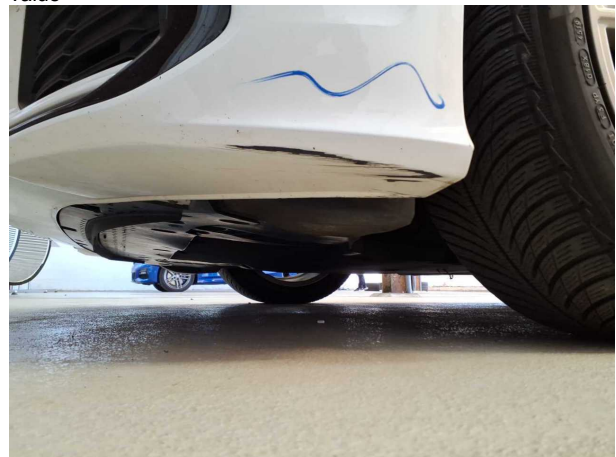
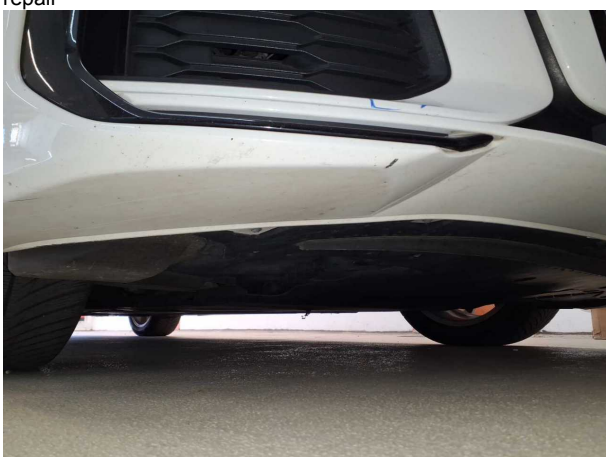
| No. | Component group | Description |
|---|---|---|
| 6 | Front bumper | Front bumper - Scratched - Smart repair |

**Damage #6:** Front bumper: Front bumper - Scratched - Smart repair

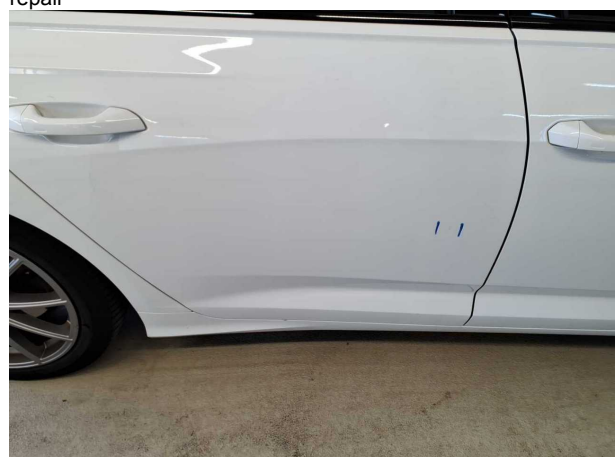
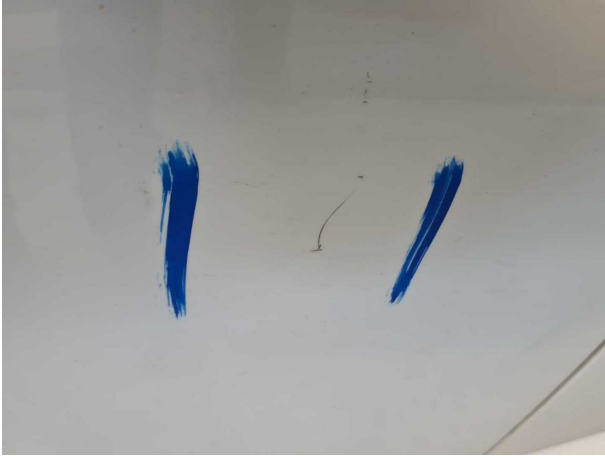
| No. | Component group | Description |
|---|---|---|
| 8 | Door - rear right side | Door - Scratch(es) - Repair and paint |

**Damage #8:** Door - rear right side: Door - Scratch(es) - Repair and paint
