**WAUZZZGY7MA086496**

## Vehicle details

## Zustandsbericht

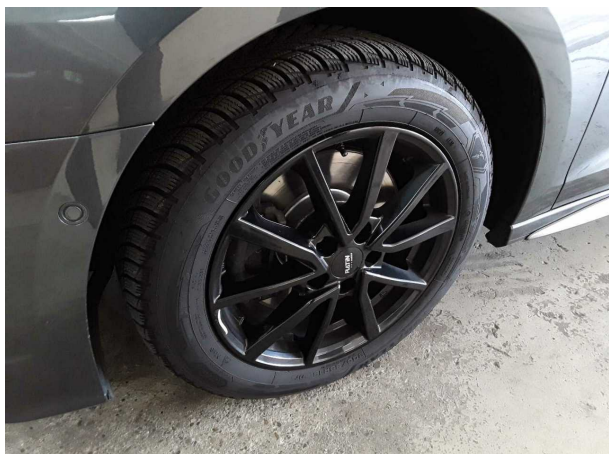
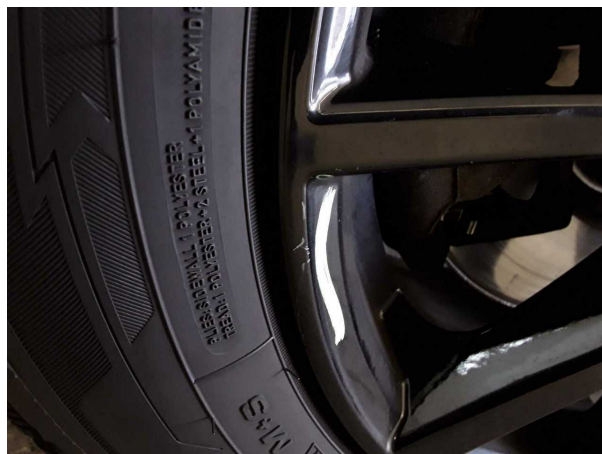
| No. | Component group | Description |
|---|---|---|
| 1 | Wheel / tyres | Alloy rim - front left side - Scratched - No deduction |

**Damage #1:** Wheel / tyres: Alloy rim - front left side - Scratched - No deduction

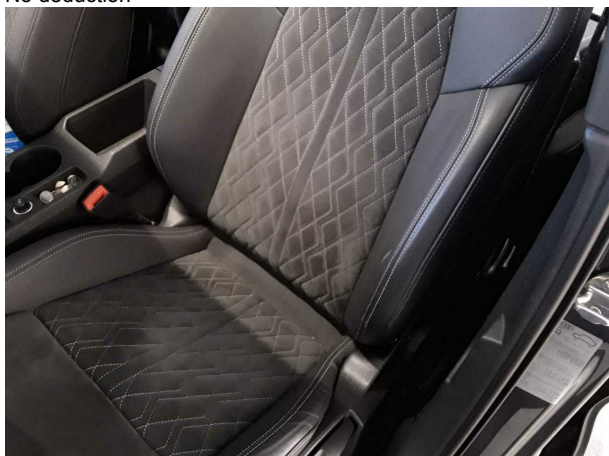
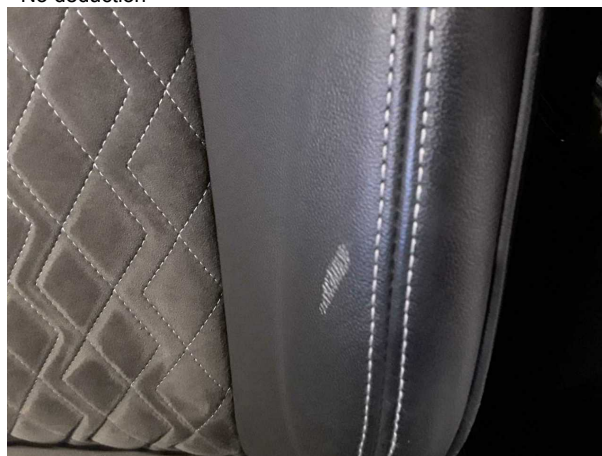
| No. | Component group | Description |
|---|---|---|
| 2 | Seat - front | Seat cover - left side - Scratched - Loss in value |

**Damage #2:** Seat - front: Seat cover - left side - Scratched - Loss in value

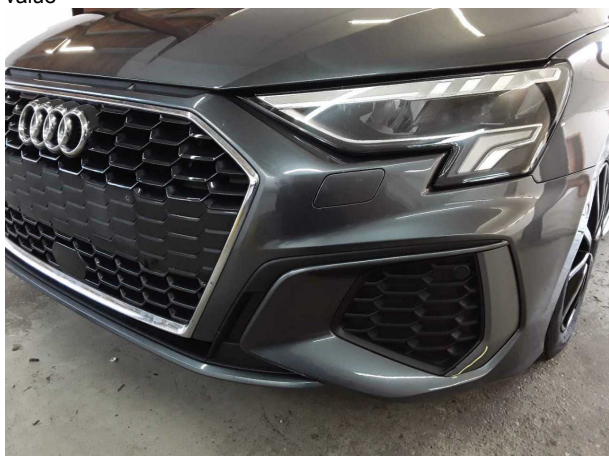
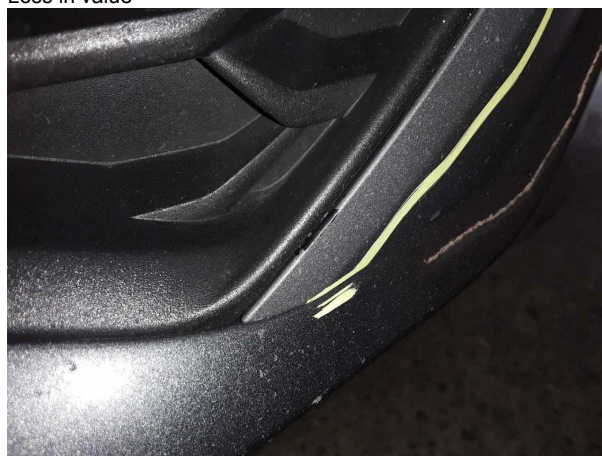
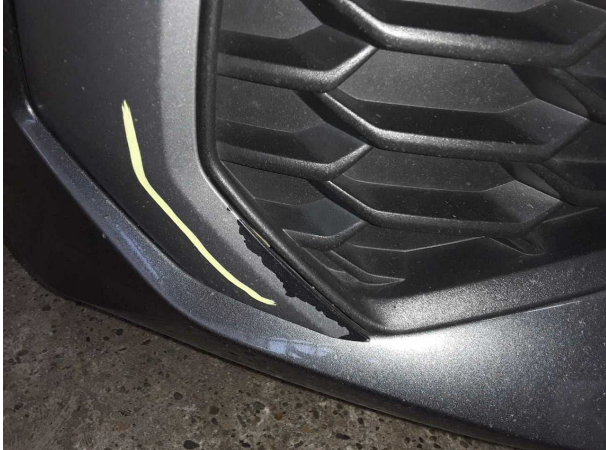
| No. | Component group | Description |
|---|---|---|
| 3 | Front bumper | Front bumper - Paint defect - Loss in value |

**Damage #3:** Front bumper: Front bumper - Paint defect - Loss in value

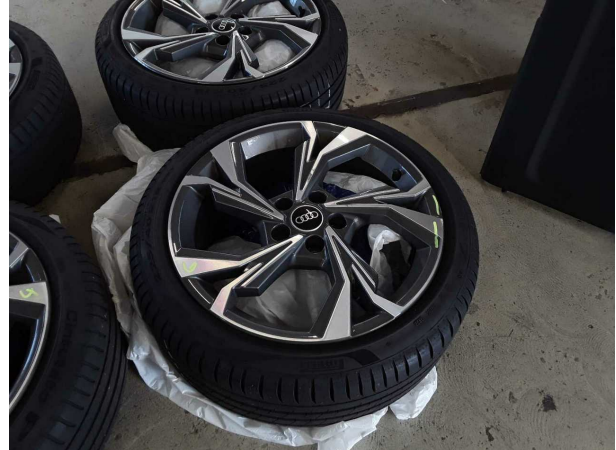
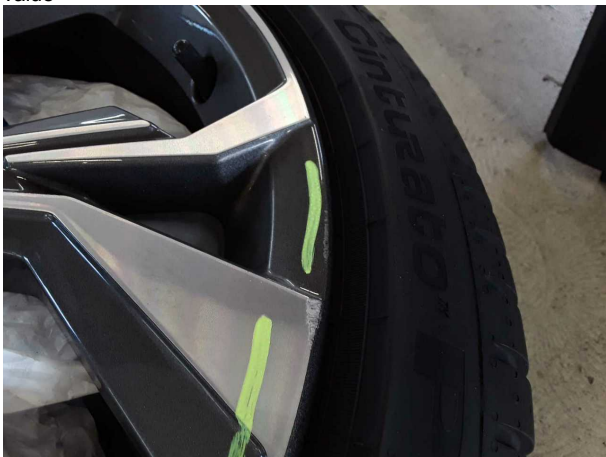
| No. | Component group | Description |
|---|---|---|
| 4 | 2nd wheel set | 1 alloy rim - Scratched - Loss in value |

**Damage #4:** 2nd wheel set: 1 alloy rim - Scratched - Loss in value

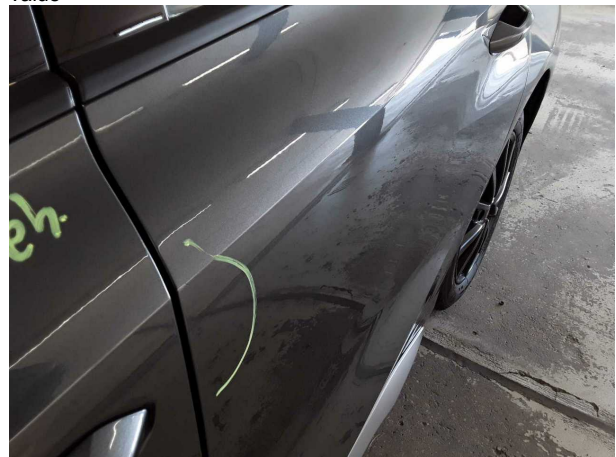
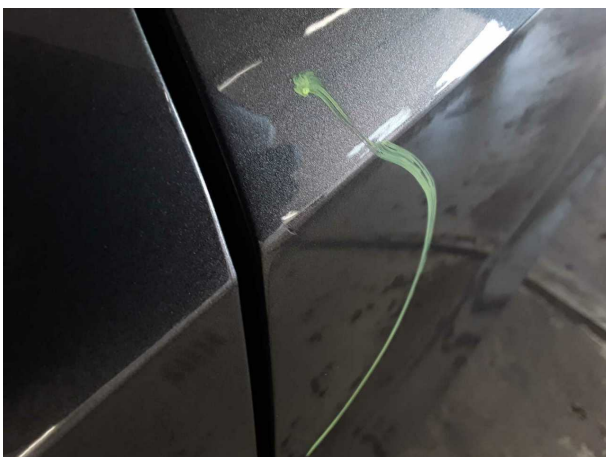
| No. | Component group | Description |
|---|---|---|
| 5 | Door - rear left side | Door - Scratched - Smart repair |

**Damage #5:** Door - rear left side: Door - Scratched - Smart repair
