**WAUZZZF49MA055328**

## Zustandsbericht

Inspection date: 8 Apr 2025  
**Protocol number:** 39226416  
Delivery date: 8 Apr 2025

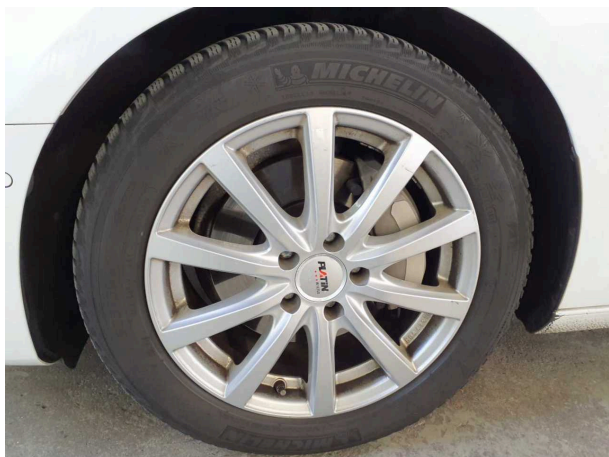
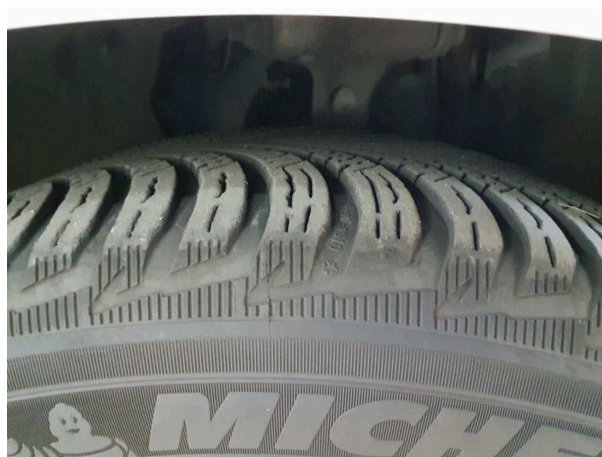
| No. | Component group | Description |
|---|---|---|
| 1 | Wheel / tyres | Tyre - front - Worn - No deduction |

| Axle | Tyre size | Manufacturer | Type of tyre | Tread depth | Roadworthy | Permissibility |
|---|---|---|---|---|---|---|
| 1 | 225/50 R17 98V | Michelin | Winter tyres | 4mm - 4mm | Not o.k. | |

**Damage #1:** Wheel / tyres: Tyre - front - Worn - No deduction

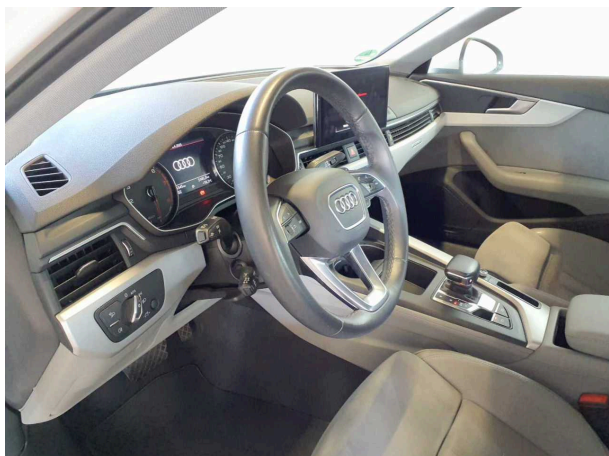
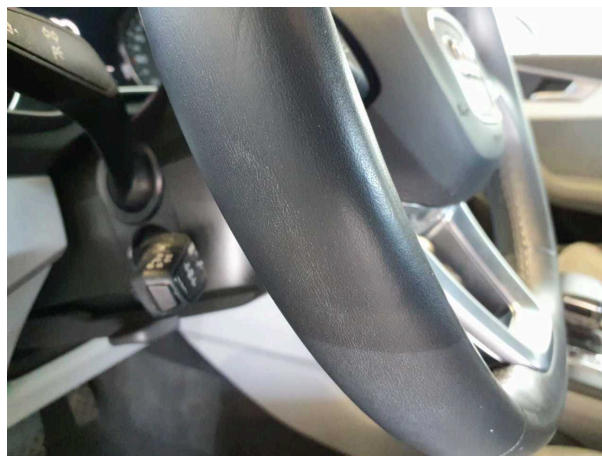
| No. | Component group | Description |
|---|---|---|
| 3 | Steering system | Steering wheel - Abrasion - Loss in value |

**Damage #3:** Steering system: Steering wheel - Abrasion - Loss in value

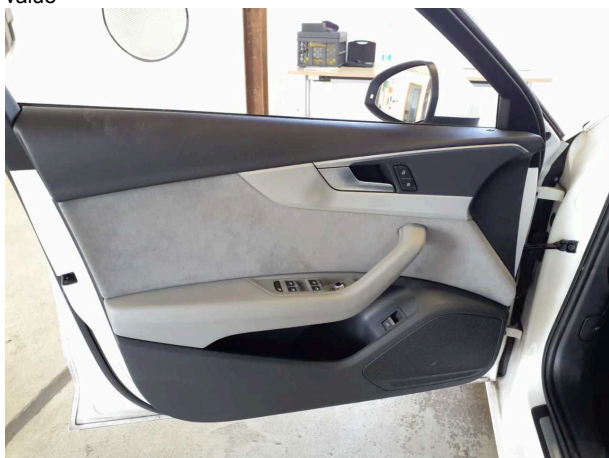
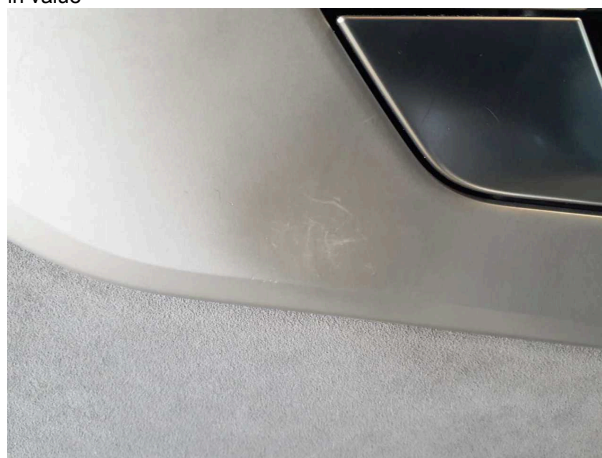
| No. | Component group | Description |
|---|---|---|
| 4 | Trim / covers | Brightware / decorative strip (türverkleidung VL) - Scratched - Replace |

**Damage #4:** Trim / covers: Brightware / decorative strip (türverkleidung VL) - Scratched - Replace

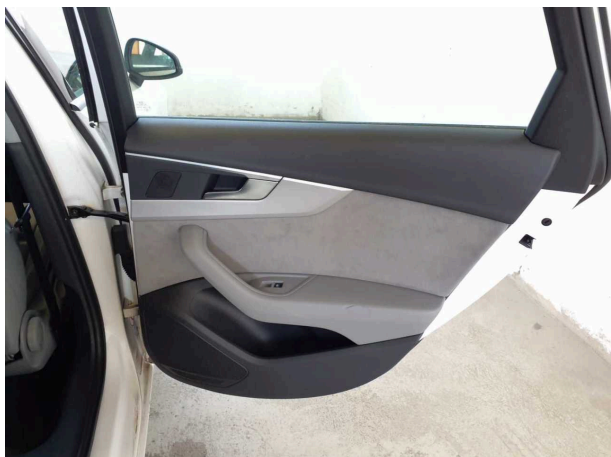
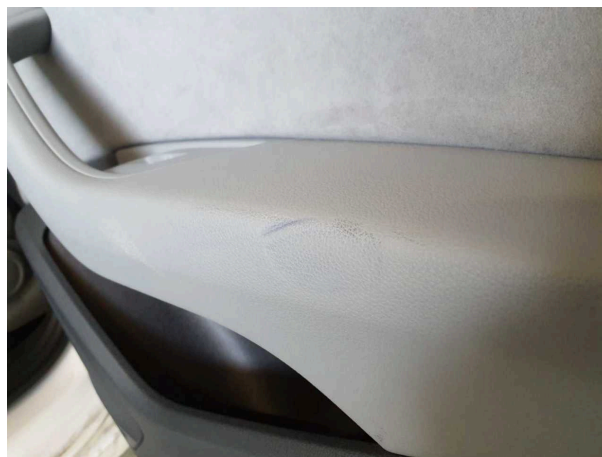
| No. | Component group | Description |
|---|---|---|
| 5 | Trim / covers | Door trim - rear right side - Deformed - Loss in value |

**Damage #5:** Trim / covers: Door trim - rear right side - Deformed - Loss in value

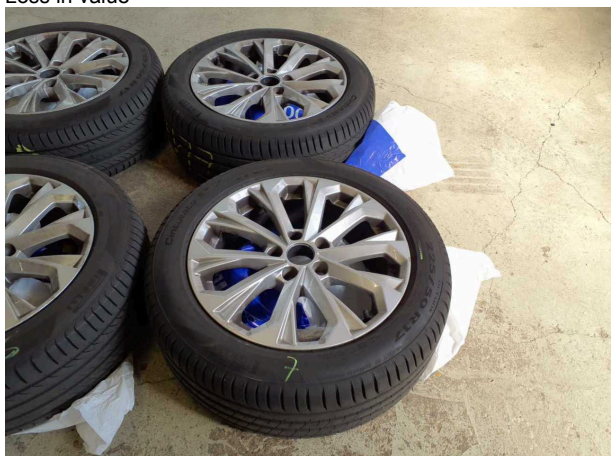
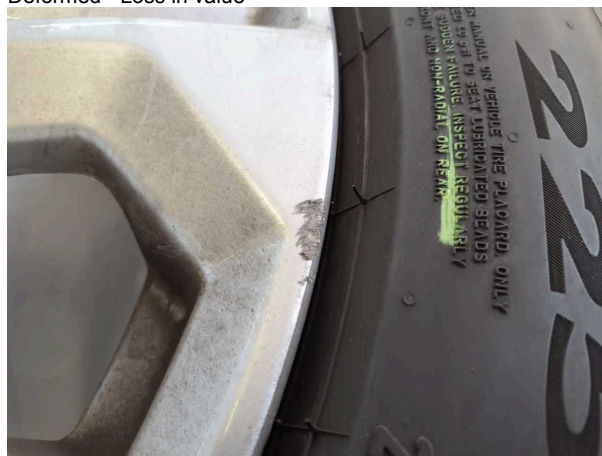
| No. | Component group | Description |
|---|---|---|
| 6 | 2nd wheel set | 1 alloy rim - Scratched - Loss in value |

**Damage #6:** 2nd wheel set: 1 alloy rim - Scratched - Loss in value

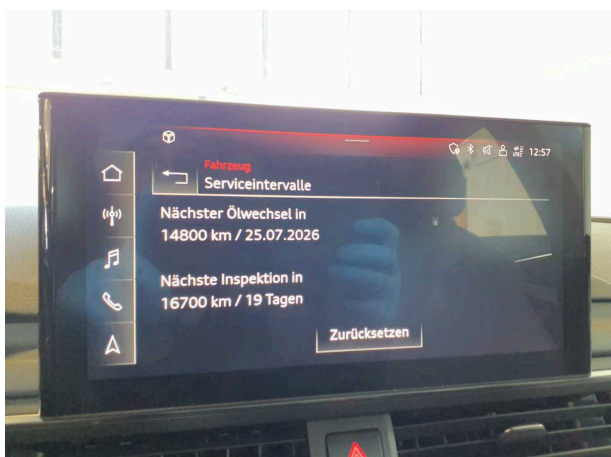
| No. | Component group | Description |
|---|---|---|
| 7 | Misc. | Inspection / maintenance - Due - Replace |

**Damage #7:** Misc.: Inspection / maintenance - Due - Replace

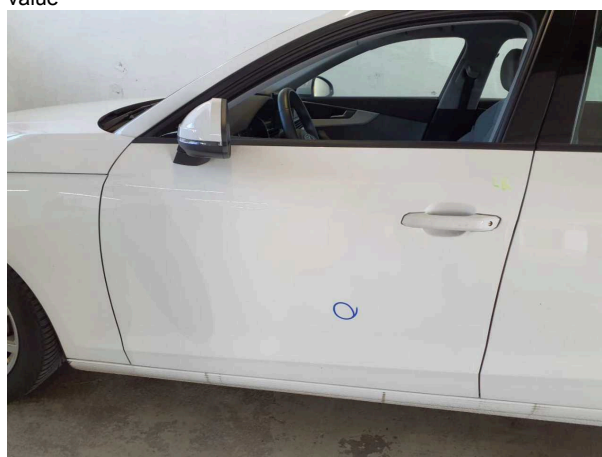
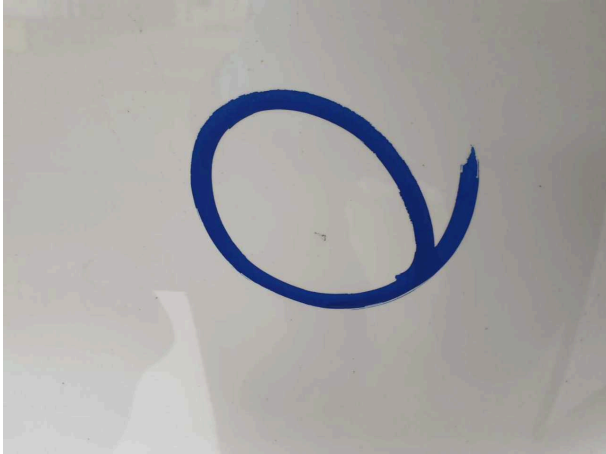
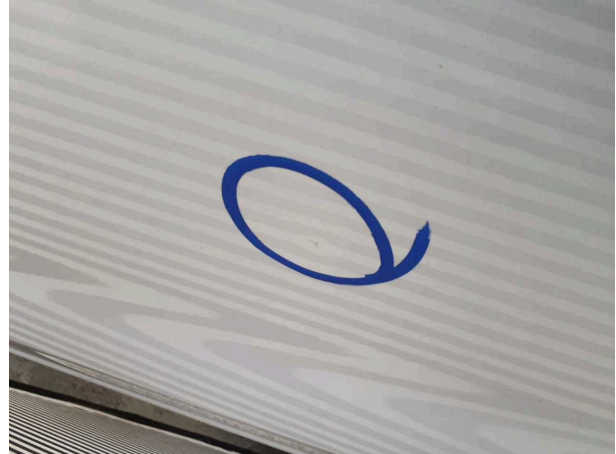
| No. | Component group | Description |
|---|---|---|
| 8 | Door - front left side | Door - Dent / paintcoat damage - Repair and paint |

**Damage #8:** Door - front left side: Door - Dent / paintcoat damage - Repair and paint

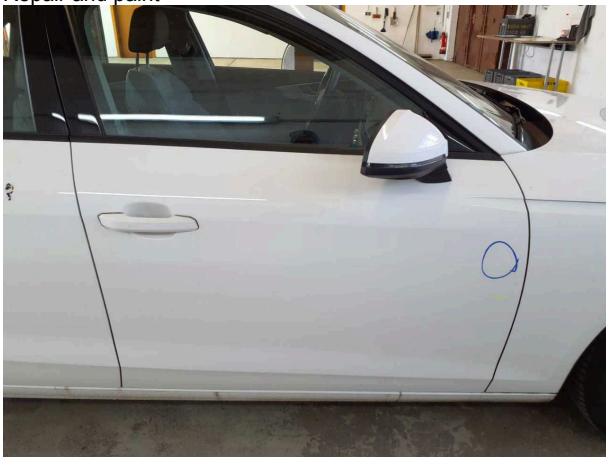
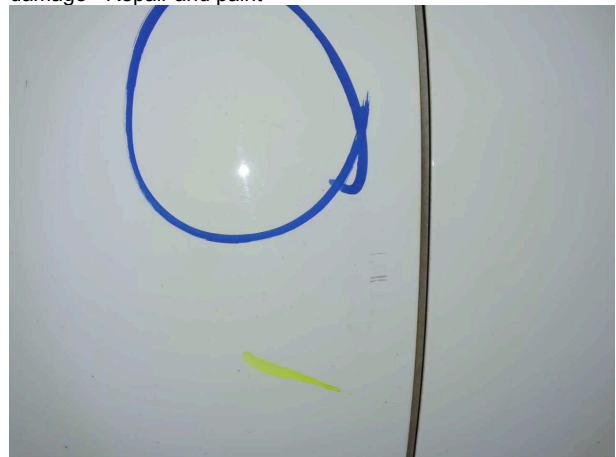
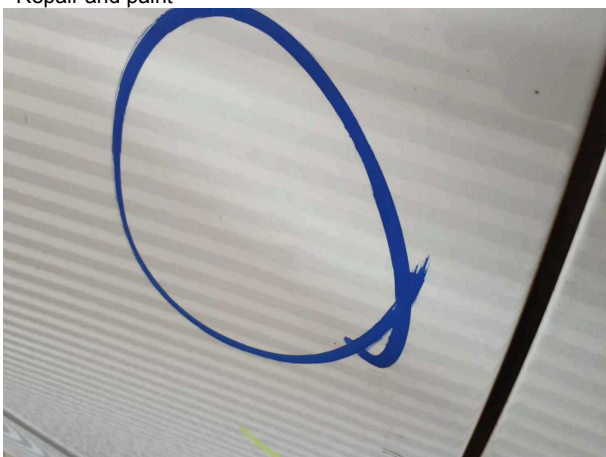
| No. | Component group | Description |
|---|---|---|
| 9 | Door - front right side | Door - Dent / paintcoat damage - Repair and paint |

**Damage #9:** Door - front right side: Door - Dent / paintcoat damage - Repair and paint
