**WBA31AJ070CM53073**

## Vehicle details

## Zustandsbericht

Inspection date: 22 Apr 2025  
**Protocol number:** 39394628  
Delivery date: 22 Apr 2025

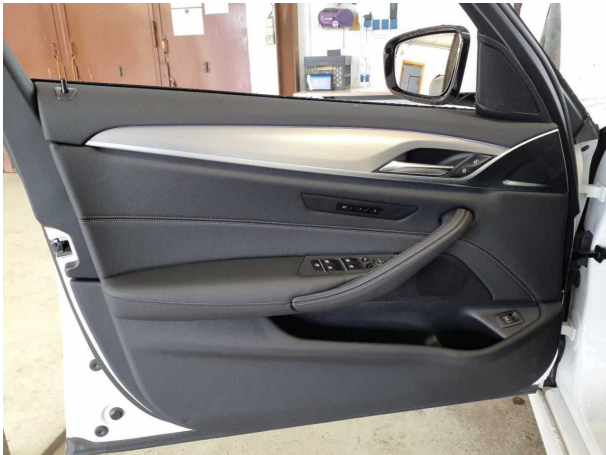
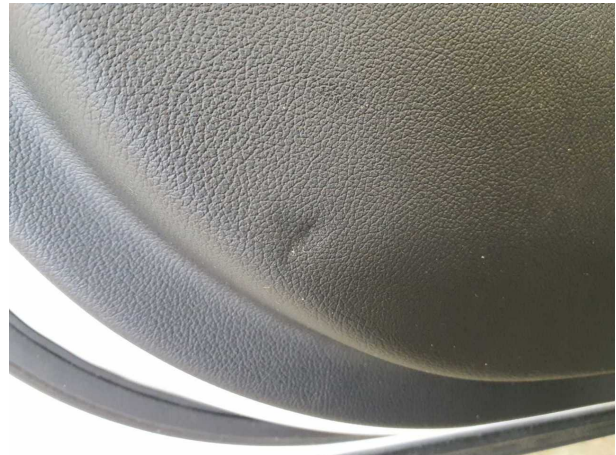
| No. | Component group | Description |
|---|---|---|
| 1 | Trim / covers | Door trim - front left side - Deformed - Loss in value |

**Damage #1:** Trim / covers: Door trim - front left side - Deformed - Loss in value

**Damage #1:** Trim / covers: Door trim - front left side - Deform... - Loss in value

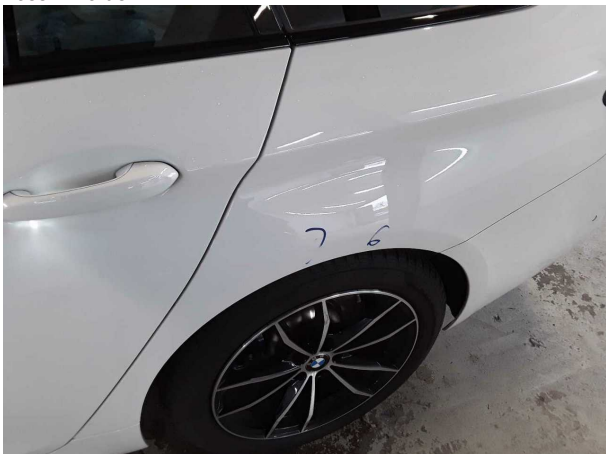
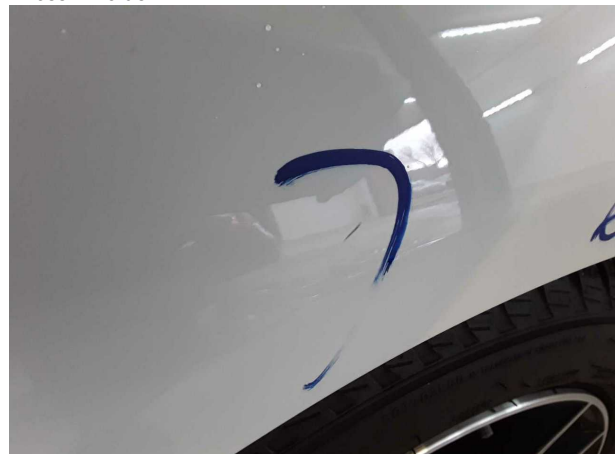
| No. | Component group | Description |
|---|---|---|
| 2 | Side panel - rear left side | Side panel - Scratched - Repair and paint |

**Damage #2:** Side panel - rear left side: Side panel - Scratched - Repair and paint

**Damage #2:** Side panel - rear left side: Side panel - Scratched... Repair and paint
