**WBA31BN070CG47752**

## Vehicle details

## Zustandsbericht

**Protocol number:** 39061455

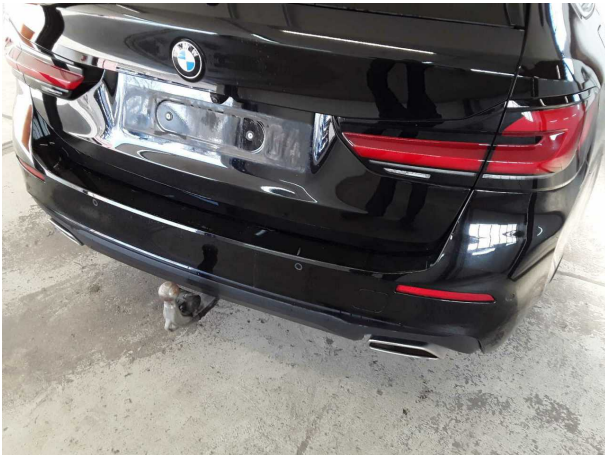
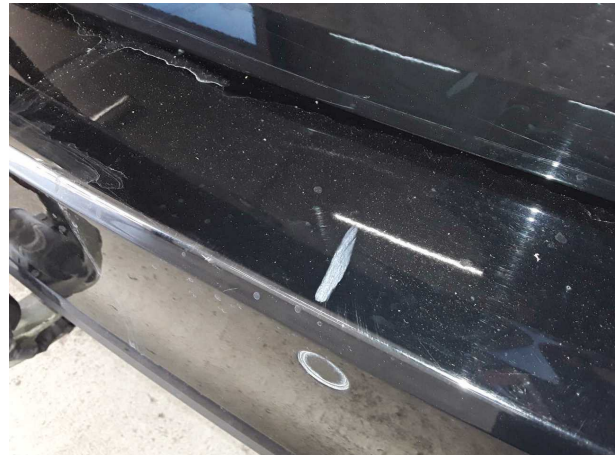
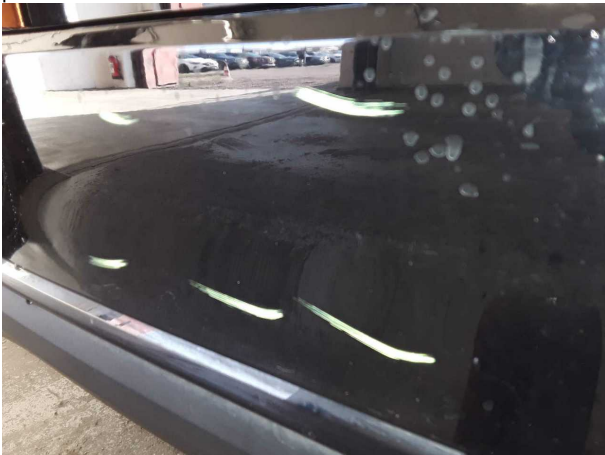
| No. | Component group | Description |
|---|---|---|
| 1 | Rear bumper | Rear bumper - Scratched - Repair and paint |

**Damage #1:** Rear bumper: Rear bumper - Scratched - Repair and paint

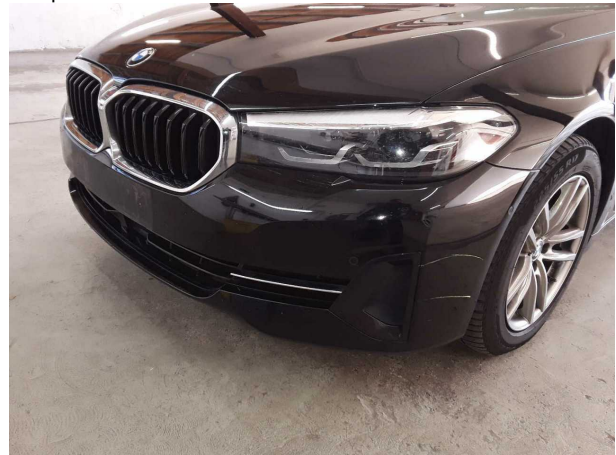
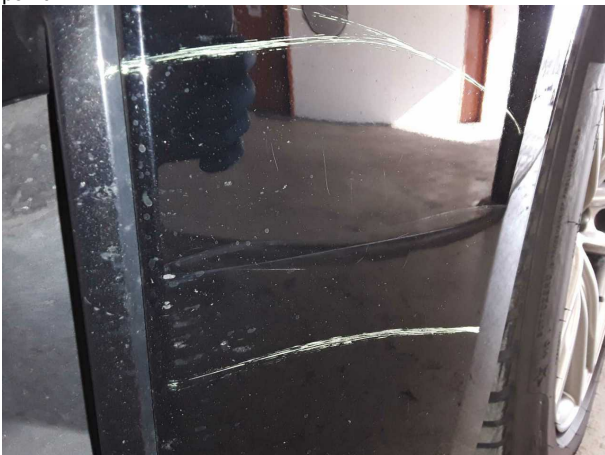
| No. | Component group | Description |
|---|---|---|
| 2 | Front bumper | Front bumper - Scratched - Repair and paint |

**Damage #2:** Front bumper: Front bumper - Scratched - Repair and paint

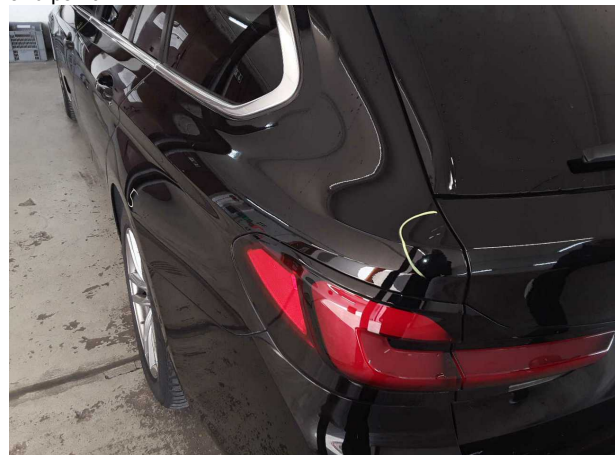
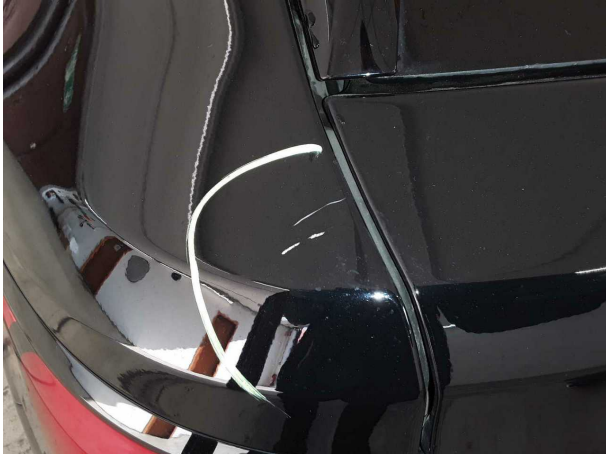
| No. | Component group | Description |
|---|---|---|
| 3 | Side panel - rear left side | Side panel - Scratched - Repair and paint |

**Damage #3:** Side panel - rear left side: Side panel - Scratched - Repair and paint

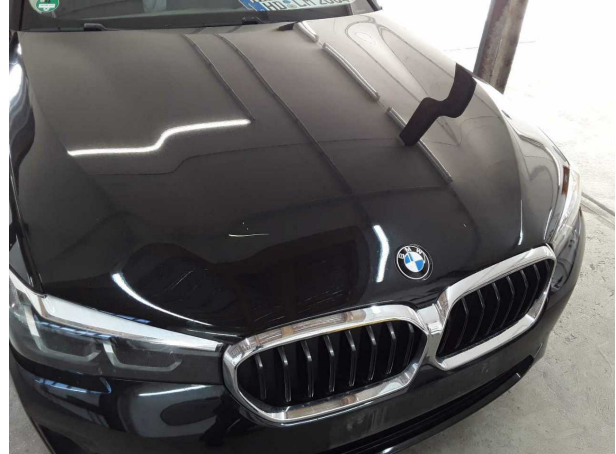
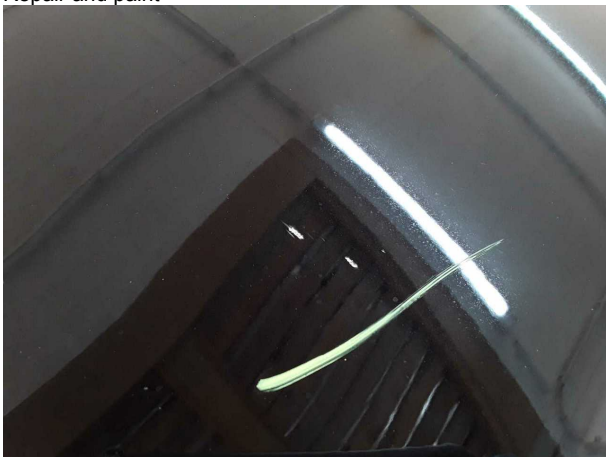
| No. | Component group | Description |
|---|---|---|
| 4 | Bonnet | Bonnet - Scratched - Paint |

**Damage #4:** Bonnet: Bonnet - Scratched - Paint
