**WAUZZZF47MA003146**

## Vehicle details

## Zustandsbericht

**Protocol number:** 39479475

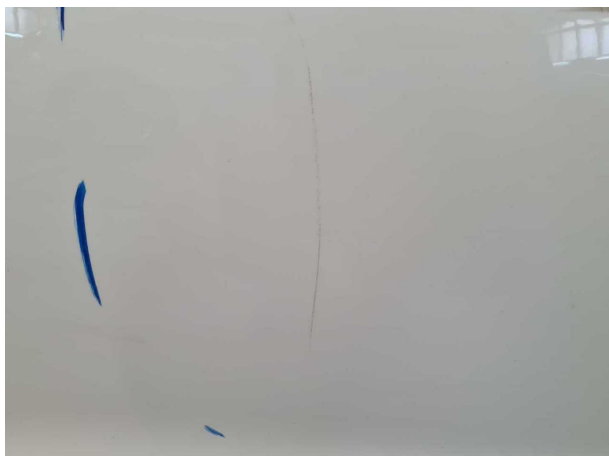
| No. | Component group | Description |
|---|---|---|
| 2 | Door - rear right side | Door - Abrasion - Cover / polish |

| No. | Location |
|---|---|
| 1 | Door - rear right side |

**Damage #2:** Door - rear right side: Door - Abrasion - Cover / polish

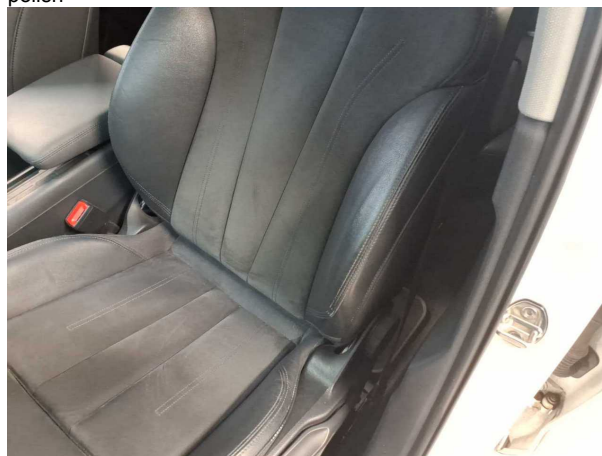
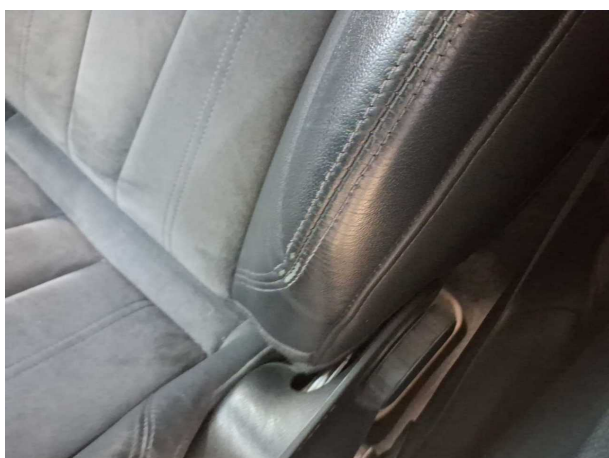
| No. | Component group | Description |
|---|---|---|
| 4 | Seat - front | Backrest cover - left side - Abrasion - Loss in value |

**Damage #4:** Seat - front: Backrest cover - left side - Abrasion - Loss in value

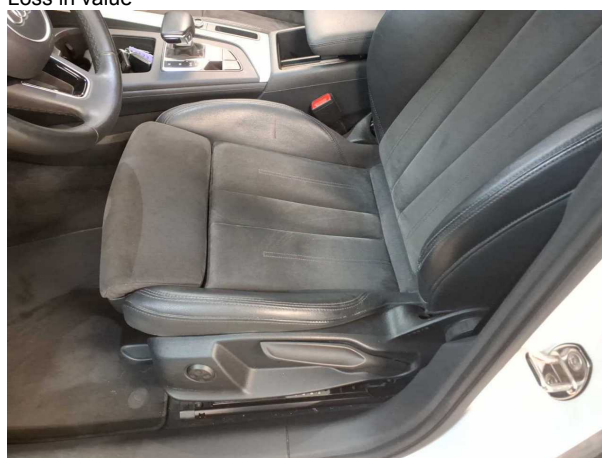
| No. | Component group | Description |
|---|---|---|
| 5 | Seat - front | Seat cover - left side - Abrasion - Loss in value |

**Damage #5:** Seat - front: Seat cover - left side - Abrasion - Loss in value

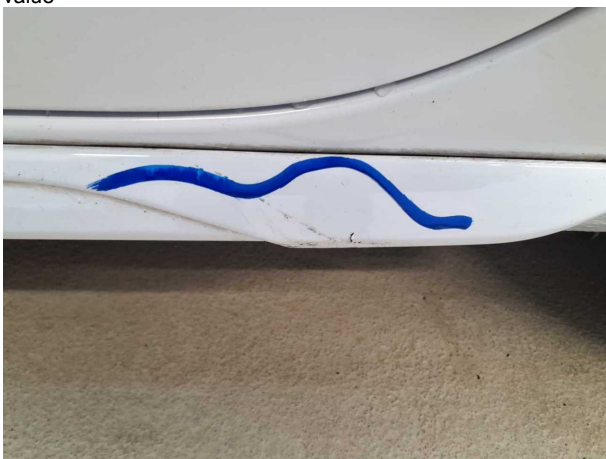
| No. | Component group | Description |
|---|---|---|
| 6 | Sill - left side | Trim - Scratched - Smart repair |

**Damage #6:** Sill - left side: Trim - Scratched - Smart repair

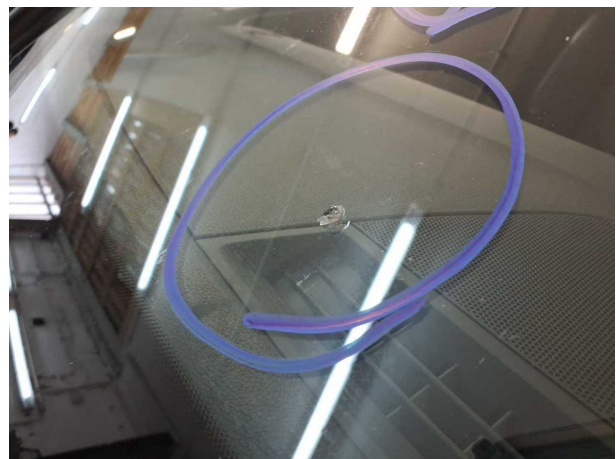
| No. | Component group | Description |
|---|---|---|
| 7 | Vehicle glazing | Windscreen - Stone chips - Replace |

**Damage #7:** Vehicle glazing: Windscreen - Stone chips - Replace

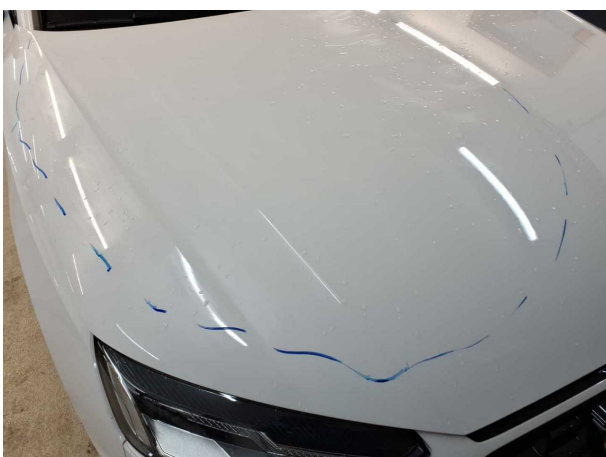
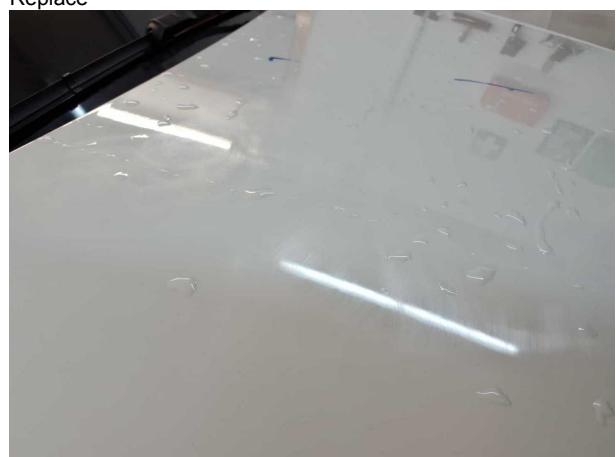
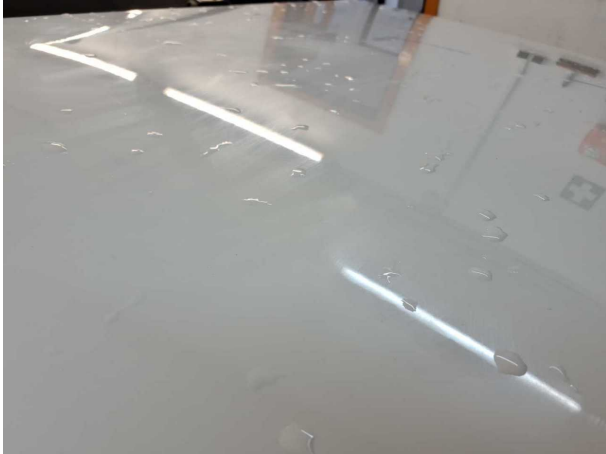
| No. | Component group | Description |
|---|---|---|
| 8 | Bonnet | Bonnet - Scratch(es) - Repair and paint |

**Damage #8:** Bonnet: Bonnet - Scratch(es) - Repair and paint
