**WBA11FY020FP43603**

## Vehicle details

## Zustandsbericht

Inspection date: 29 Apr 2025  
**Protocol number:** 39505755  
Delivery date: 29 Apr 2025

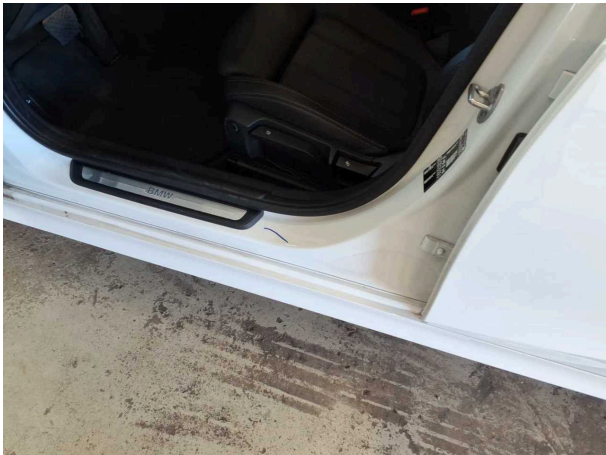
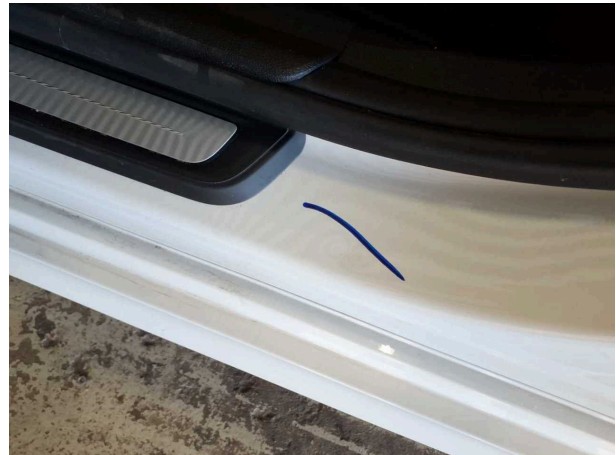
| No. | Component group | Description |
|---|---|---|
| 1 | Sill - left side | Sill - dent(s) - Smooth repair work |

**Damage #1:** Sill - left side: Sill - dent(s) - Smooth repair work

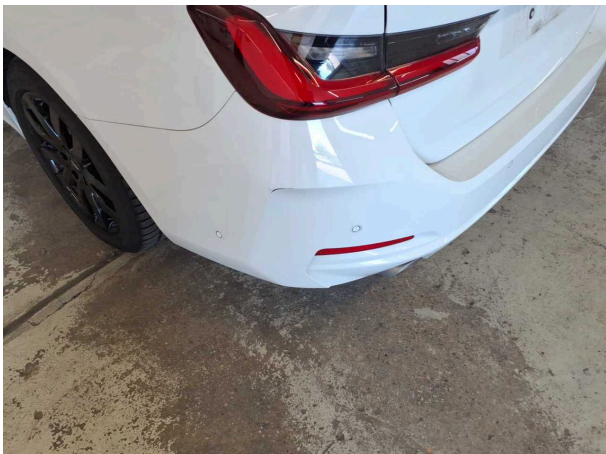
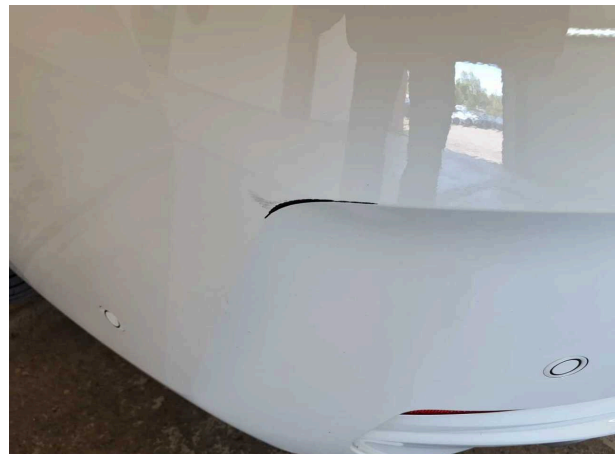
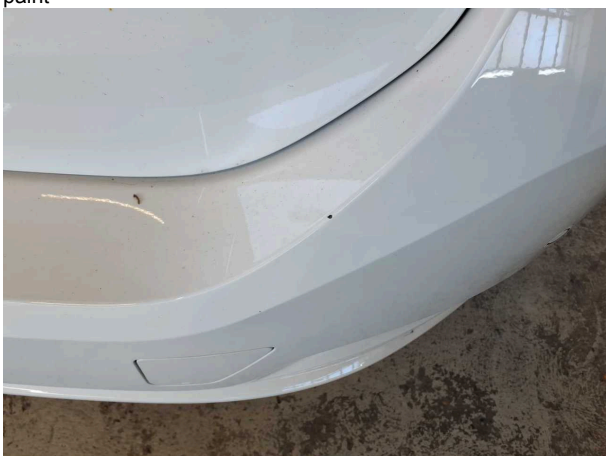
| No. | Component group | Description |
|---|---|---|
| 2 | Rear bumper | Rear bumper - Scratched - Repair and paint |

**Damage #2:** Rear bumper: Rear bumper - Scratched - Repair and paint
