WBA7K310907J21462

## Zustandsbericht

**TÜV SÜD Auto Plus GmbH**  
Gutenbergstr. 13  
70771 Leinfelden-Echterdingen

**Protocol number:** 39470285

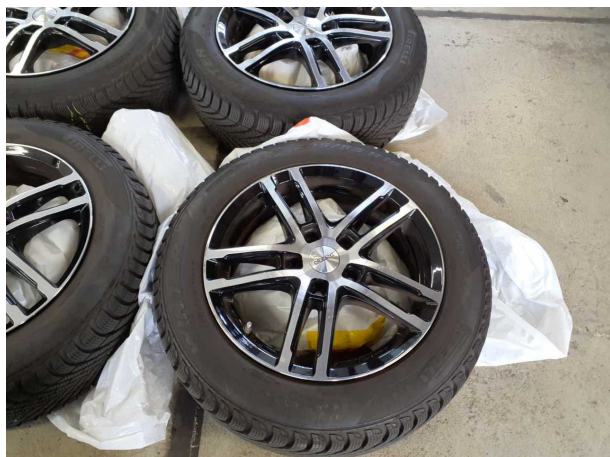
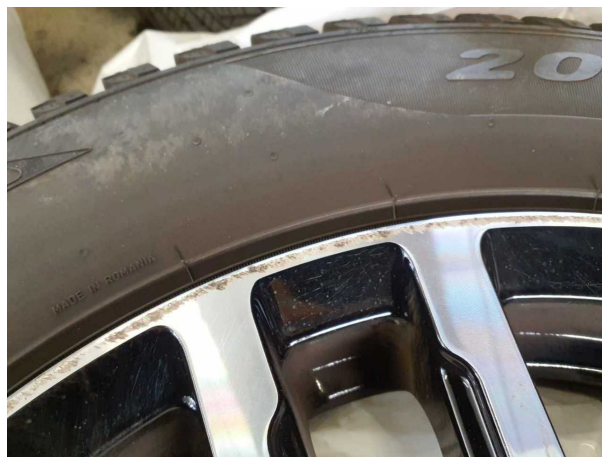
**Damage #1:** 2nd wheel set: 1 alloy rim - Scratched - No deduction

| No. | Component group | Description |
|---|---|---|
| 1 | 2nd wheel set | 1 alloy rim - Scratched - No deduction |

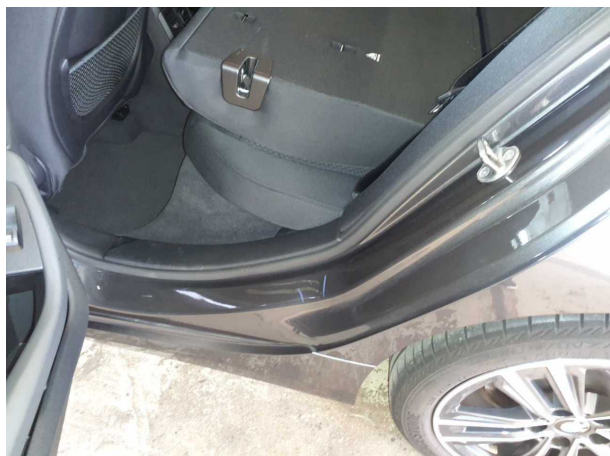
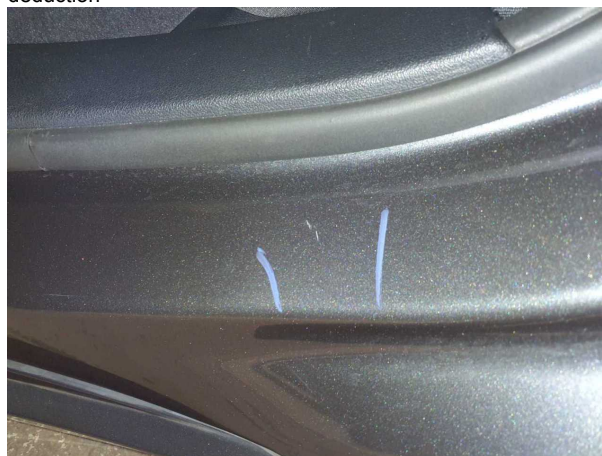
**Damage #2:** Side panel - rear left side: Sill - Scratch(es) - Smart repair

| No. | Component group | Description |
|---|---|---|
| 2 | Side panel - rear left side | Sill - Scratch(es) - Smart repair |

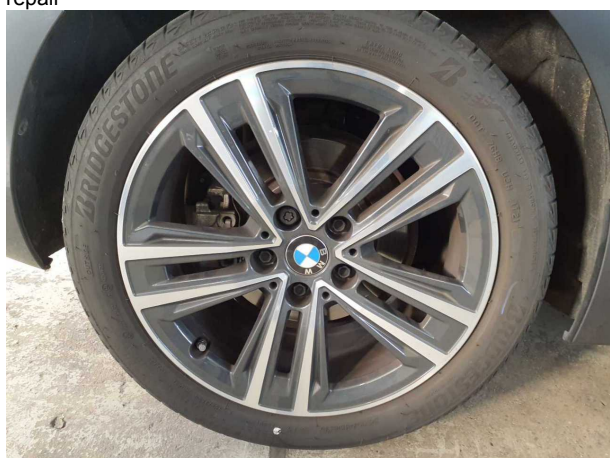
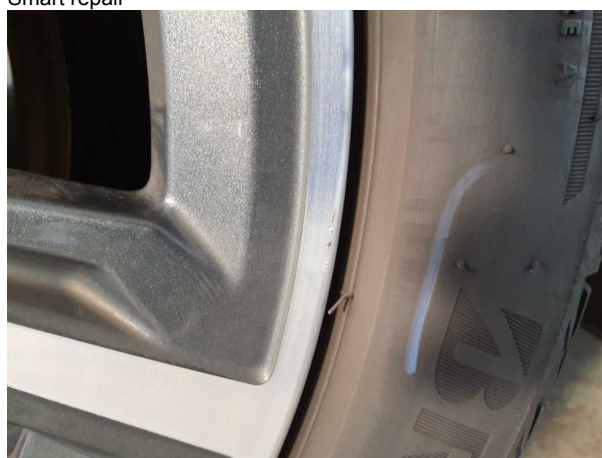
**Damage #3:** Wheel / tyres: Alloy rim - rear right side - Scratched - Loss in value

| No. | Component group | Description |
|---|---|---|
| 3 | Wheel / tyres | Alloy rim - rear right side - Scratched - Loss in value |

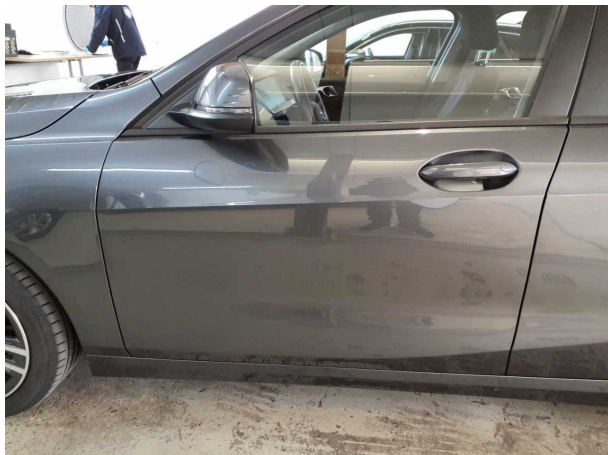
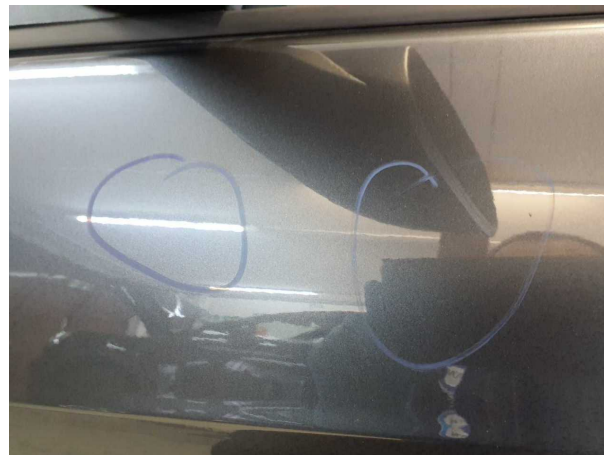
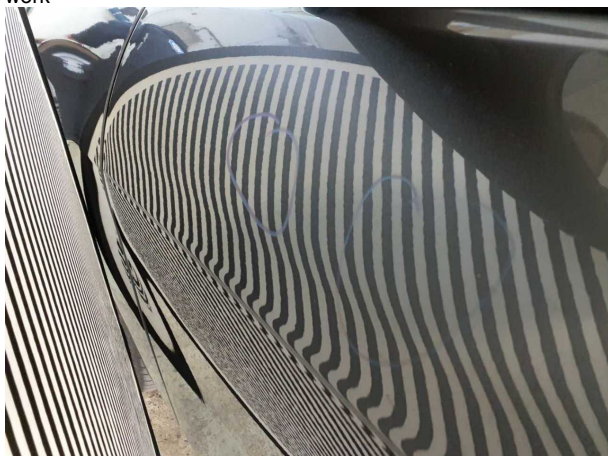
**Damage #4:** Door - front left side: Door - dent(s) - Smooth repair work

| No. | Component group | Description |
|---|---|---|
| 4 | Door - front left side | Door - dent(s) - Smooth repair work |

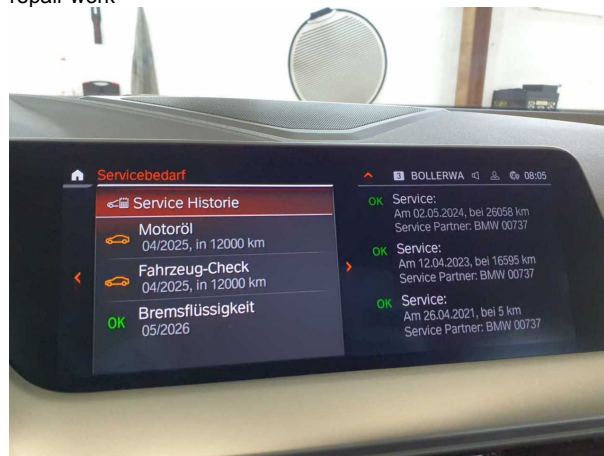
**Damage #5:** Misc.: Inspection / maintenance - Due - Perform

| No. | Component group | Description |
|---|---|---|
| 5 | Misc. | Inspection / maintenance - Due - Perform |

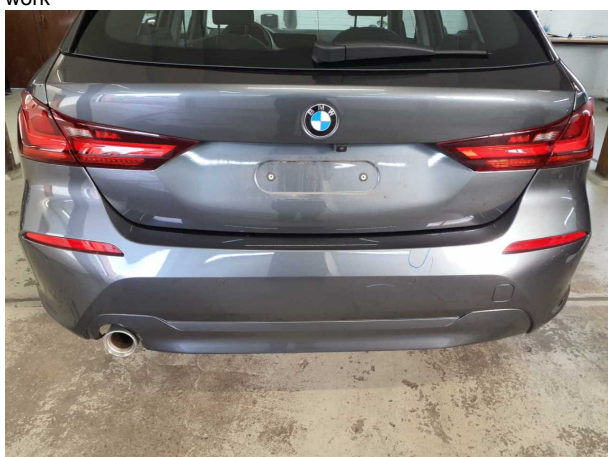
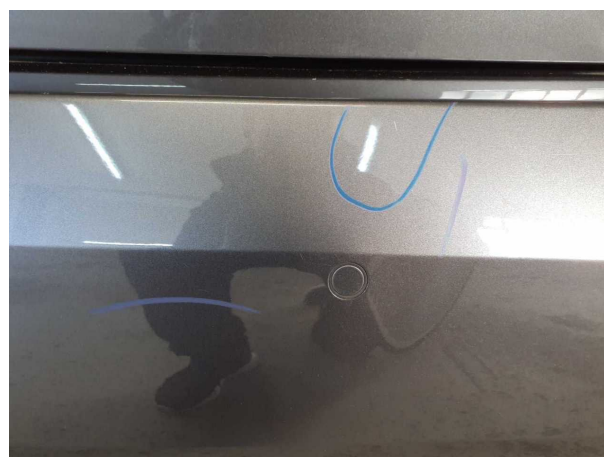
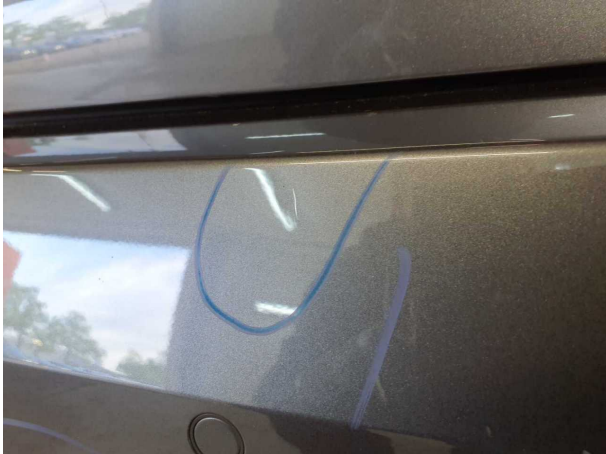
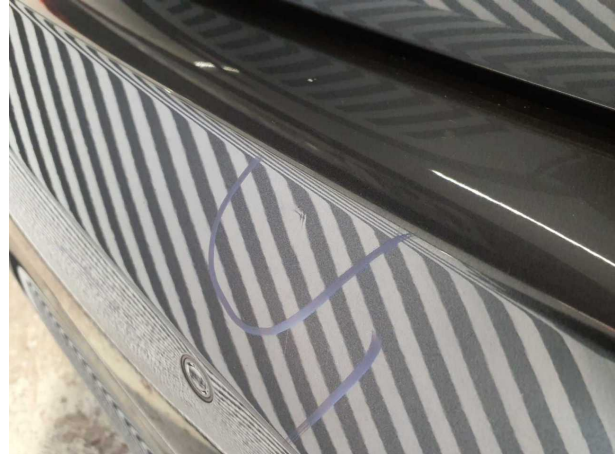
**Damage #6:** Rear bumper: Rear bumper - Deformed - Repair and paint

| No. | Component group | Description |
|---|---|---|
| 6 | Rear bumper | Rear bumper - Deformed - Repair and paint |

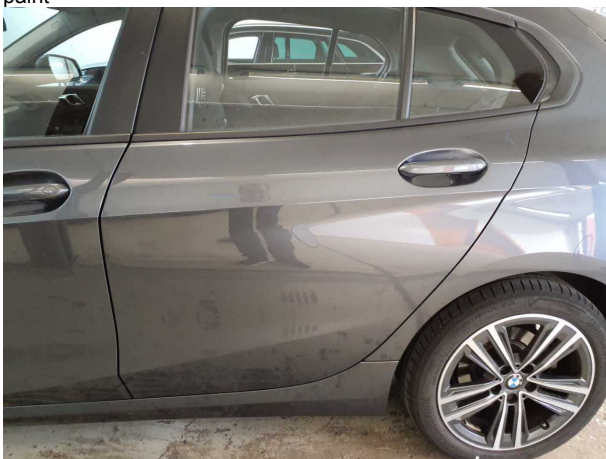
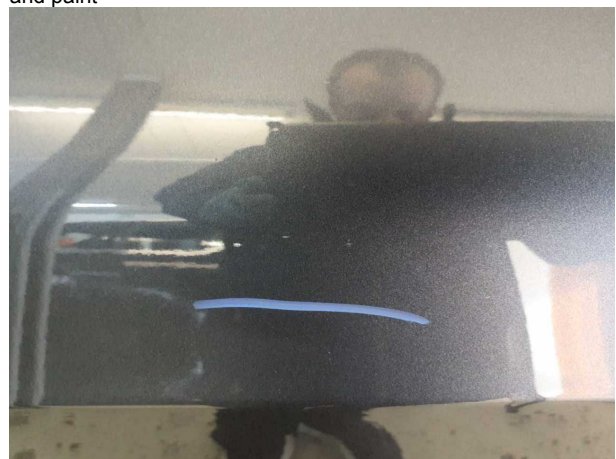
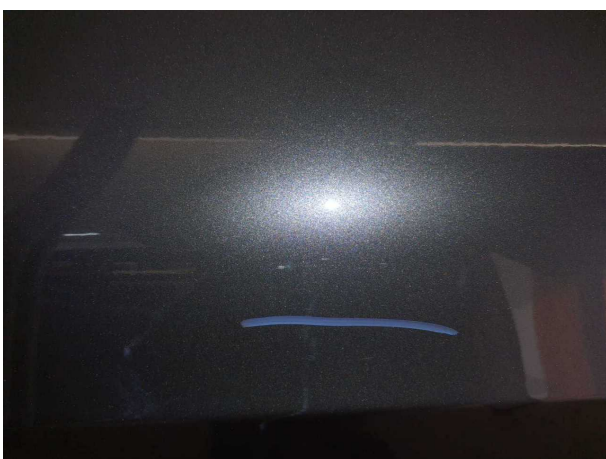
**Damage #7:** Door - rear left side: Door - Scratch(es) - Paint

| No. | Component group | Description |
|---|---|---|
| 7 | Door - rear left side | Door - Scratch(es) - Paint |

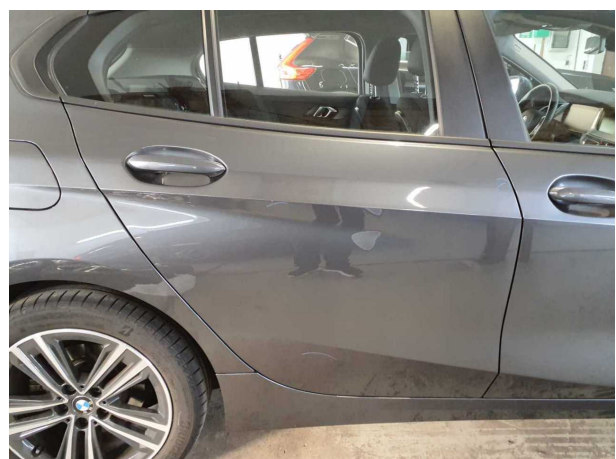
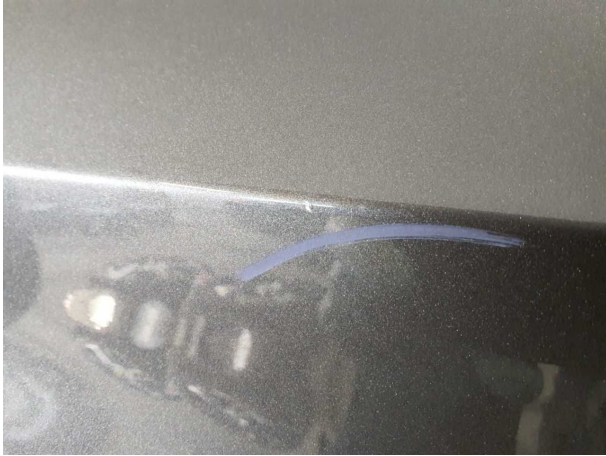
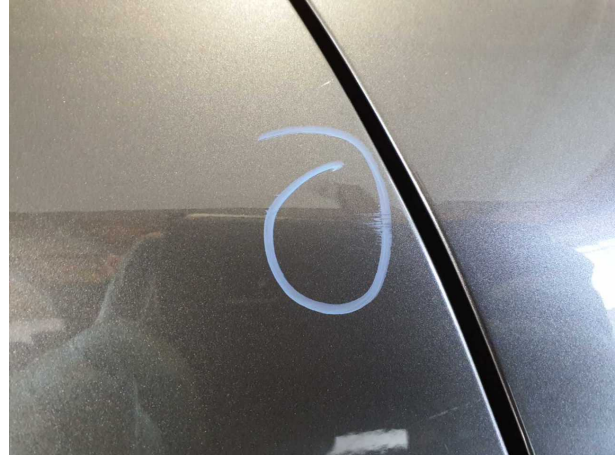
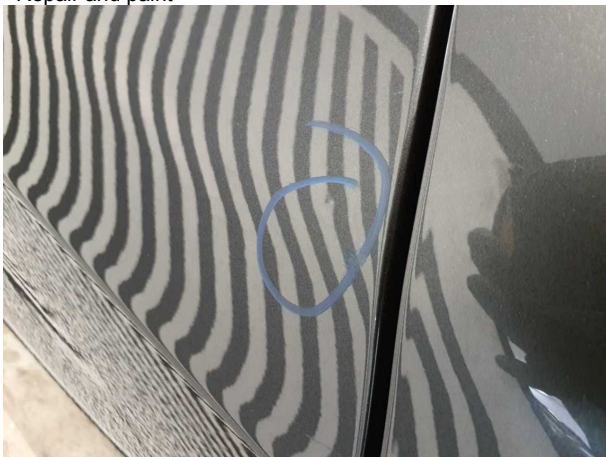
**Damage #8:** Door - rear right side: Door - Dent / paintcoat damage - Repair and paint

**Damage #8:** Door - rear right side: Door - Dent / paintcoat damage  
- Repair and paint

| No. | Component group | Description |
|---|---|---|
| 8 | Door - rear right side | Door - Dent / paintcoat damage - Repair and paint |
