**WBA5P51090FL19744**

## Zustandsbericht

**Protocol number:** 39483573

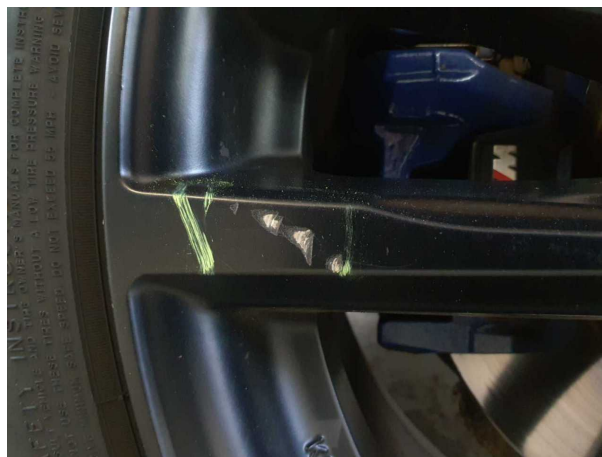
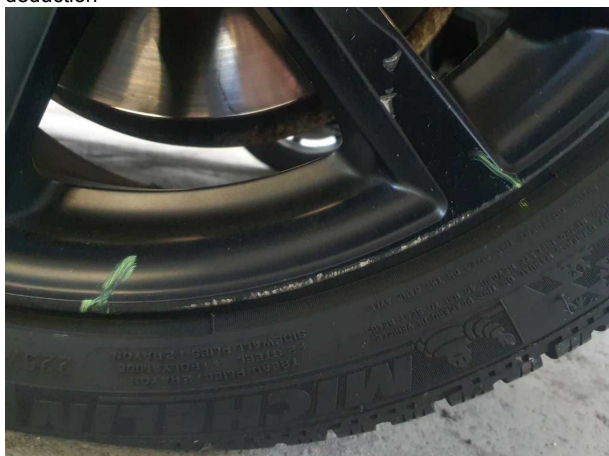
| No. | Component group | Description |
|---|---|---|
| 1 | Wheel / tyres | Alloy rim - rear left side - Scratched - No deduction |

**Damage #1:** Wheel / tyres: Alloy rim - rear left side - Scratched - ... deduction

**Damage #1:** Wheel / tyres: Alloy rim - rear left side - Scratched - No deduction

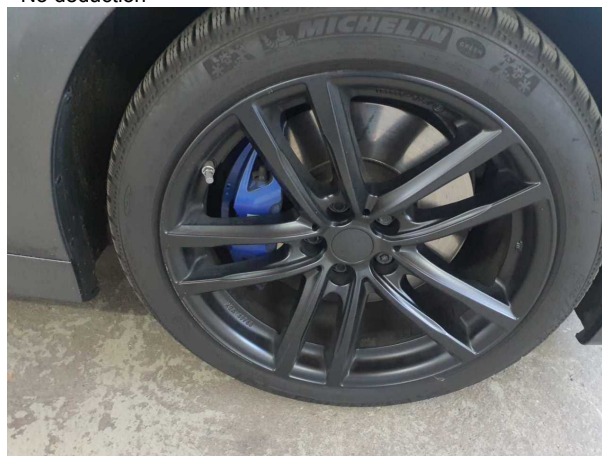
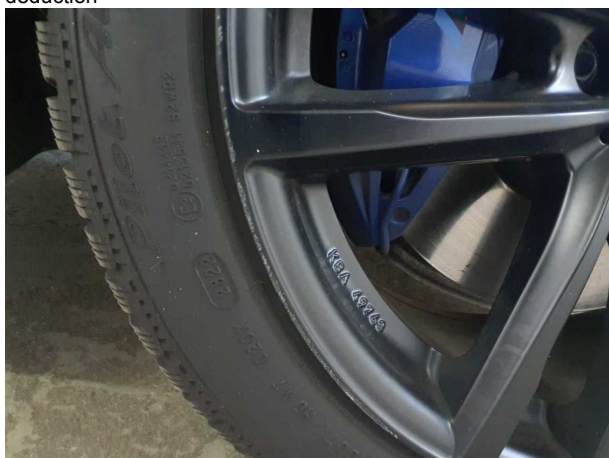
| No. | Component group | Description |
|---|---|---|
| 2 | Wheel / tyres | Alloy rim - front right side - Scratched - Loss in value |

**Damage #2:** Wheel / tyres: Alloy rim - front right side - Scratched - Loss in value

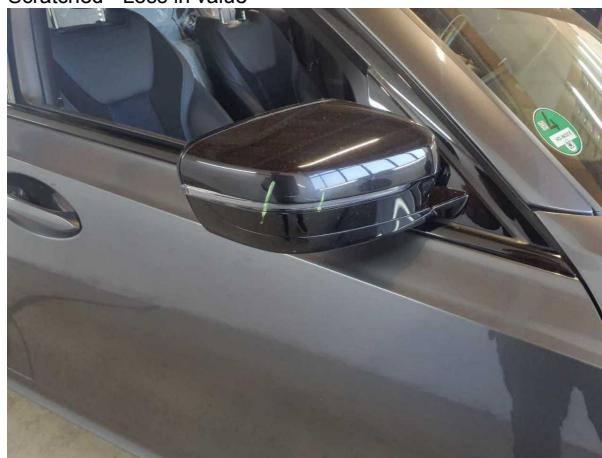
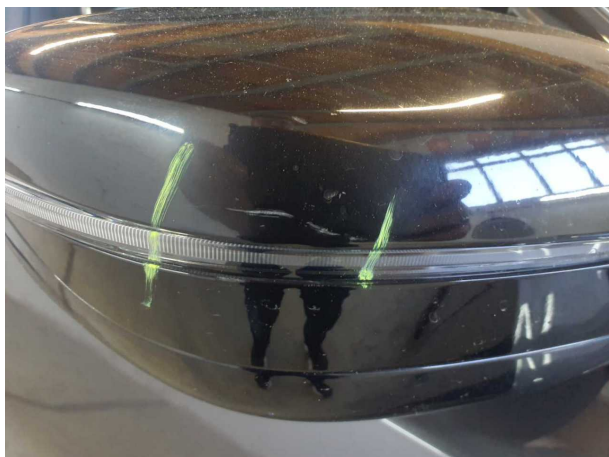
| No. | Component group | Description |
|---|---|---|
| 3 | Wing mirror - right side | Cap - Scratched - Paint |

**Damage #3:** Wing mirror - right side: Cap - Scratched - Paint

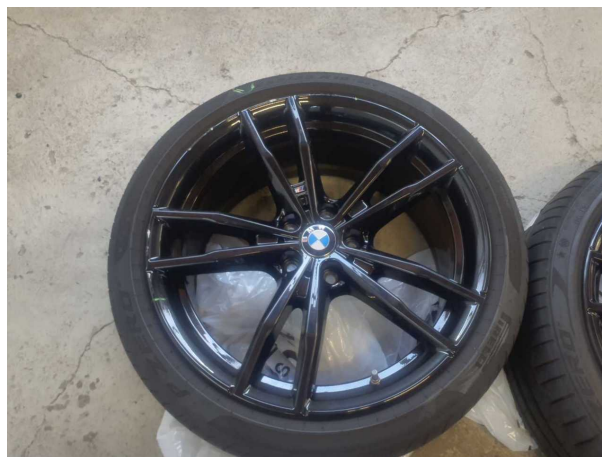
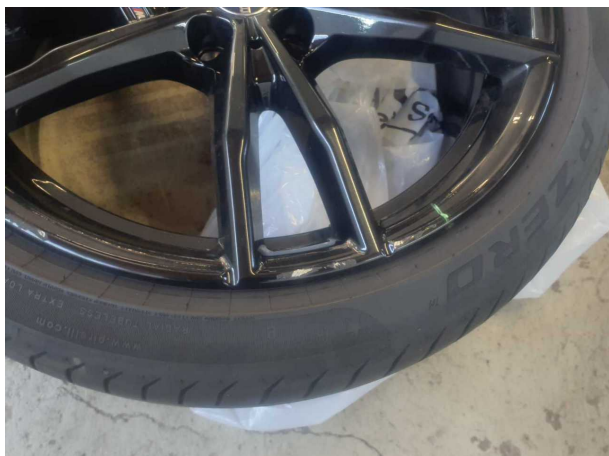
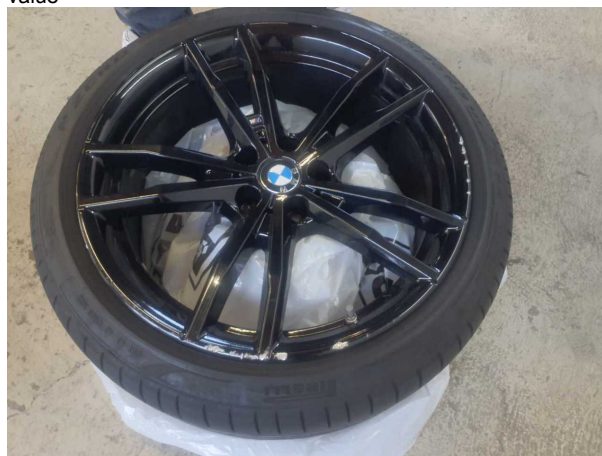
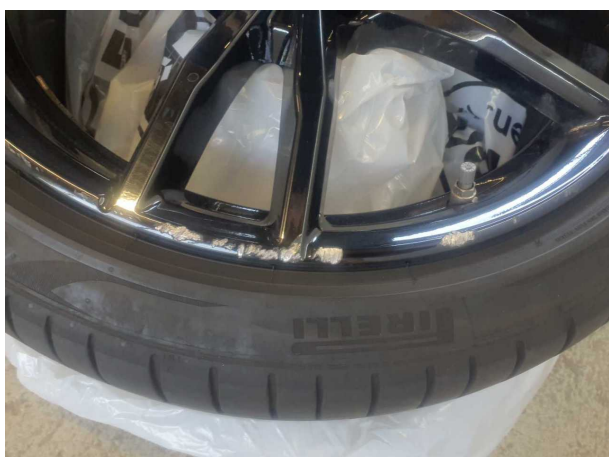
| No. | Component group | Description |
|---|---|---|
| 4 | 2nd wheel set | 2 alloy rims - Scratched - Loss in value |

**Damage #4:** 2nd wheel set: 2 alloy rims - Scratched - Loss in value

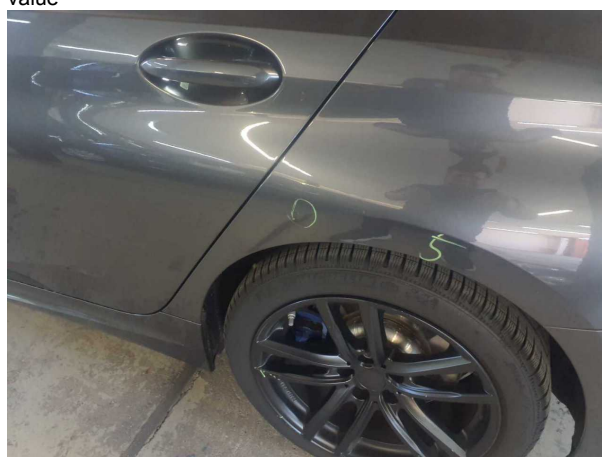
| No. | Component group | Description |
|---|---|---|
| 5 | Side panel - rear left side | Side panel - Dent / paintcoat damage - Repair and paint |

**Damage #5:** Side panel - rear left side: Side panel - Dent / paintcoat damage - Repair and paint
