**WAUZZZFY4L2128617**

## Zustandsbericht

Inspection date: 29 Apr 2025

**Protocol number:** 39505707

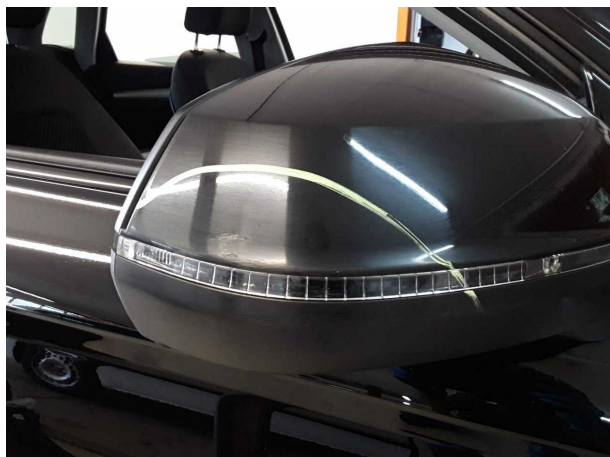
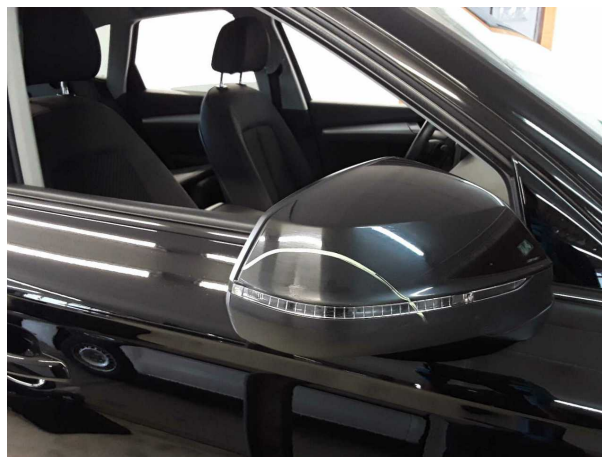
| No. | Component group | Description |
|---|---|---|
| 1 | Wing mirror - right side | Cap - Scratched - Smart repair |

**Damage #1:** Wing mirror - right side: Cap - Scratched - Smart repair

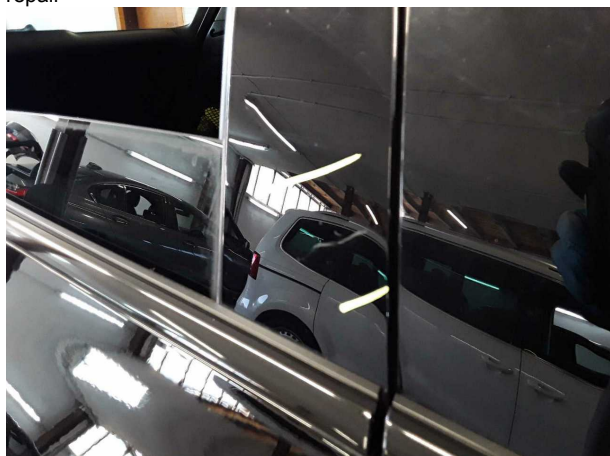
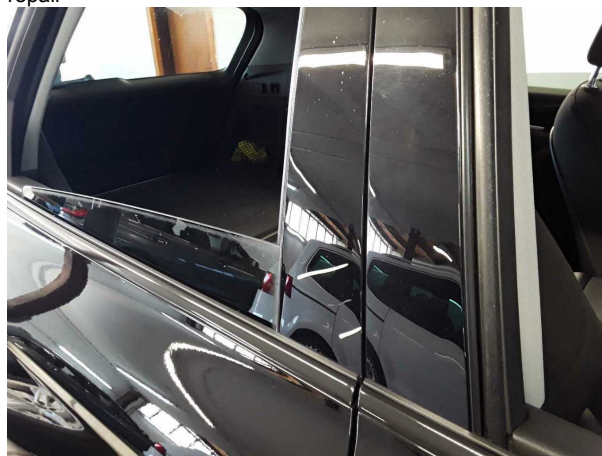
| No. | Component group | Description |
|---|---|---|
| 2 | Trim / covers | Brightware / decorative strip - Scratched - Replace |

**Damage #2:** Trim / covers: Brightware / decorative strip - Scratched - Replace

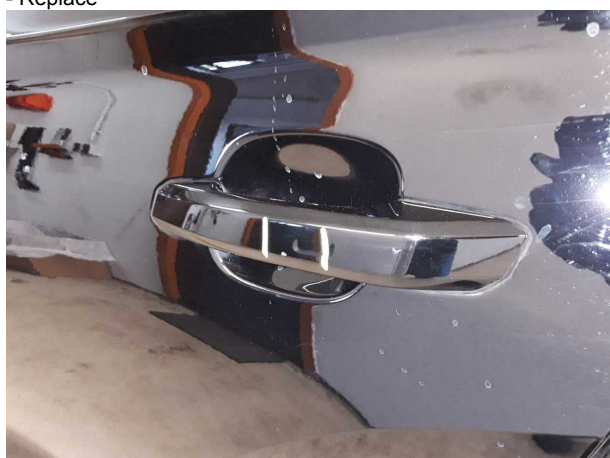
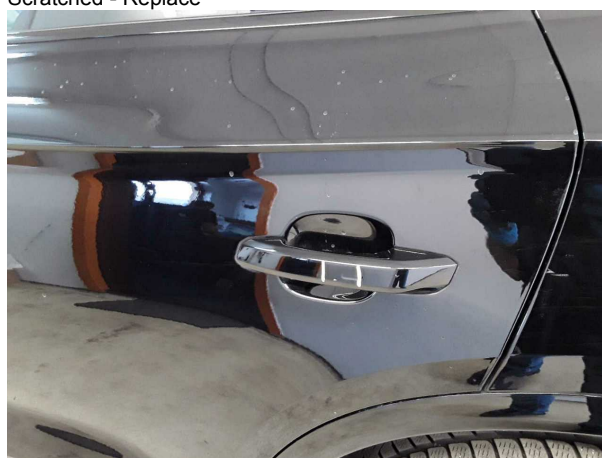
| No. | Component group | Description |
|---|---|---|
| 3 | Door - rear left side | Door handle - outside - Scratched - Smart repair |

**Damage #3:** Door - rear left side: Door handle - outside - Scratched - Smart repair

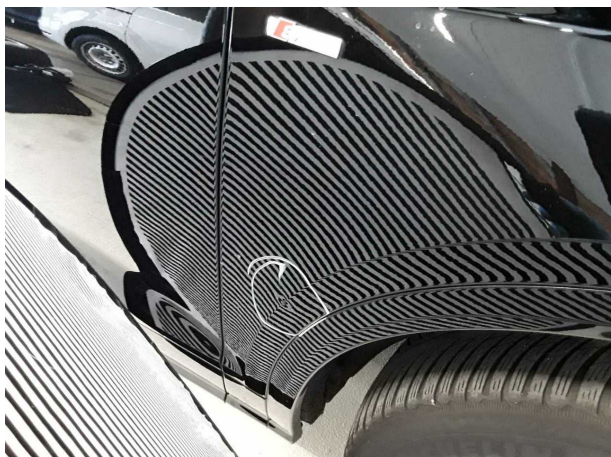
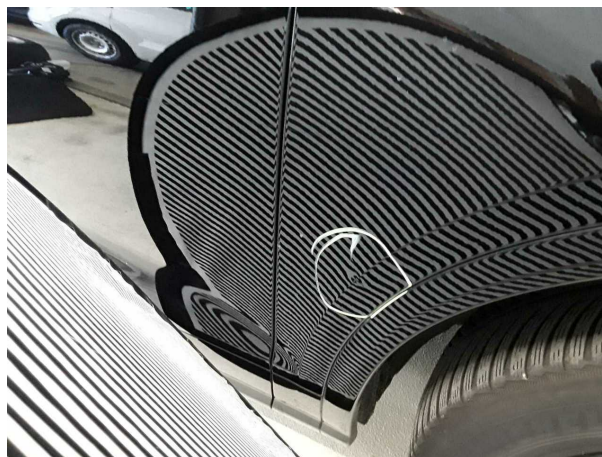
| No. | Component group | Description |
|---|---|---|
| 4 | Mudguard - right side | Mudguard - right side - dent(s) - Smooth repair work |

**Damage #4:** Mudguard - right side: Mudguard - right side - dent(s)...  
Smooth repair work

**Damage #4:** Mudguard - right side: Mudguard - right side -  
dent(s) - Smooth repair work

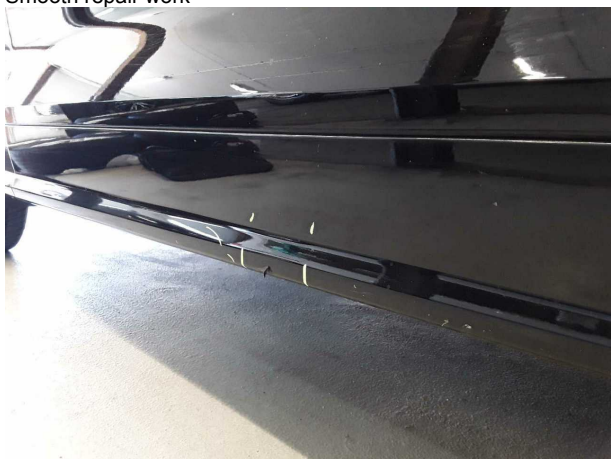
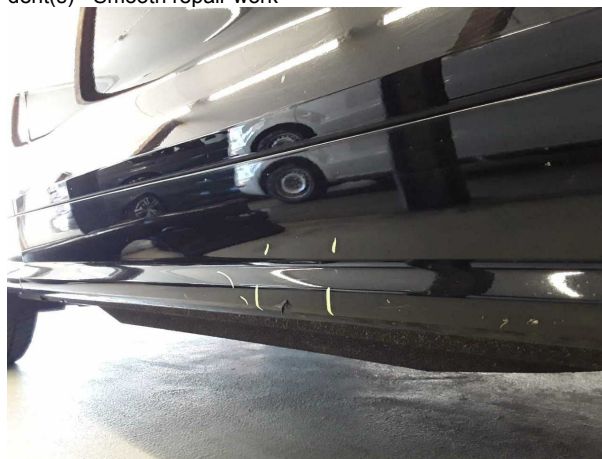
| No. | Component group | Description |
|---|---|---|
| 5 | Sill - right side | Trim - Scratched - Smart repair |

**Damage #5:** Sill - right side: Trim - Scratched - Smart repair

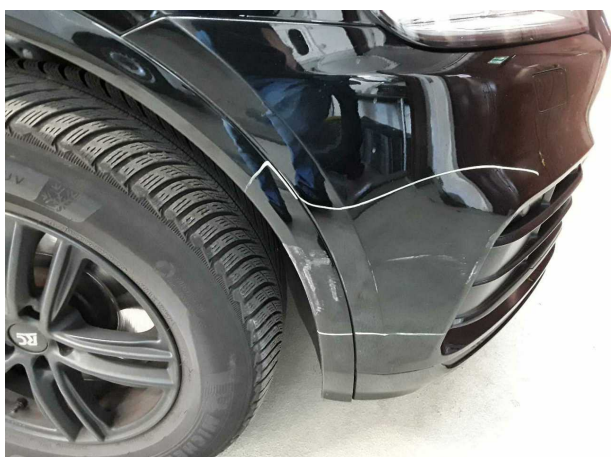
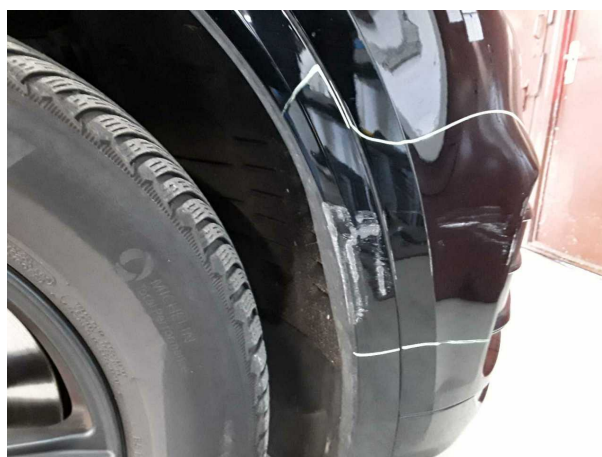
| No. | Component group | Description |
|---|---|---|
| 6 | Mudguard - right side | Wheel arch - Scratched - Replace |

**Damage #6:** Mudguard - right side: Wheel arch - Scratched -  
Replace

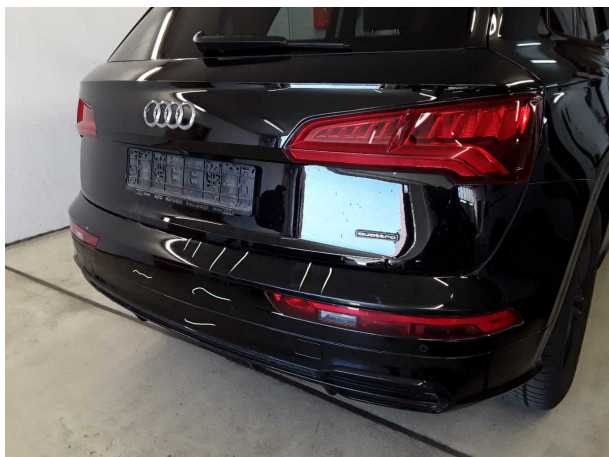
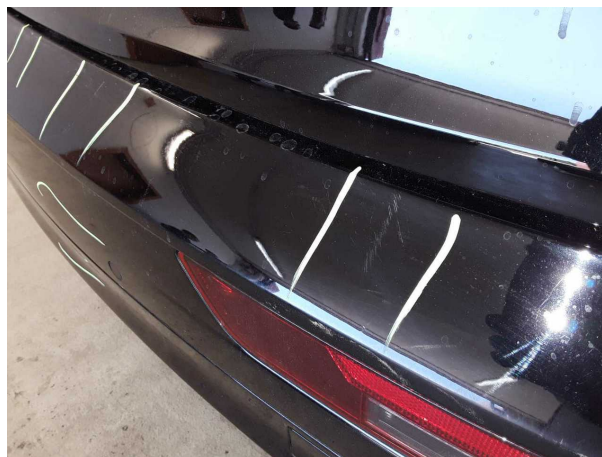
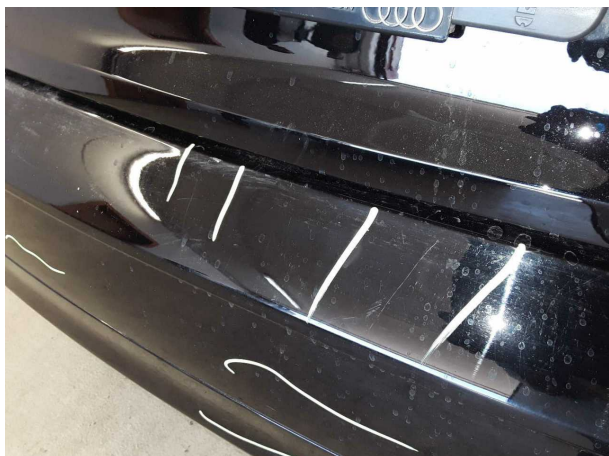
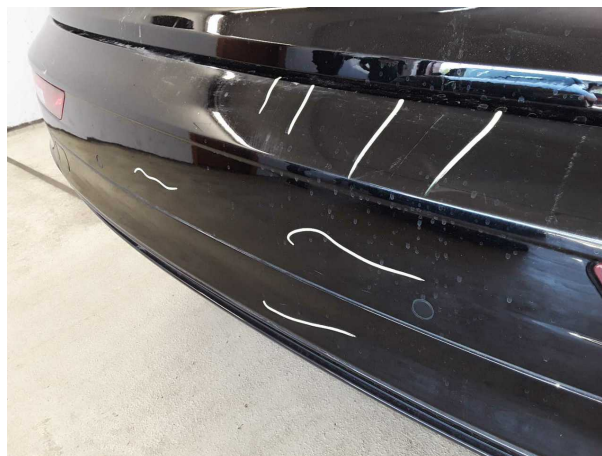
| No. | Component group | Description |
|---|---|---|
| 7 | Rear bumper | Rear bumper - Scratched - Paint |

**Damage #7:** Rear bumper: Rear bumper - Scratched - Paint

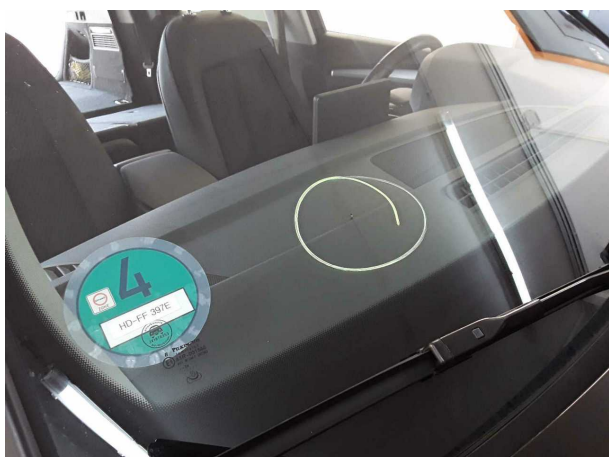
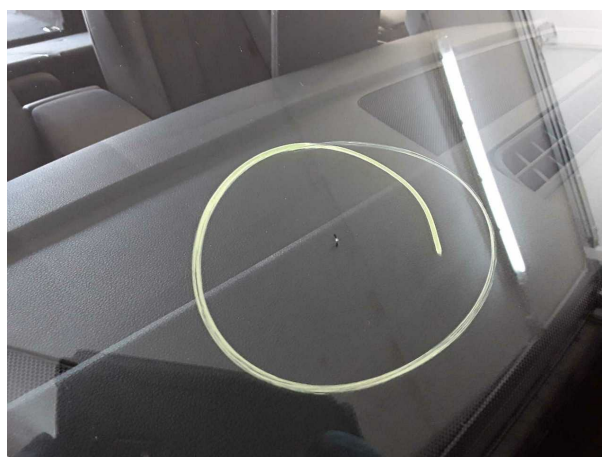
| No. | Component group | Description |
|---|---|---|
| 8 | Vehicle glazing | Windscreen - Stone chips - Replace |

**Damage #8:** Vehicle glazing: Windscreen - Stone chips - Replace

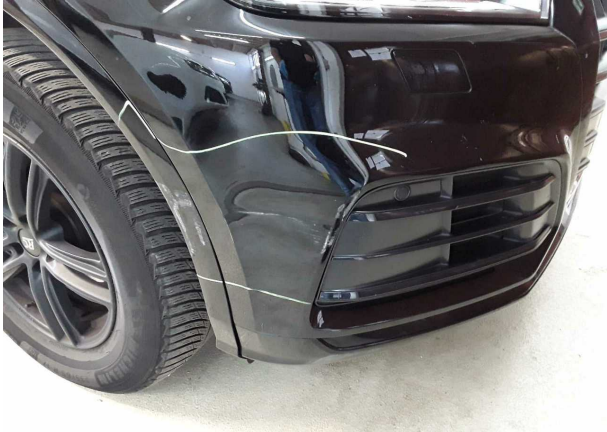
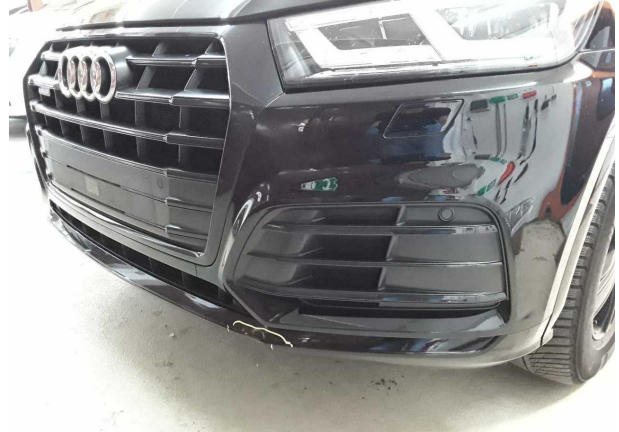
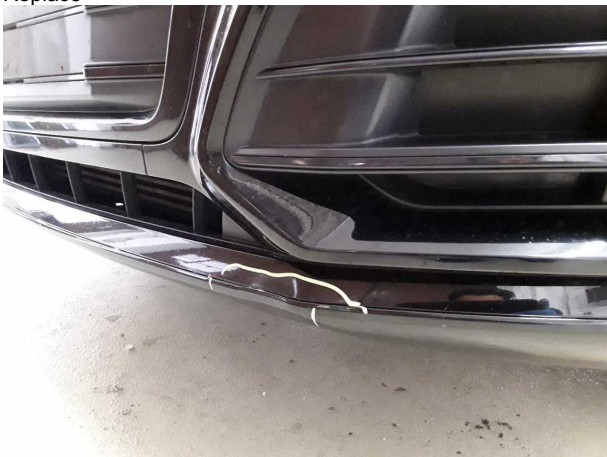
| No. | Component group | Description |
|---|---|---|
| 9 | Front bumper | Front bumper (Verformt) - Scratched - Replace |

**Damage #9:** Front bumper: Front bumper (Verformt) - Scratched - Replace
