WBA51BN070CH09630

## Zustandsbericht

Inspection date: 15 Apr 2025

**Protocol number:** 39360055

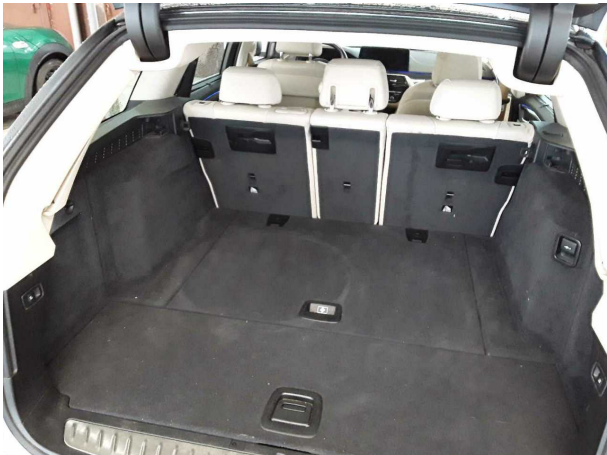
| No. | Component group | Description |
|---|---|---|
| 1 | Interior | Boot cover / roller cover (Fehlt) - No deduction |

**Damage #1:** Interior: Boot cover / roller cover (Fehlt) - No deduction

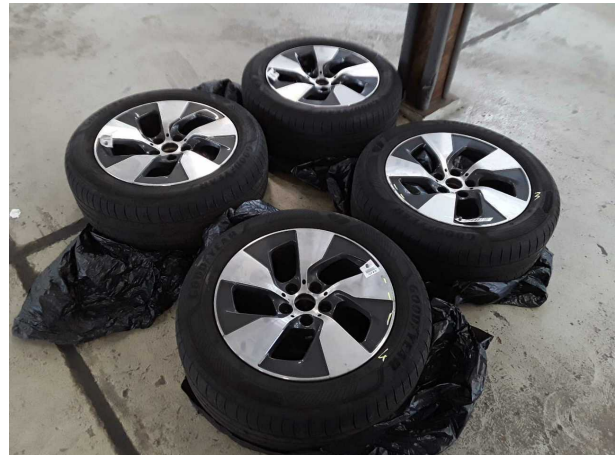
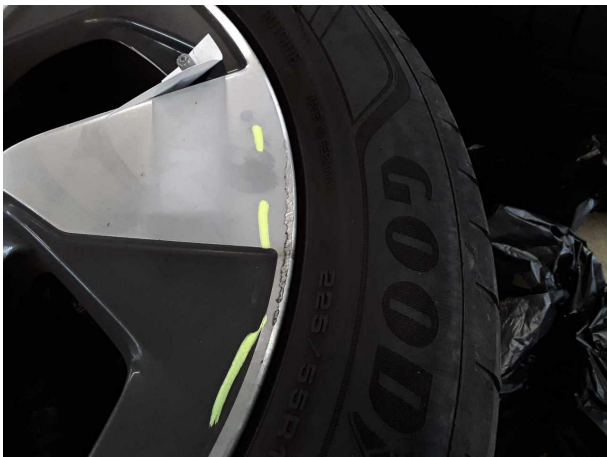
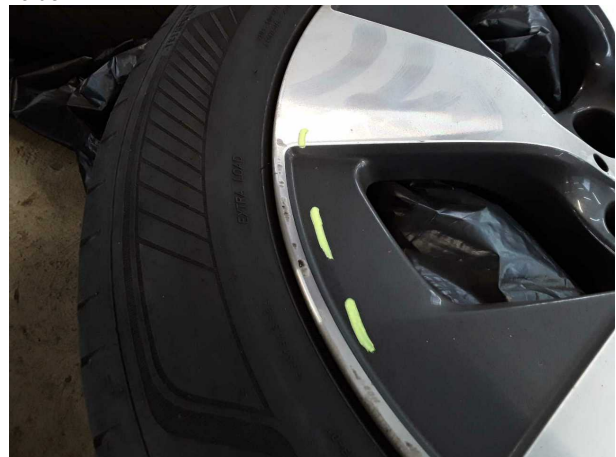
| No. | Component group | Description |
|---|---|---|
| 2 | 2nd wheel set | 2 alloy rims - Scratched - Loss in value |

**Damage #2:** 2nd wheel set: 2 alloy rims - Scratched - Loss in value
