**WAUZZZGE6RB062813**

## Zustandsbericht

Inspection date: 6 May 2025  
**Protocol number: 39581025**  
Delivery date: 6 May 2025

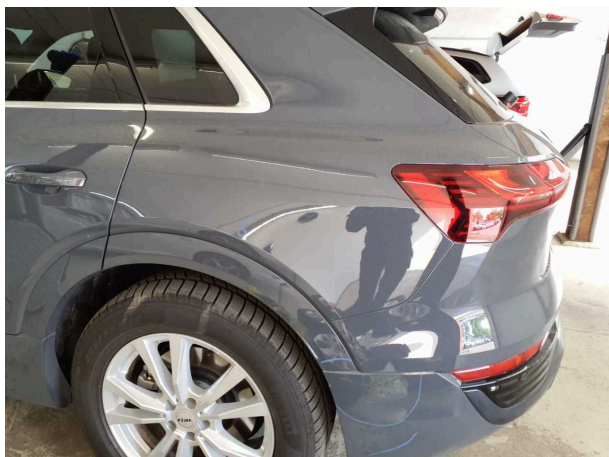
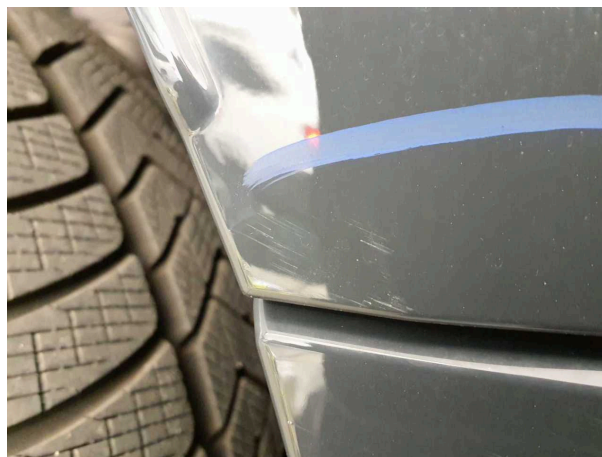
| No. | Component group | Description |
|---|---|---|
| 1 | Side panel - rear left side | Wheel well extension - Scratched - Smart repair |

**Damage #1:** Side panel - rear left side: Wheel well extension - Scratched - Smart repair

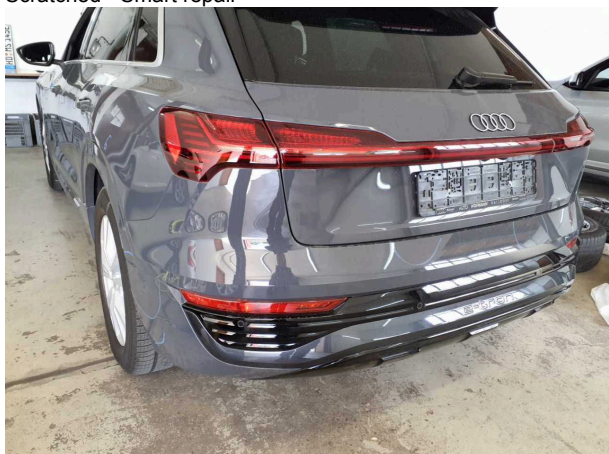
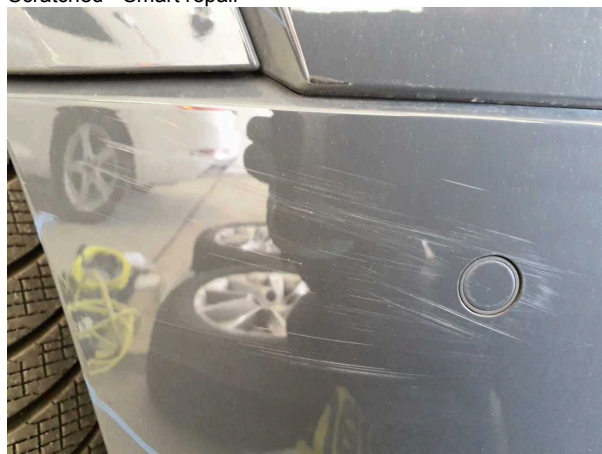
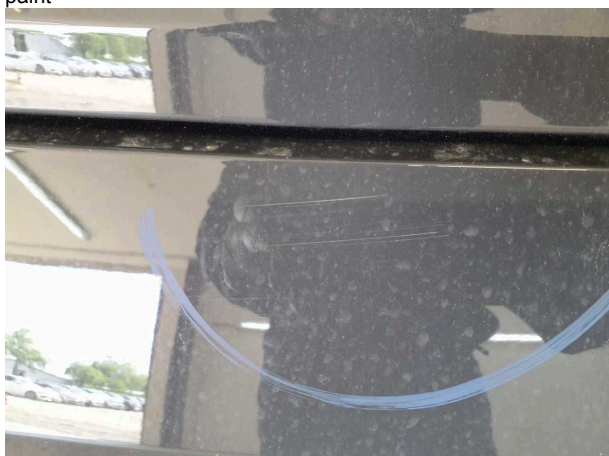
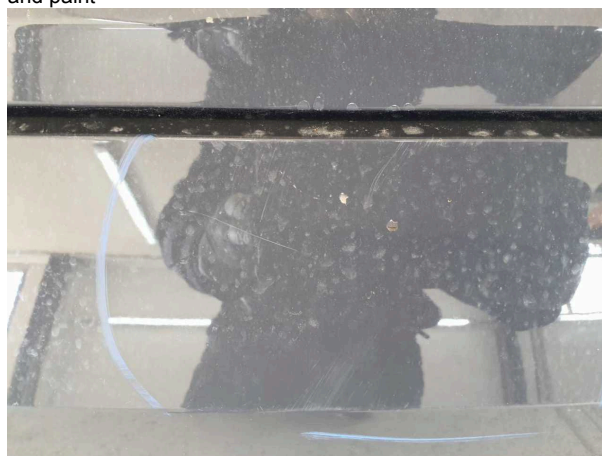
| No. | Component group | Description |
|---|---|---|
| 2 | Rear bumper | Rear bumper - Scratched - Repair and paint |

**Damage #2:** Rear bumper: Rear bumper - Scratched - Repair and paint

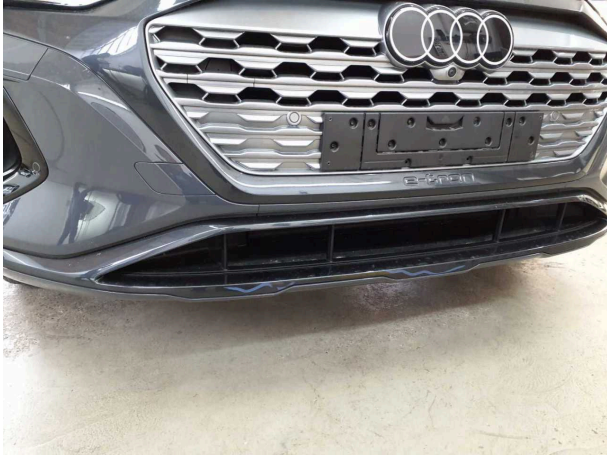
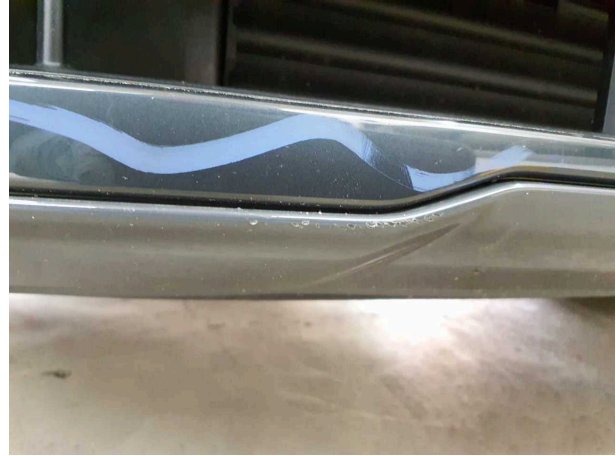
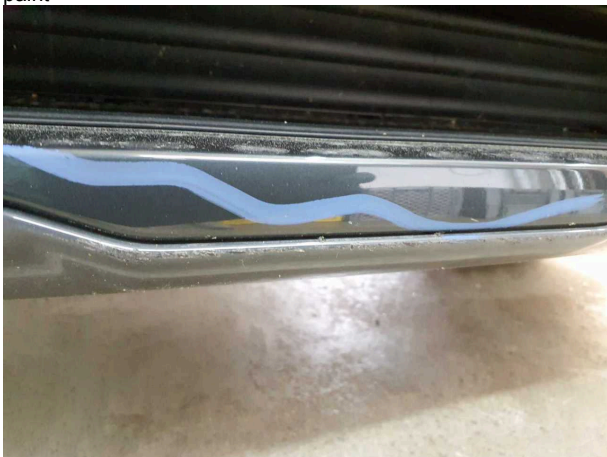
| No. | Component group | Description |
|---|---|---|
| 3 | Front bumper | Front bumper - Scratched - Repair and paint |

**Damage #3:** Front bumper: Front bumper - Scratched - Repair and paint
