**WAUZZZF7L2126991**

## Zustandsbericht

Inspection date: 29 Apr 2025  
**Protocol number: 39653101**

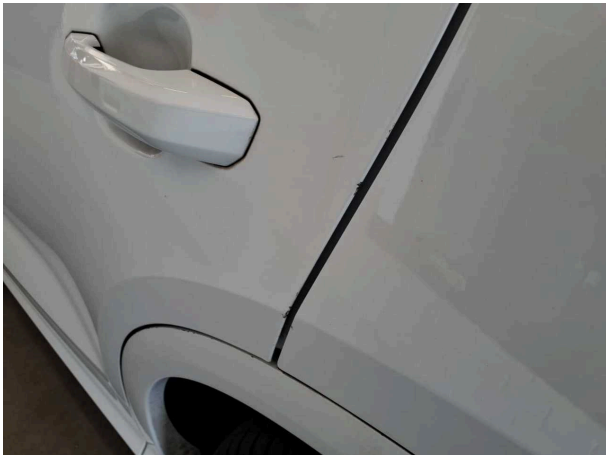
| No. | Component group | Description |
|---|---|---|
| 2 | Door - rear left side | Door edge - Scratched - Smart repair |

**Damage #2:** Door - rear left side: Door edge - Scratched - Smart repair

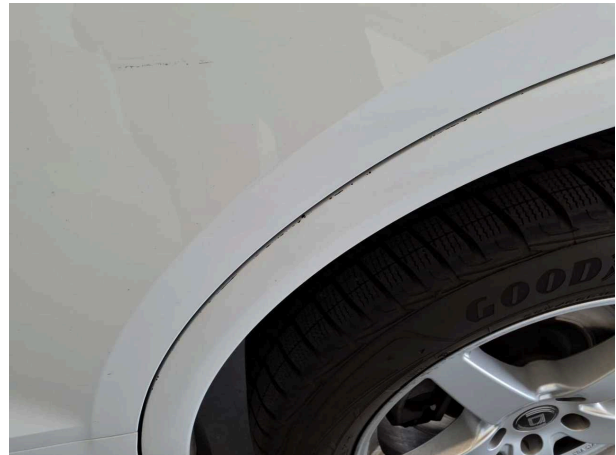
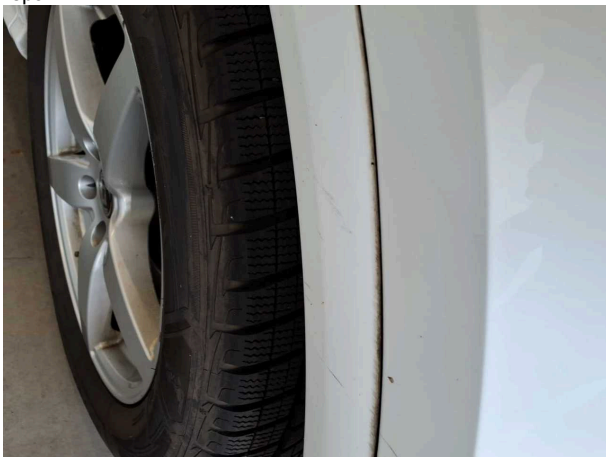
| No. | Component group | Description |
|---|---|---|
| 4 | Side panel - rear left side | Wheel well extension - Scratched - Replace |

**Damage #4:** Side panel - rear left side: Wheel well extension - Scratched - Replace

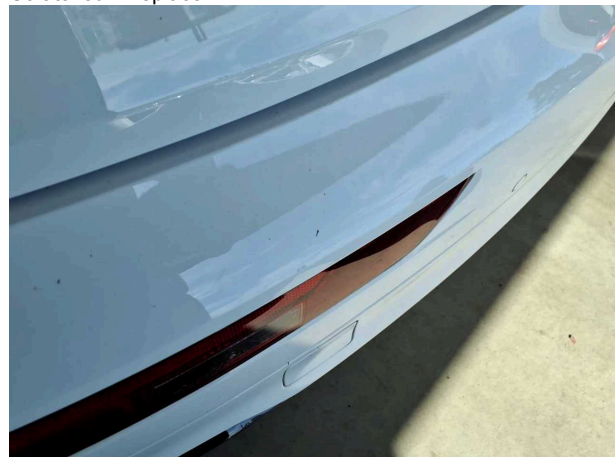
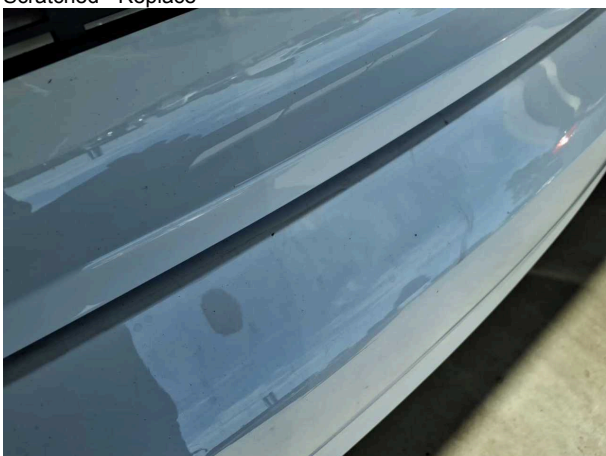
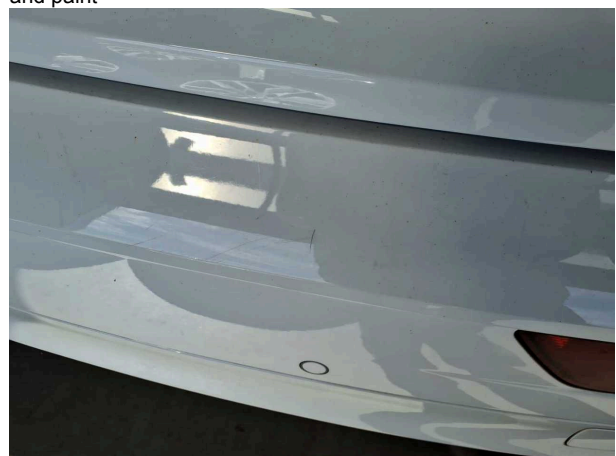
| No. | Component group | Description |
|---|---|---|
| 5 | Rear bumper | Rear bumper - Scratched - Repair and paint |

**Damage #5:** Rear bumper: Rear bumper - Scratched - Repair and paint

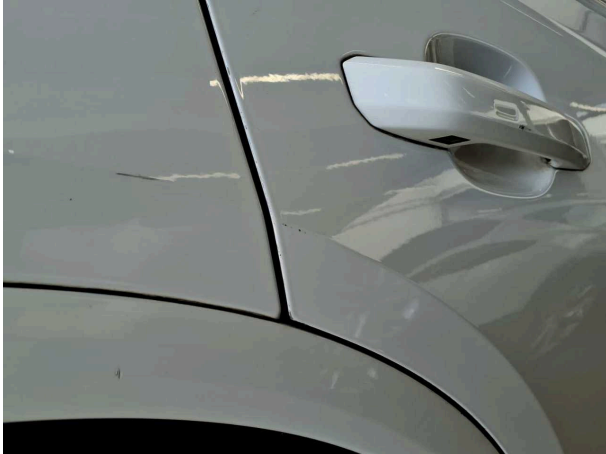
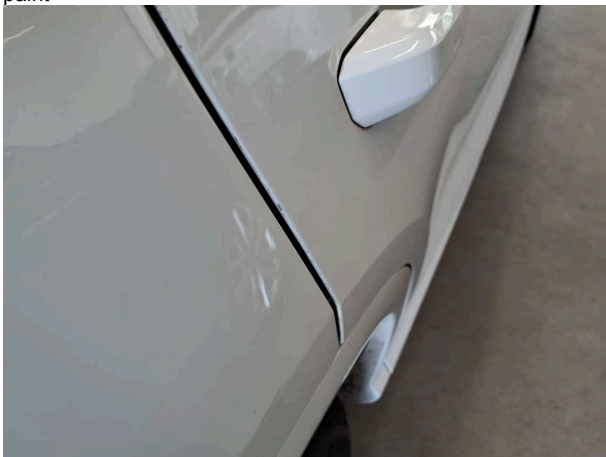
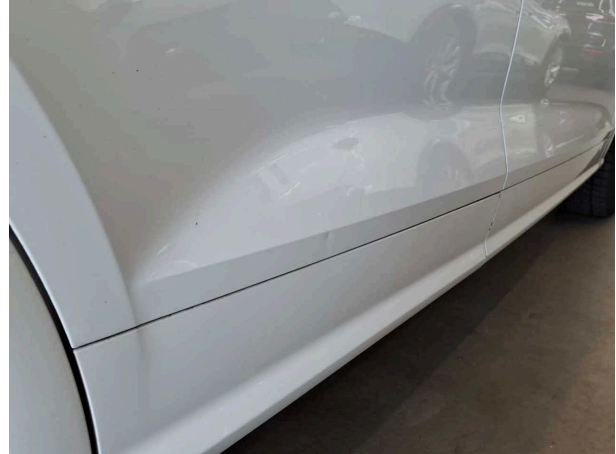
| No. | Component group | Description |
|---|---|---|
| 6 | Door - rear right side | Door - Scratched - Repair and paint |

**Damage #6:** Door - rear right side: Door - Scratched - Repair and paint

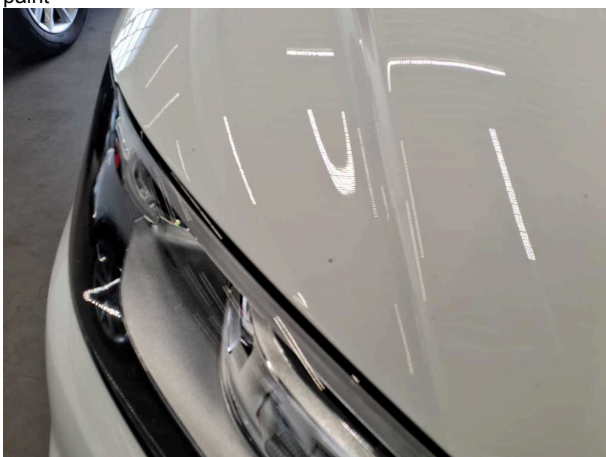
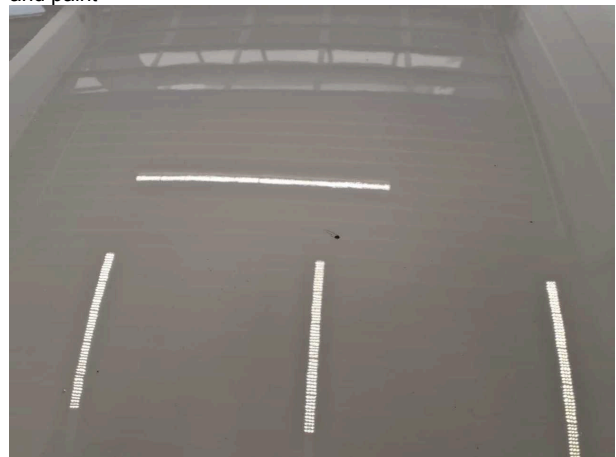
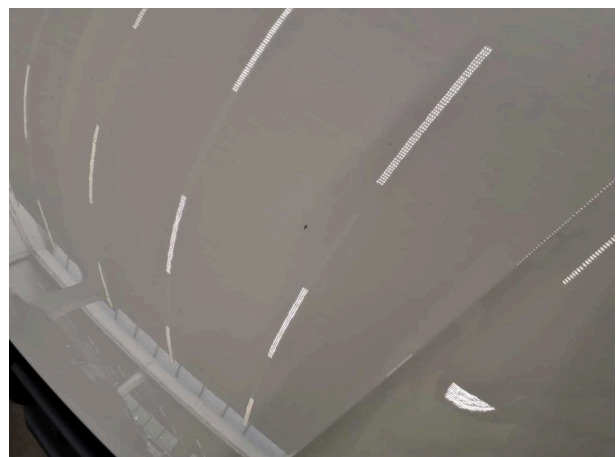
| No. | Component group | Description |
|---|---|---|
| 7 | Bonnet | Bonnet - Scratched - Repair and paint |

**Damage #7:** Bonnet: Bonnet - Scratched - Repair and paint

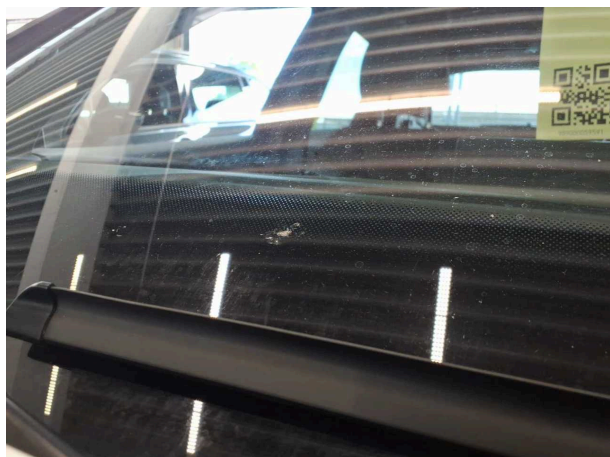
| No. | Component group | Description |
|---|---|---|
| 8 | Vehicle glazing | Windscreen with rain sensor - Broken / torn - Replace |

**Damage #8:** Vehicle glazing: Windscreen with rain sensor - Broken / torn - Replace
