**WAUZZZFZ4NP035322**

## Zustandsbericht

**Inspection location**  
SAP SE  
Dietmar-Hopp-Allee 16  
69190 Walldorf

Inspection date: 6 May 2025  
**Protocol number:** 39585691  
Delivery date: 6 May 2025

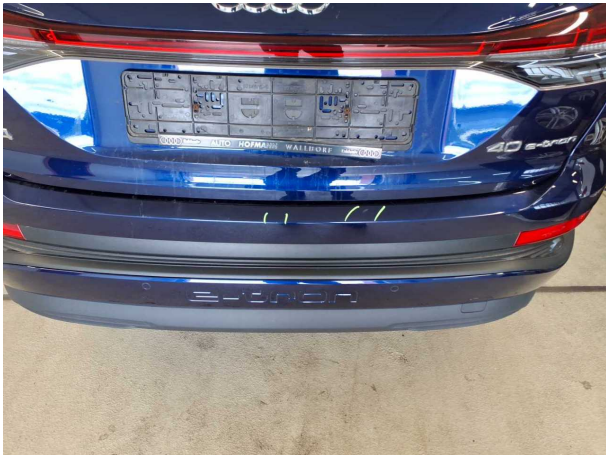
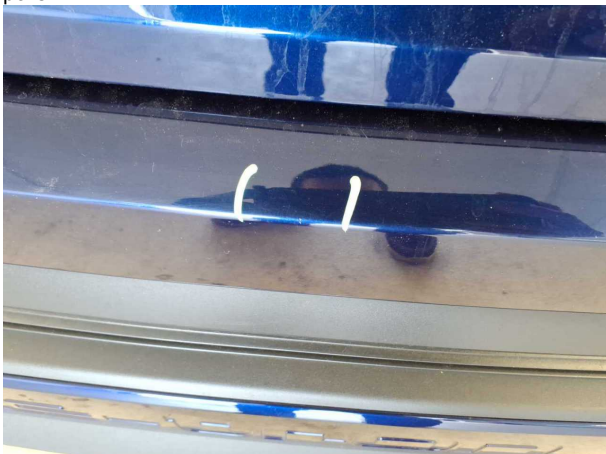
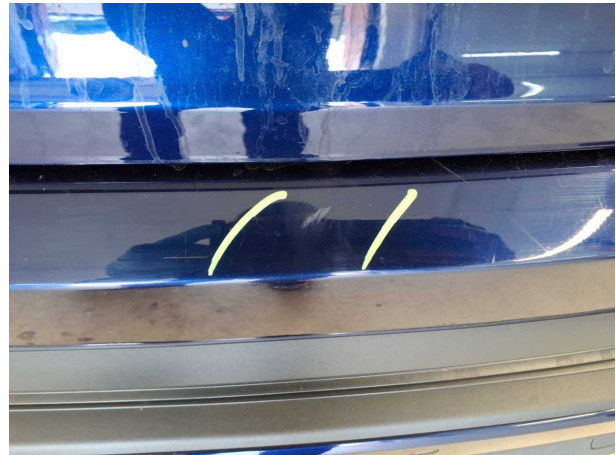
| No. | Component group | Description |
|---|---|---|
| 2 | Rear bumper | Rear bumper - Scratched - Cover / polish |

**Damage #2:** Rear bumper: Rear bumper - Scratched - Cover / polish

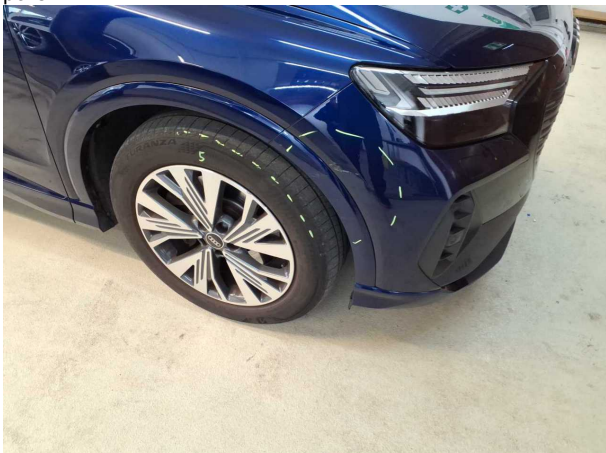
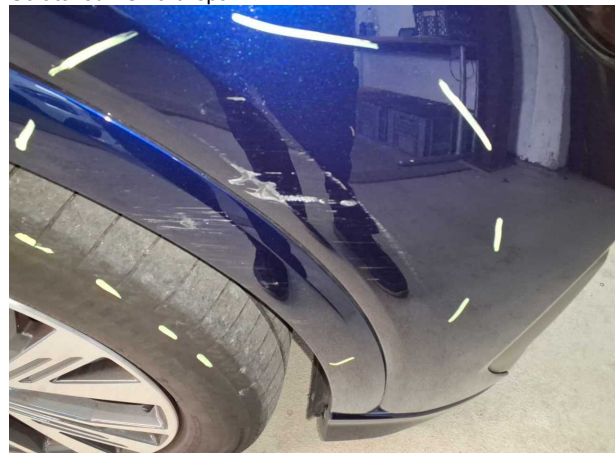
| No. | Component group | Description |
|---|---|---|
| 6 | Front bumper | Front bumper - Scratched - Smart repair |

**Damage #6:** Front bumper: Front bumper - Scratched - Smart repair

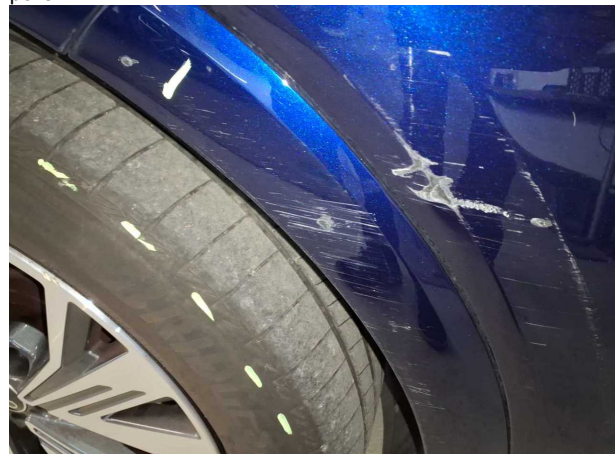
| No. | Component group | Description |
|---|---|---|
| 4 | Mudguard - right side | Wheel well extension - Scratched - Smart repair |

**Damage #4:** Mudguard - right side: Wheel well extension - Scratched - Smart repair

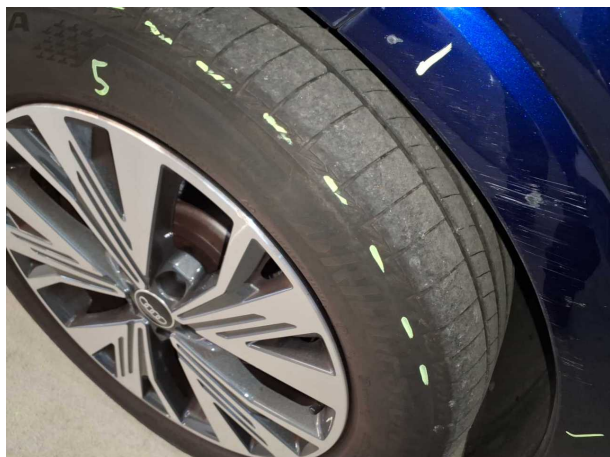
| No. | Component group | Description |
|---|---|---|
| 7 | Wheel / tyres | Tyre - front - Expired - Replace |

| Axle | Tyre size | Manufacturer | Type of tyre | Tread depth | Roadworthy | Permissibility |
|---|---|---|---|---|---|---|
| 1 | 235/55 R19 101T | Bridgestone | Summer tyres | 5mm - 5mm | Not o.k. | |

**Damage #7:** Wheel / tyres: Tyre - front - Expired - Replace
