WBA7K510207J34923

## Vehicle details

## Zustandsbericht

## Overview pictures

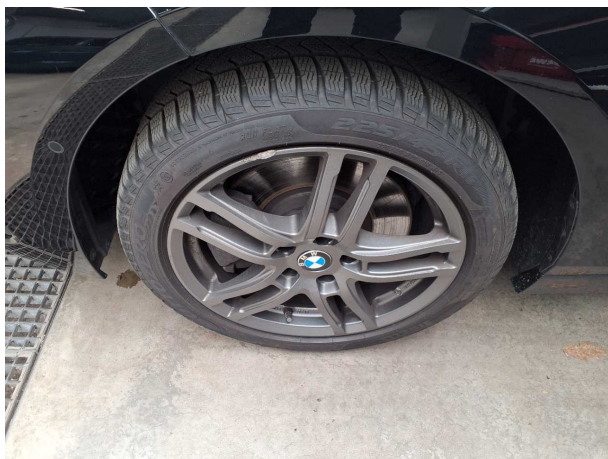
Figure 15: Mounted tyres

| Axle | Tyre size | Manufacturer | Type of tyre | Tread depth | Roadworthy | Permissibility |
|---|---|---|---|---|---|---|
| 1 | 225/45 R17 91H | Pirelli | Winter tyres | 7mm - 7mm | o.k. | o.k. |
| 2 | 225/45 R17 91H | Pirelli | Winter tyres | 8mm - 8mm | o.k. | o.k. |

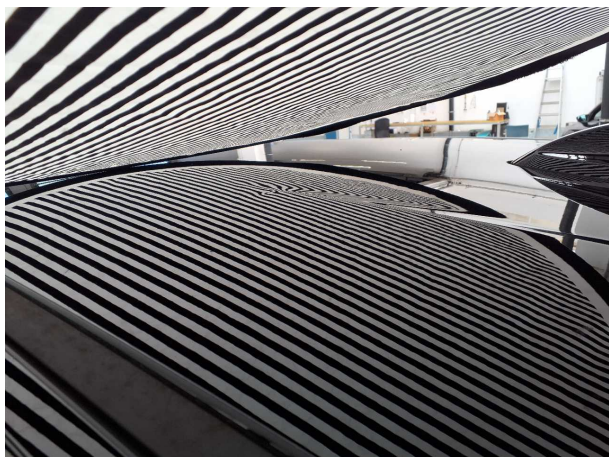
**Damage #1:** Roof: Roof - dent(s) - Smooth repair work

| No. | Component group | Description |
|---|---|---|
| 1 | Roof | Roof - dent(s) - Smooth repair work |

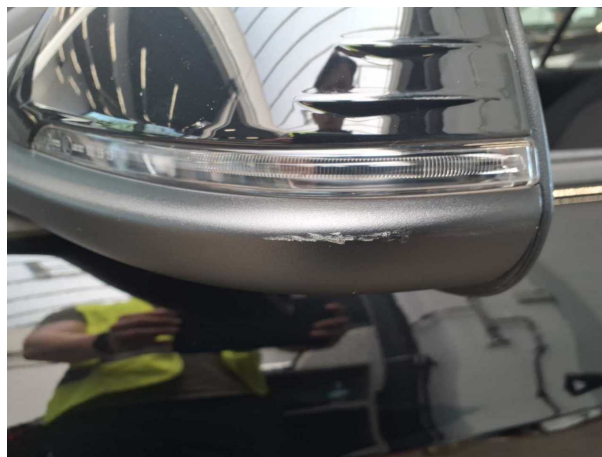
**Damage #2:** Wing mirror - left side: Cap - Abrasion - Replace

| No. | Component group | Description |
|---|---|---|
| 2 | Wing mirror - left side | Cap - Abrasion - Replace |

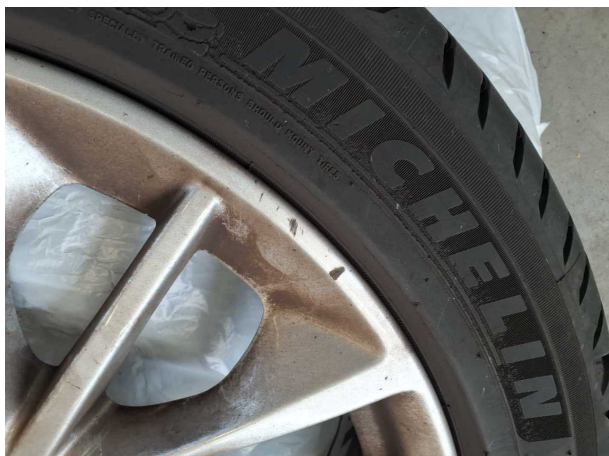
**Damage #3:** 2nd wheel set: 1 alloy rim - Scratched - Loss in value

| No. | Component group | Description |
|---|---|---|
| 3 | 2nd wheel set | 1 alloy rim - Scratched - Loss in value |

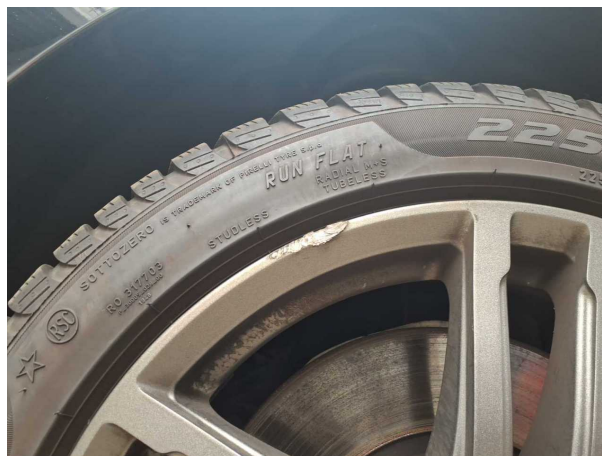
**Damage #4:** Wheel / tyres: Alloy rim - front left side - Scratched - Replace

| No. | Component group | Description |
|---|---|---|
| 4 | Wheel / tyres | Alloy rim - front left side - Scratched - Replace |

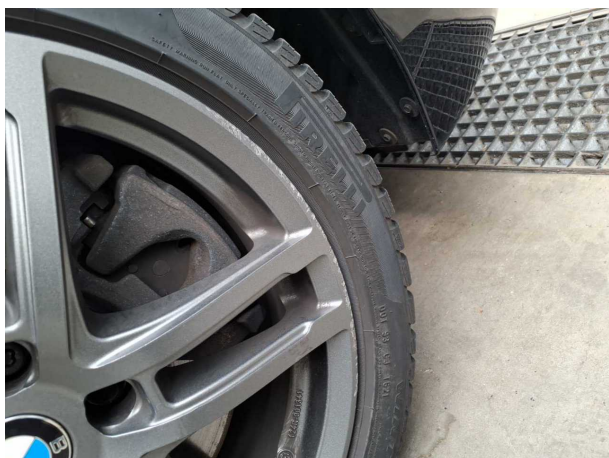
**Damage #5:** Wheel / tyres: Alloy rim - front right side - Scratched - Replace

| No. | Component group | Description |
|---|---|---|
| 5 | Wheel / tyres | Alloy rim - front right side - Scratched - Replace |

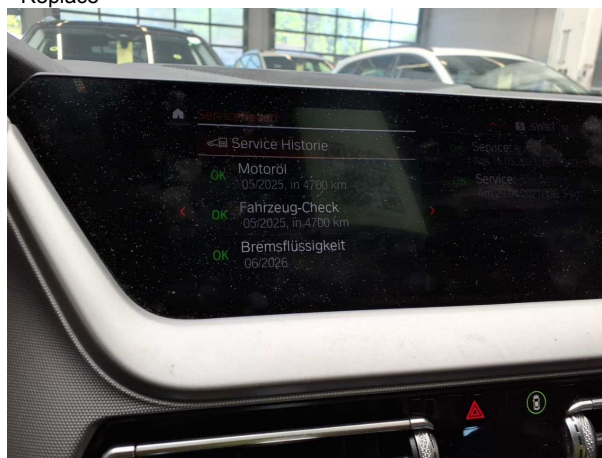
**Damage #6:** Misc.: Inspection / maintenance (Bevorstehend) - Due - Perform

| No. | Component group | Description |
|---|---|---|
| 6 | Misc. | Inspection / maintenance (Bevorstehend) - Due - Perform |

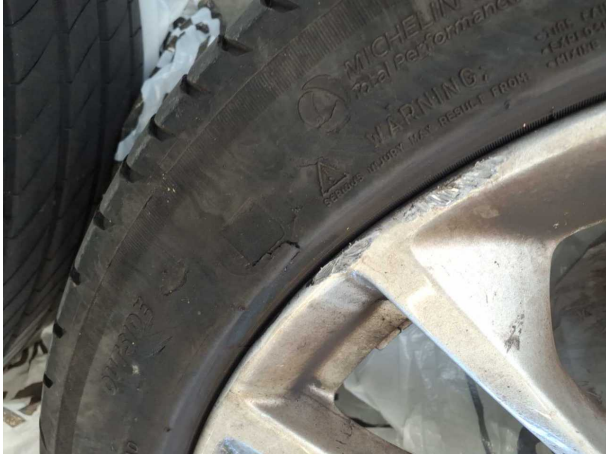
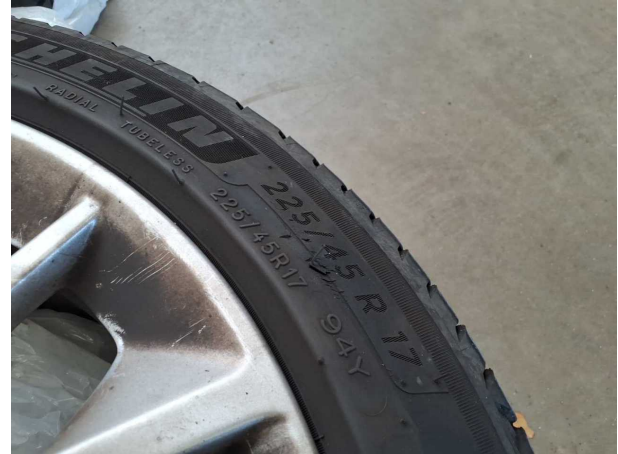
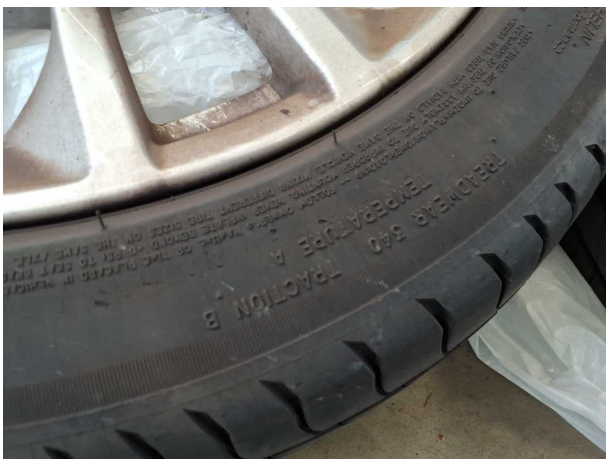
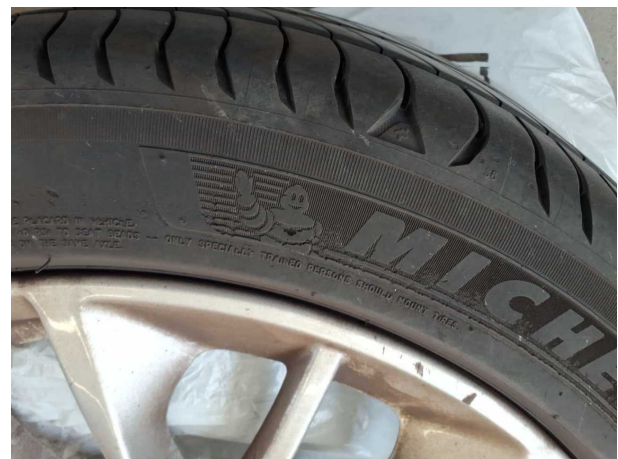
**Damage #7:** 2nd wheel set: 3 tyres - Damaged - Replace

| No. | Component group | Description |
|---|---|---|
| 7 | 2nd wheel set | 3 tyres - Damaged - Replace |

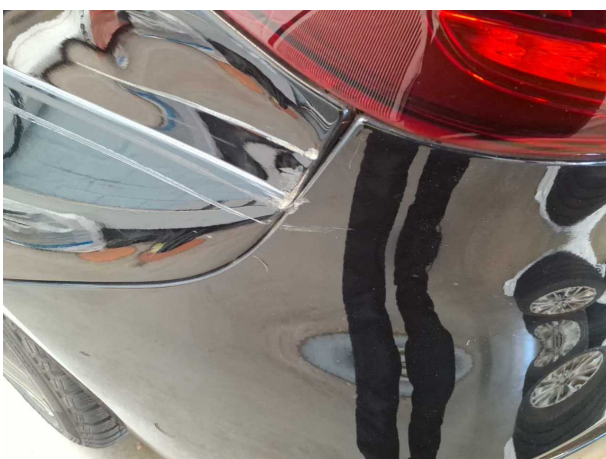
**Damage #8:** Rear bumper: Rear bumper - Scratched - Repair and paint

| No. | Component group | Description |
|---|---|---|
| 8 | Rear bumper | Rear bumper - Scratched - Repair and paint |

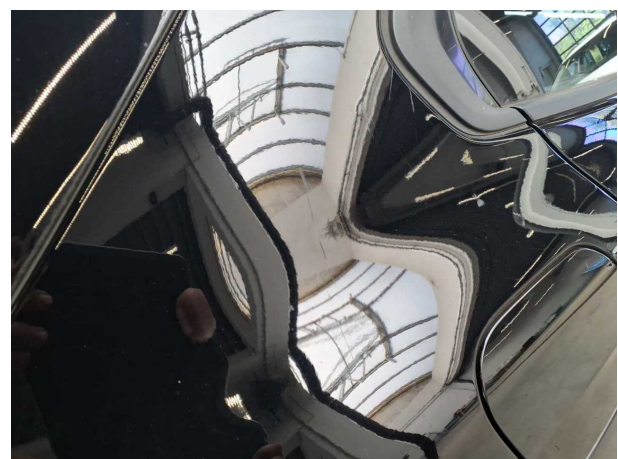
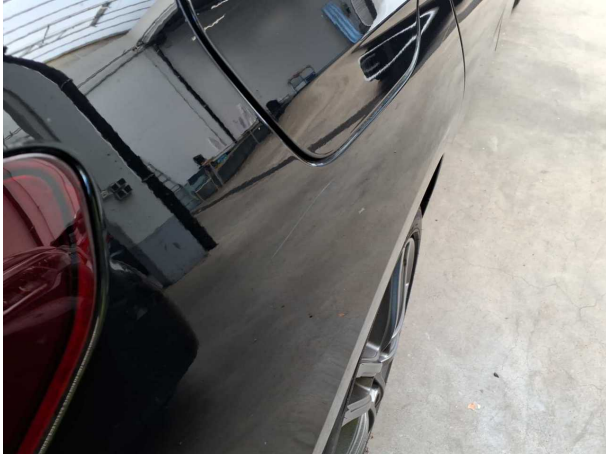
**Damage #9:** Side panel - rear right side: Side panel - Scratch... - Repair and paint

**Damage #9:** Side panel - rear right side: Side panel - Scratched - Repair and paint

| No. | Component group | Description |
|---|---|---|
| 9 | Side panel - rear right side | Side panel - Scratched - Repair and paint |

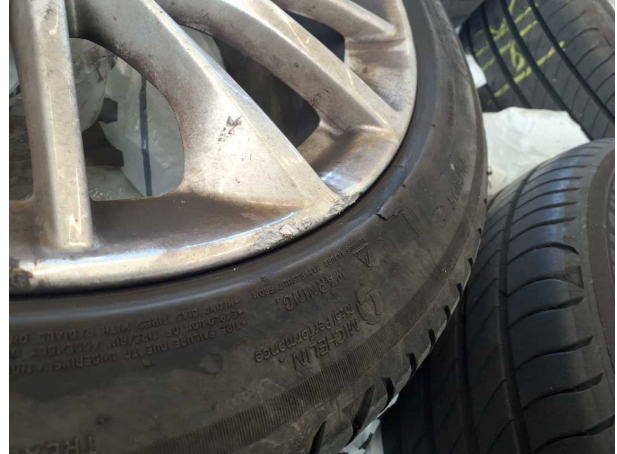
**Damage #10:** 2nd wheel set: 1 alloy rim - Scratched - Replace

| No. | Component group | Description |
|---|---|---|
| 10 | 2nd wheel set | 1 alloy rim - Scratched - Replace |

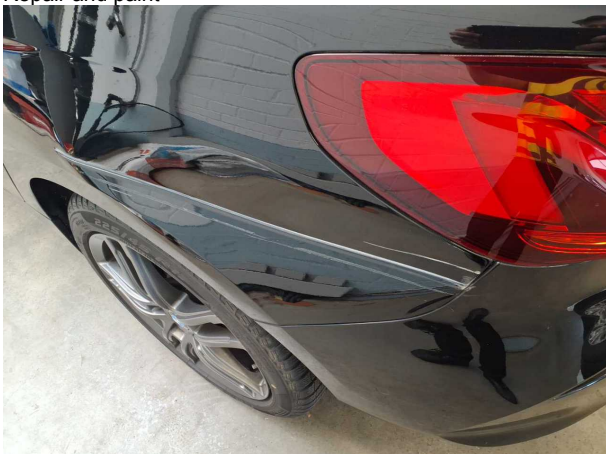
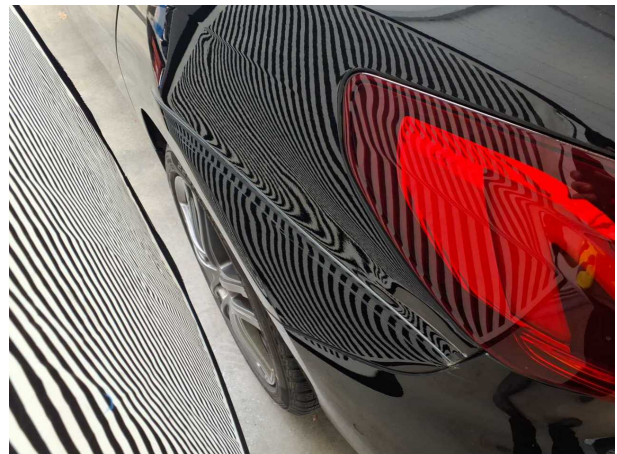
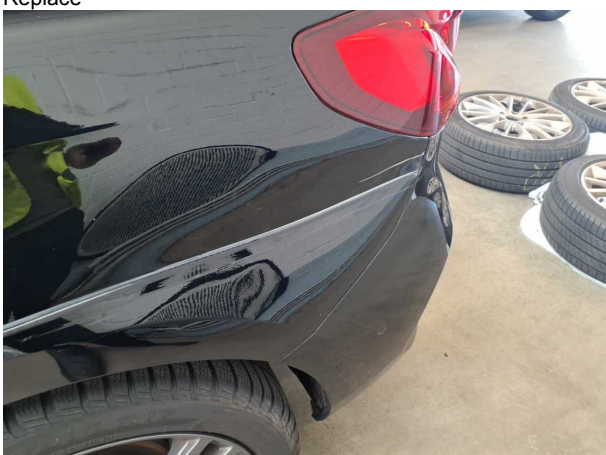
**Damage #11:** Side panel - rear left side: Side panel - Damaged - Replace

| No. | Component group | Description |
|---|---|---|
| 11 | Side panel - rear left side | Side panel - Damaged - Replace |

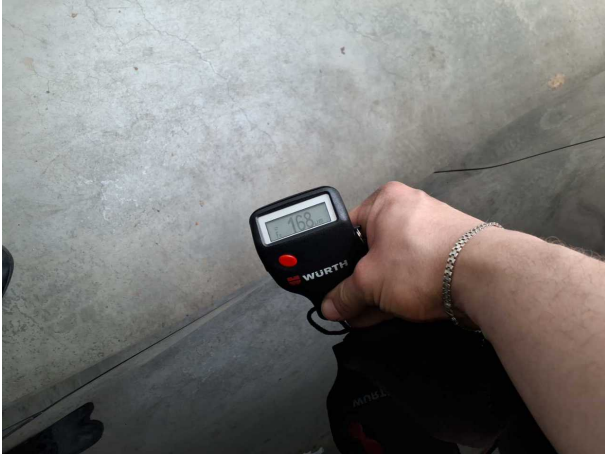
| No. | Location |
|---|---|
| 1 | Door - rear left side, Door - front left side, Professionally carried out, Invoice of repair done Non-existent |

**Repainting 1:** Door - rear left side, Door - front left side
