WBA5P51050FK81137

## Zustandsbericht

**TÜV SÜD Auto Plus GmbH**  
Gutenbergstr. 13  
70771 Leinfelden-Echterdingen

Inspection date: 30 Apr 2025  
**Protocol number: 39524525**  
Delivery date: 30 Apr 2025

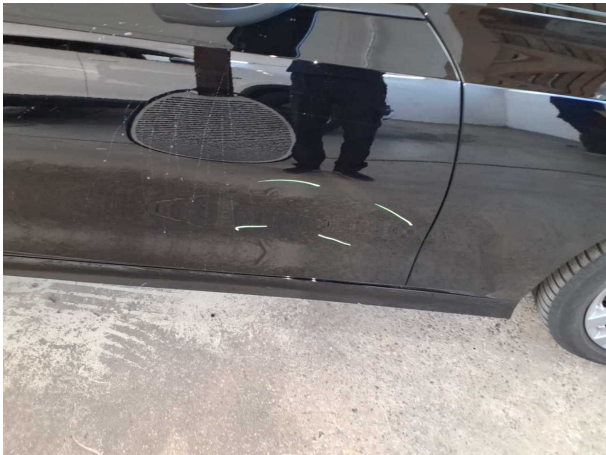
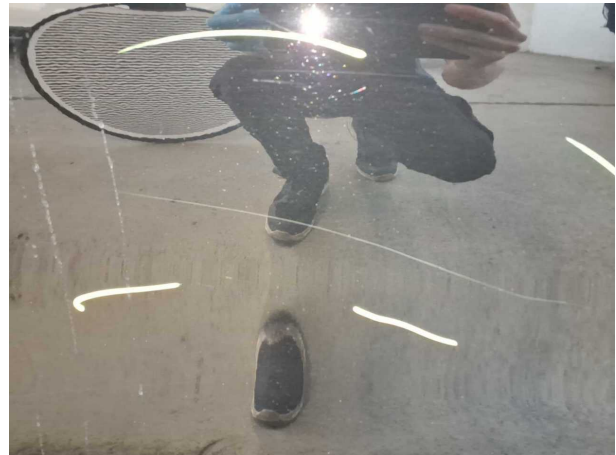
**Damage #1:** Door - front right side: Door - Scratch(es) - Cover / polish

**Damage #1:** Door - front right side: Door - Scratch(es) - Cove...  
polish

| No. | Component group | Description |
|---|---|---|
| 1 | Door - front right side | Door - Scratch(es) - Cover / polish |

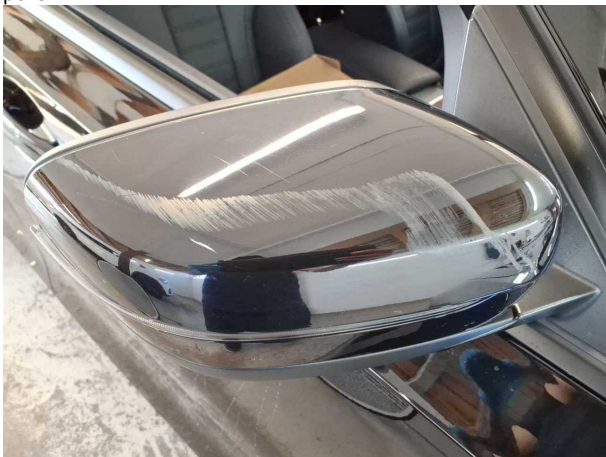
**Damage #2:** Wing mirror - right side: Cap - Scratched - Smart repair

| No. | Component group | Description |
|---|---|---|
| 2 | Wing mirror - right side | Cap - Scratched - Smart repair |

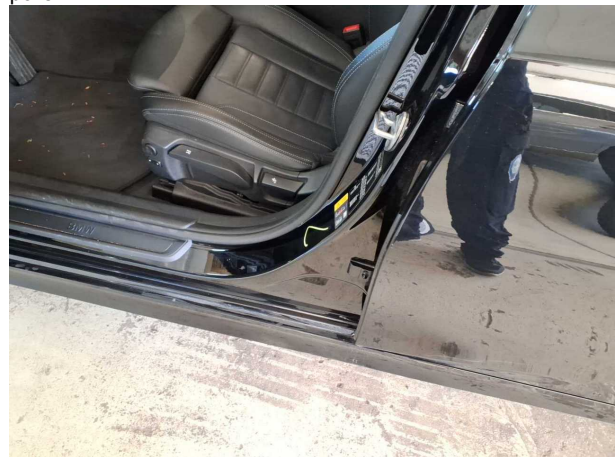
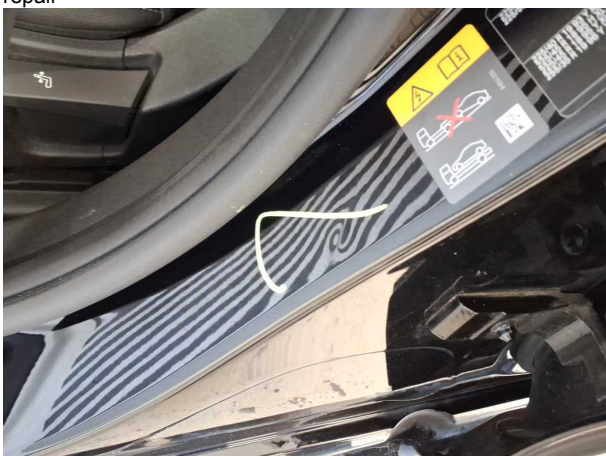
**Damage #3:** Sill - left side: Sill - dent(s) - Smooth repair work

| No. | Component group | Description |
|---|---|---|
| 3 | Sill - left side | Sill - dent(s) - Smooth repair work |

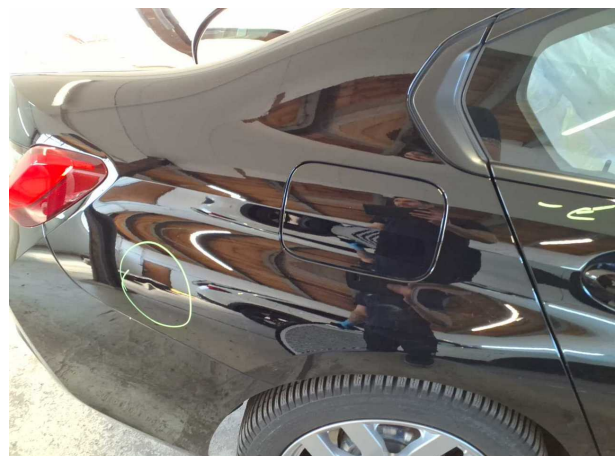
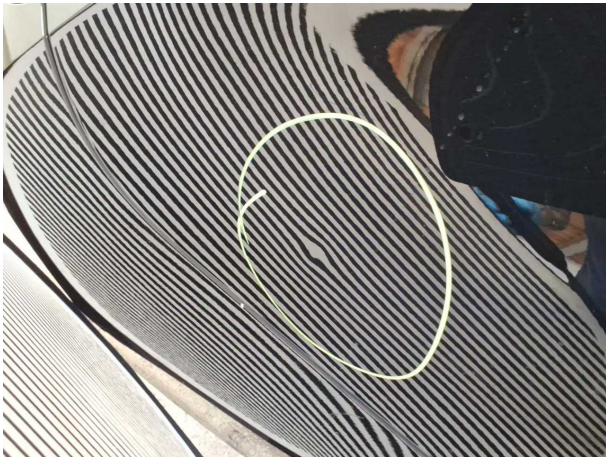
**Damage #4:** Side panel - rear right side: Side panel - dent(s) -  
Smooth repair work

**Damage #4:** Side panel - rear right side: Side panel - dent(s) - Smooth repair work

| No. | Component group | Description |
|---|---|---|
| 4 | Side panel - rear right side | Side panel - dent(s) - Smooth repair work |

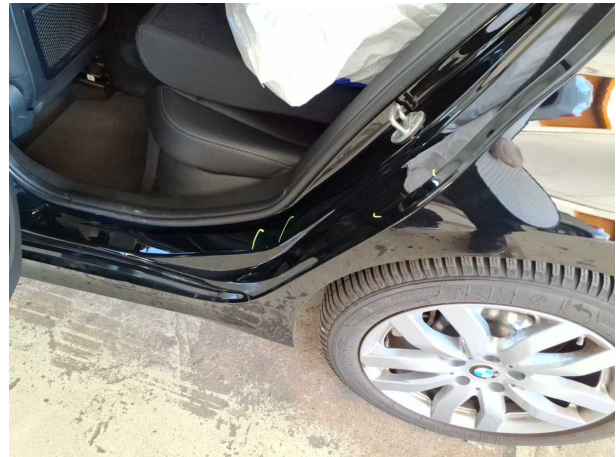
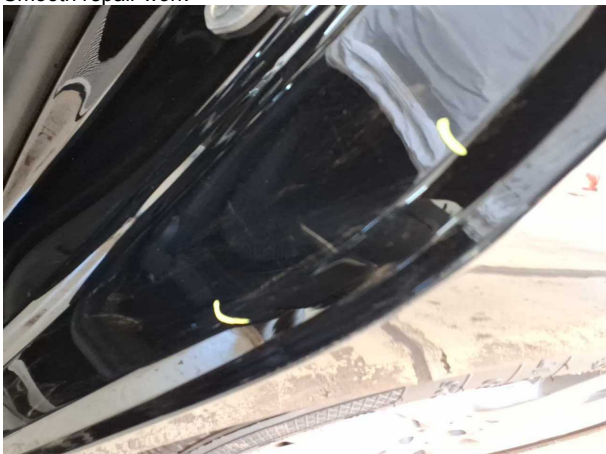
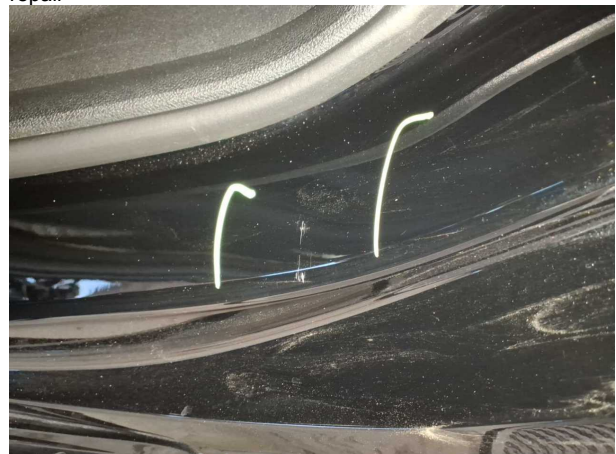
**Damage #5:** Side panel - rear left side: Sill - Scratched - Smart repair

| No. | Component group | Description |
|---|---|---|
| 5 | Side panel - rear left side | Sill - Scratched - Smart repair |

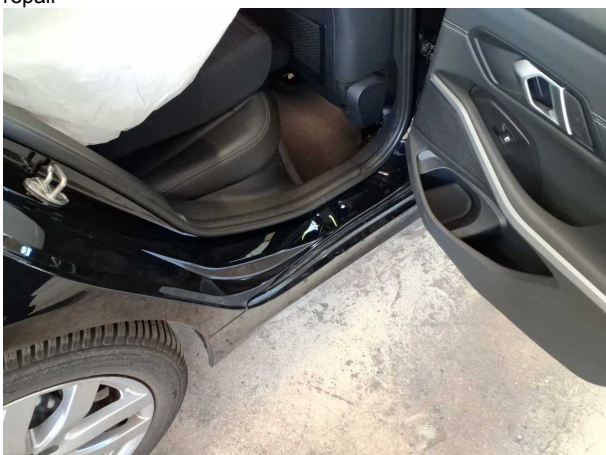
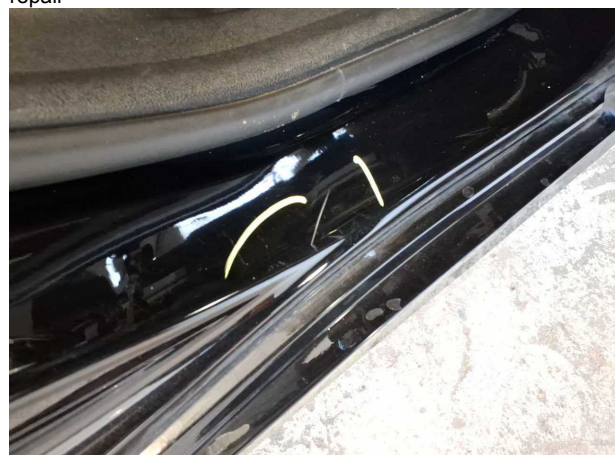
**Damage #6:** Side panel - rear right side: Sill - Scratched - Smart repair

| No. | Component group | Description |
|---|---|---|
| 6 | Side panel - rear right side | Sill - Scratched - Smart repair |

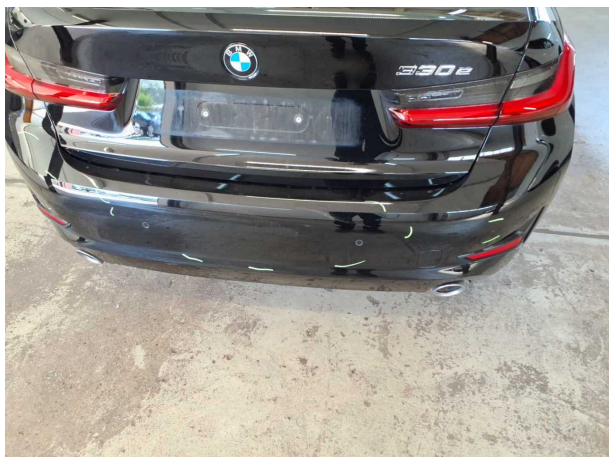
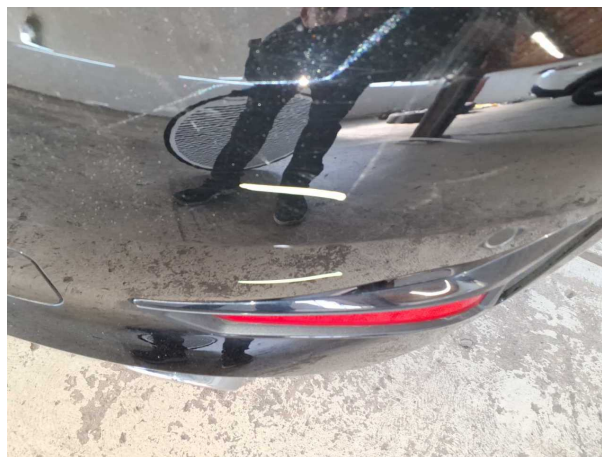
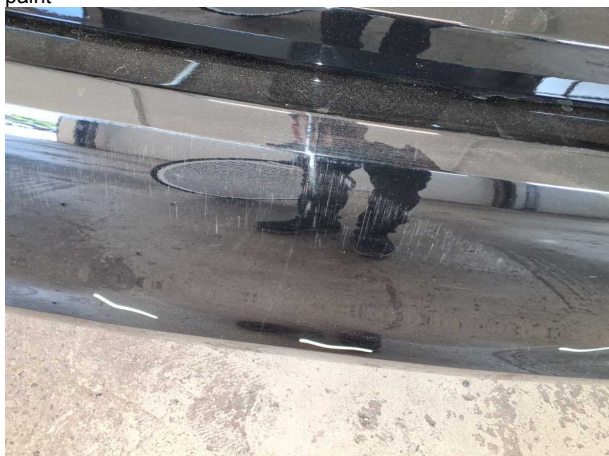
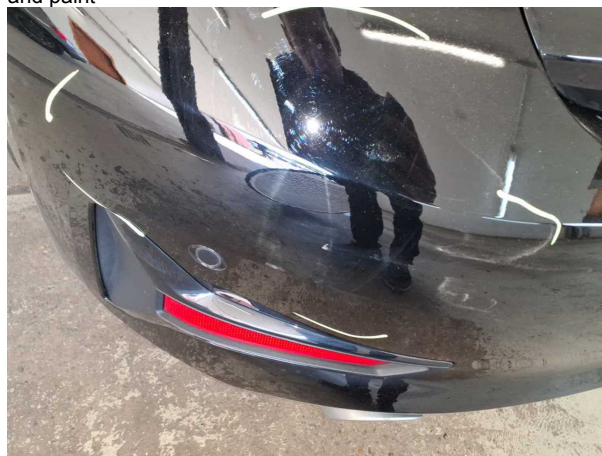
**Damage #8:** Rear bumper: Rear bumper - Scratched - Repair and paint

| No. | Component group | Description |
|---|---|---|
| 8 | Rear bumper | Rear bumper - Scratched - Repair and paint |

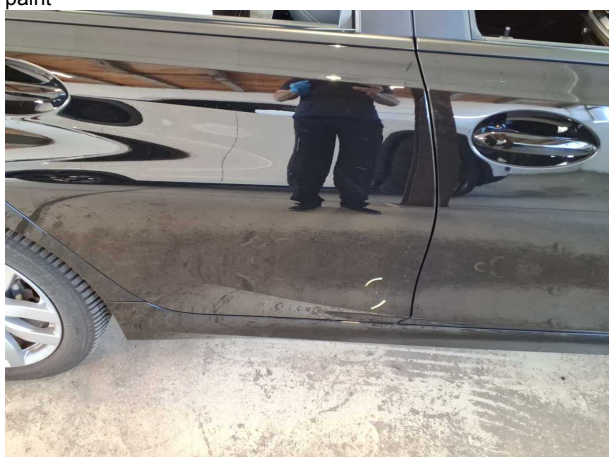
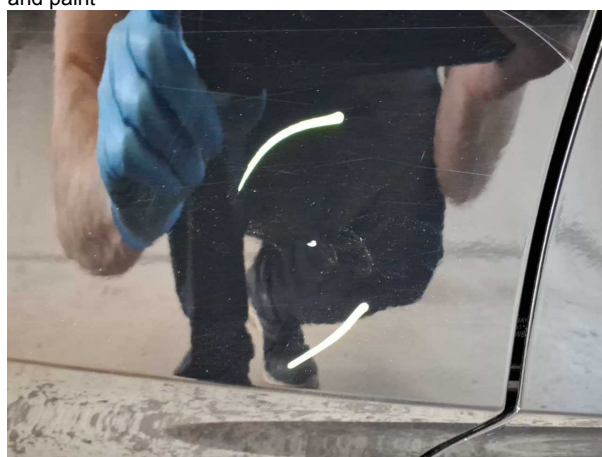
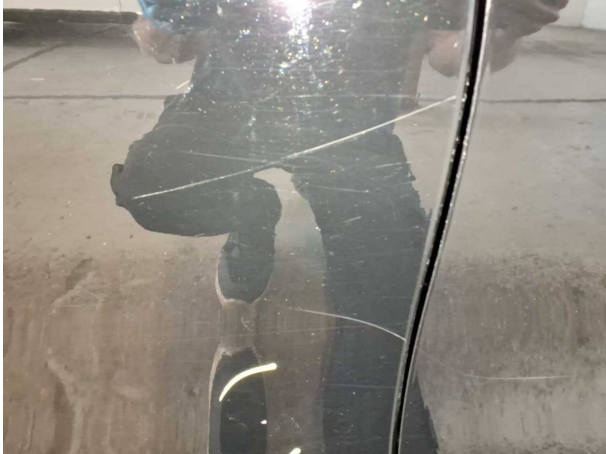
**Damage #9:** Door - rear right side: Door - Scratched - Repair and paint

| No. | Component group | Description |
|---|---|---|
| 9 | Door - rear right side | Door - Scratched - Repair and paint |

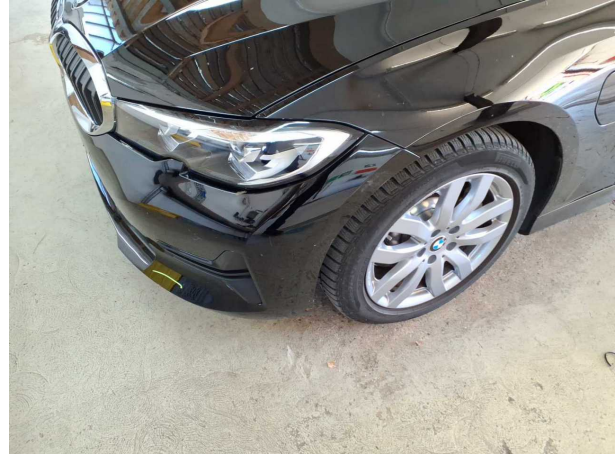
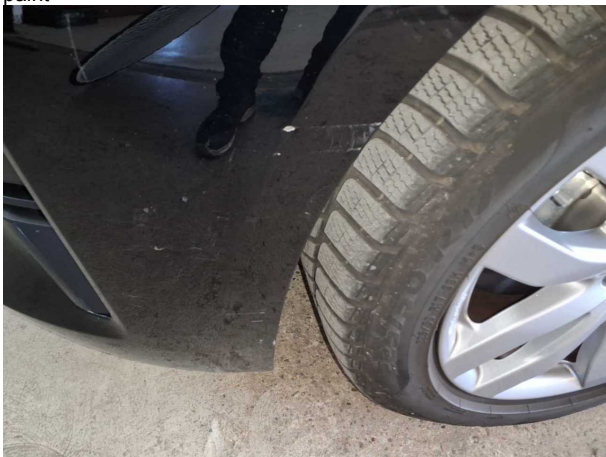
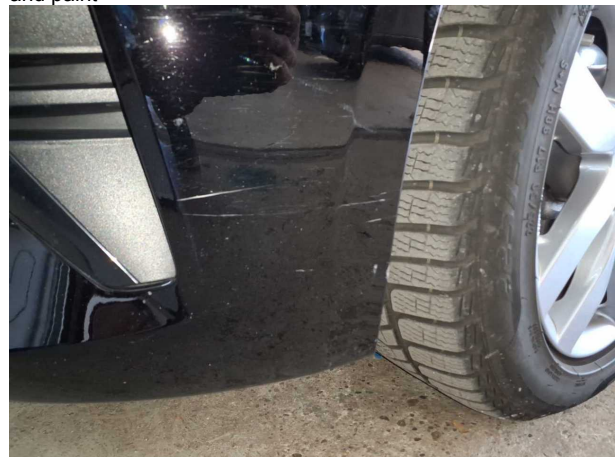
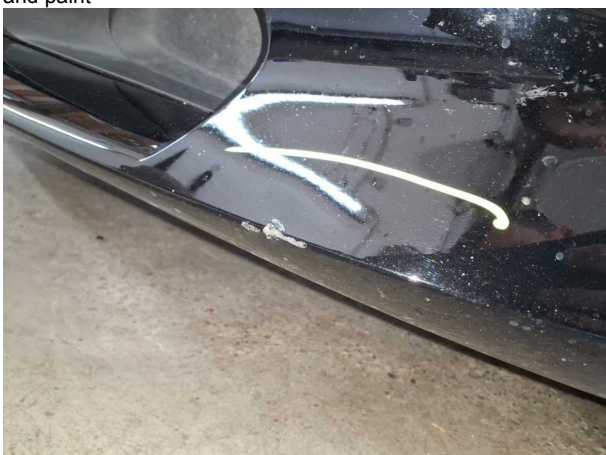
**Damage #10:** Front bumper: Front bumper - Scratched - Rep... and paint

**Damage #10:** Front bumper: Front bumper - Scratched - Repair and paint

| No. | Component group | Description |
|---|---|---|
| 10 | Front bumper | Front bumper - Scratched - Repair and paint |

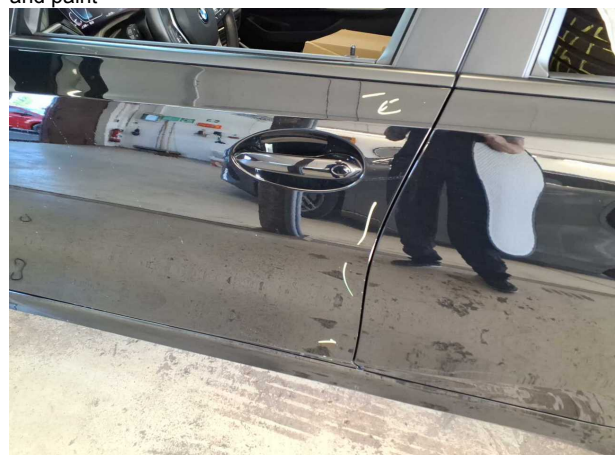
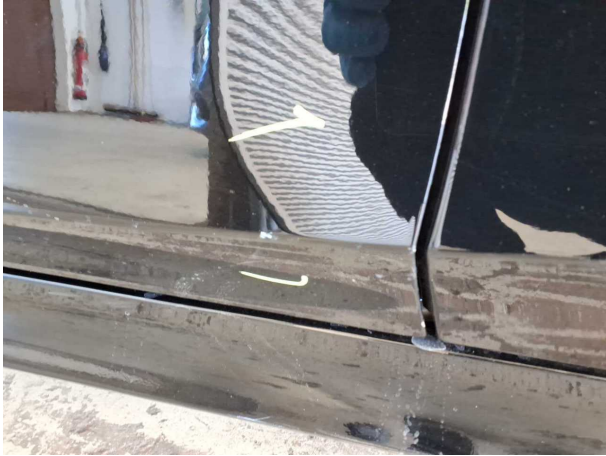
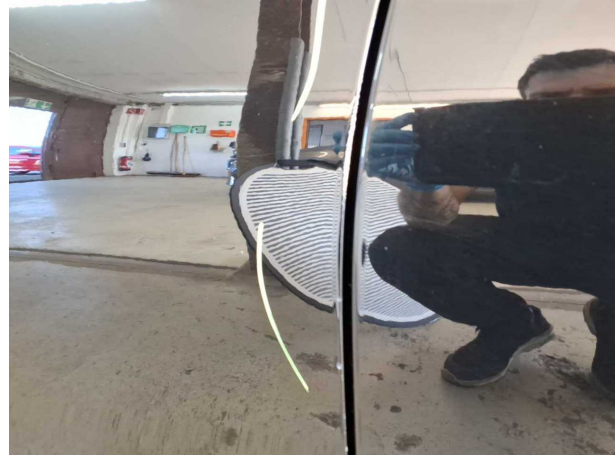
**Damage #11:** Door - front left side: Door - Scratched - Repair and paint

| No. | Component group | Description |
|---|---|---|
| 11 | Door - front left side | Door - Scratched - Repair and paint |
