WBA6N31040FL23442

## Zustandsbericht

**TÜV SÜD Auto Plus GmbH**  
Gutenbergstr. 13  
70771 Leinfelden-Echterdingen

**Protocol number:** 39429513

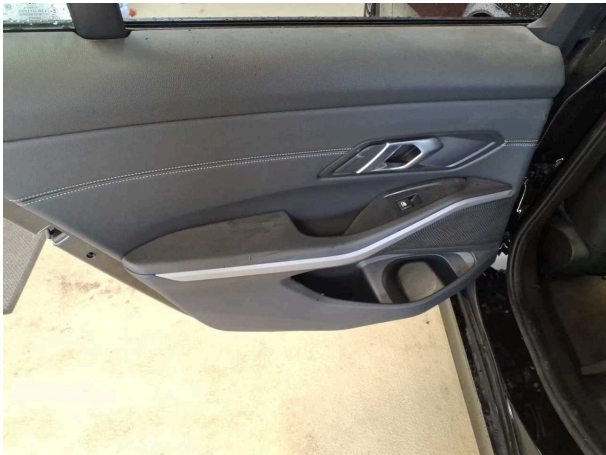
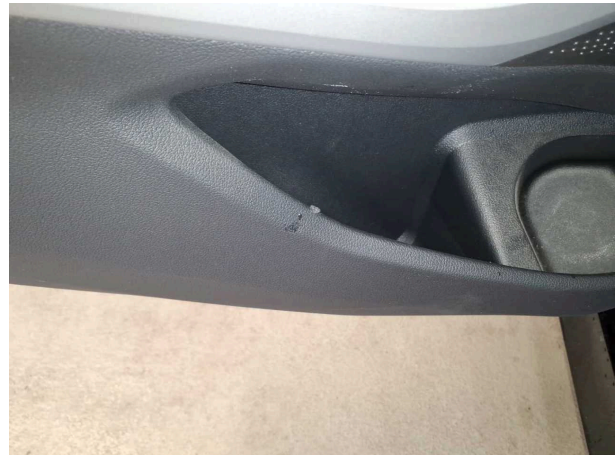
| No. | Component group | Description |
|---|---|---|
| 2 | Trim / covers | Door trim - rear left side - Damaged - Loss in value |

**Damage #2:** Trim / covers: Door trim - rear left side - Damaged - Loss in value

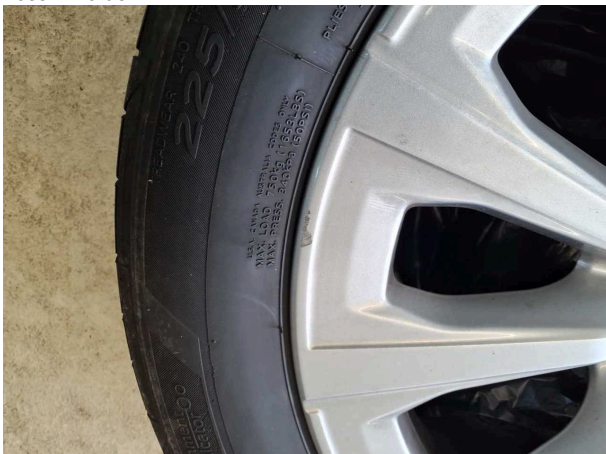
| No. | Component group | Description |
|---|---|---|
| 3 | 2nd wheel set | 1 alloy rim - Scratched - Loss in value |

**Damage #3:** 2nd wheel set: 1 alloy rim - Scratched - Loss in value

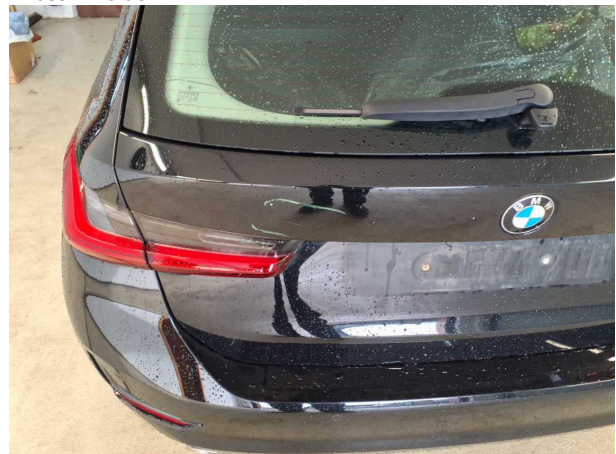
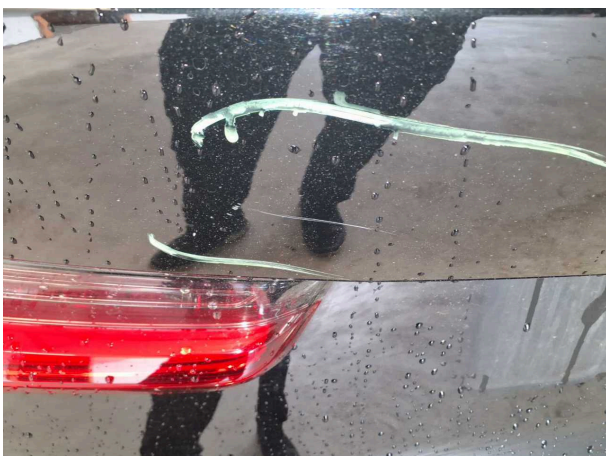
| No. | Component group | Description |
|---|---|---|
| 4 | Boot lid / rear door | Boot lid - Scratched - Smart repair |

**Damage #4:** Boot lid / rear door: Boot lid - Scratched - Smart repair

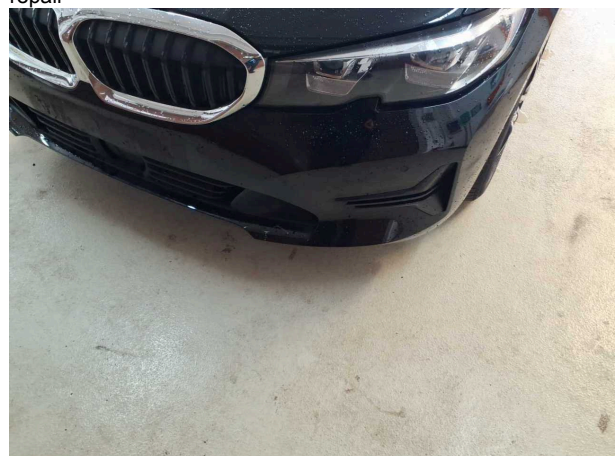
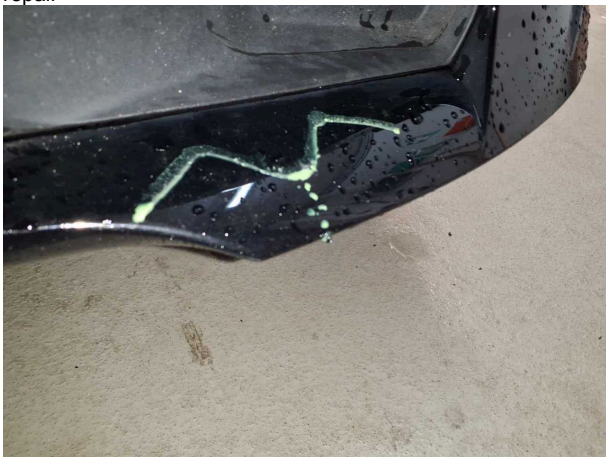
| No. | Component group | Description |
|---|---|---|
| 5 | Front bumper | Front bumper - Scratched - Smart repair |

**Damage #5:** Front bumper: Front bumper - Scratched - Smart repair
