**WAUZZZFY2N2022749**

## Zustandsbericht

Inspection date: 25 Apr 2025  
**Protocol number: 39611933**

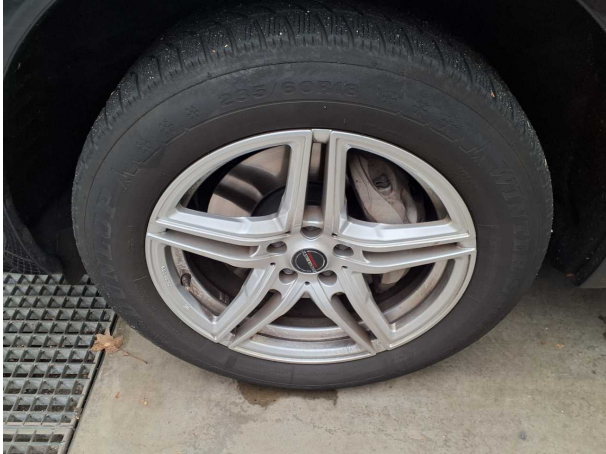
| Axle | Tyre size | Manufacturer | Type of tyre | Tread depth | Roadworthy | Permissibility |
|---|---|---|---|---|---|---|
| 1 | 235/60 R18 107H | Dunlop | Winter tyres | 4mm - 4mm | Not o.k. | o.k. |
| 2 | 235/60 R18 107H | Dunlop | Winter tyres | 5mm - 5mm | Not o.k. | o.k. |

**Figure 19:** Mounted tyres

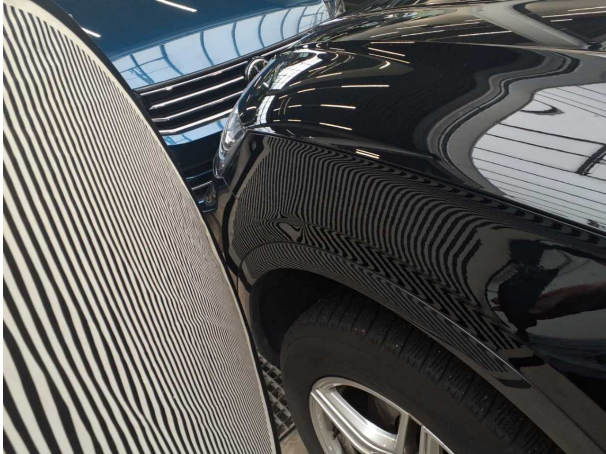
**Damage #1:** Mudguard - left side: Mudguard - left side - dent(s) - Smooth repair work

| No. | Component group | Description |
|---|---|---|
| 1 | Mudguard - left side | Mudguard - left side - dent(s) - Smooth repair work |

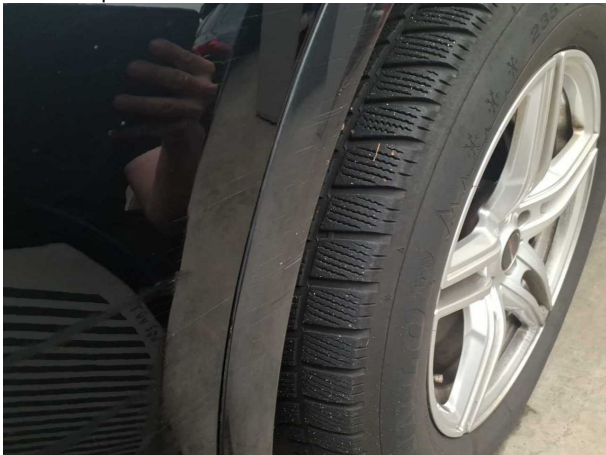
**Damage #3:** Mudguard - left side: Wheel well extension - Scratch... - Replace

| No. | Component group | Description |
|---|---|---|
| 3 | Mudguard - left side | Wheel well extension - Scratched - Replace |

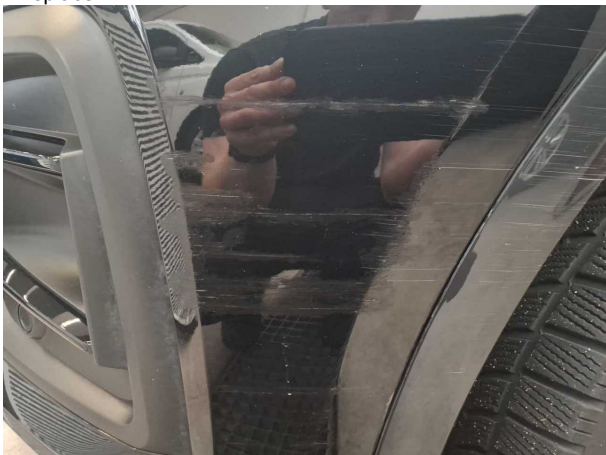
**Damage #5:** Front bumper: Front bumper - Scratched - Repair and paint

| No. | Component group | Description |
|---|---|---|
| 5 | Front bumper | Front bumper - Scratched - Repair and paint |

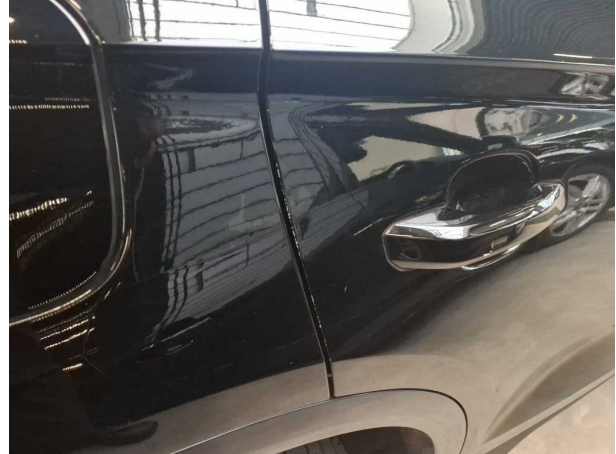
**Damage #2:** Door - rear right side: Door edge - Scratched - Smart repair

| No. | Component group | Description |
|---|---|---|
| 2 | Door - rear right side | Door edge - Scratched - Smart repair |

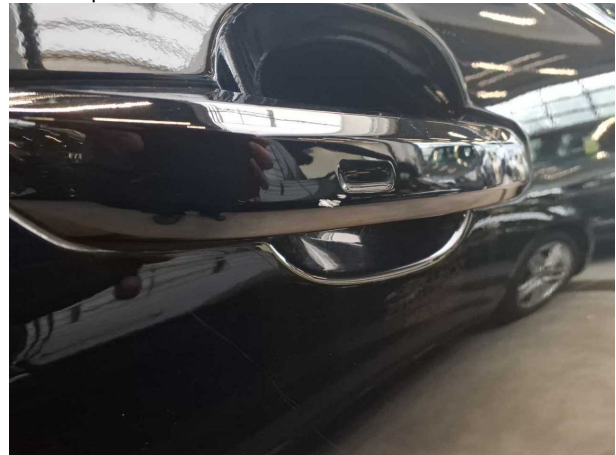
**Damage #4:** Door - rear right side: Door handle - outside - Scratched - Repair and paint

| No. | Component group | Description |
|---|---|---|
| 4 | Door - rear right side | Door handle - outside - Scratched - Repair and paint |

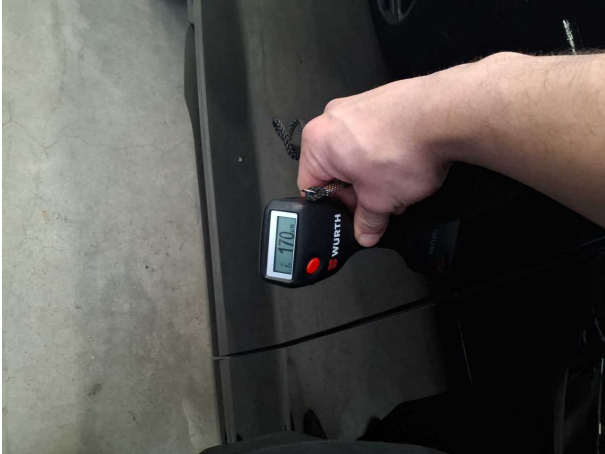
| No. | Location |
|---|---|
| 1 | Door - rear right side, Professionally carried out, Invoice of repair done Non-existent |

**Repainting 1:** Door - rear right side
