**WAUZZZF27PN031279**

| Type / Model | A6 Avant 50 TFSI e | Main inspection (Read from ZBI) | 12/2025 |

## Zustandsbericht

Inspection date: 14 Apr 2025  
**Protocol number:** 39317203  
Delivery date: 14 Apr 2025

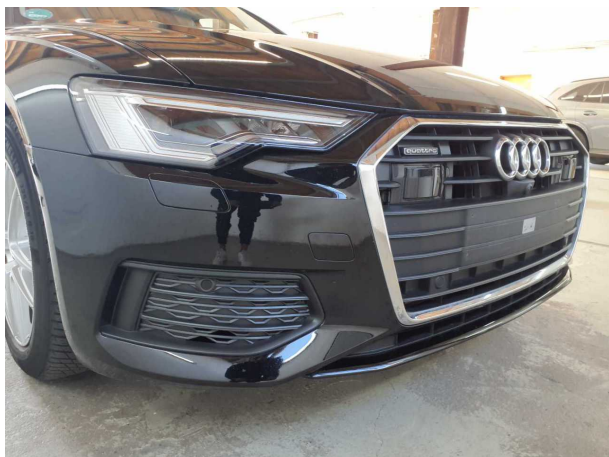
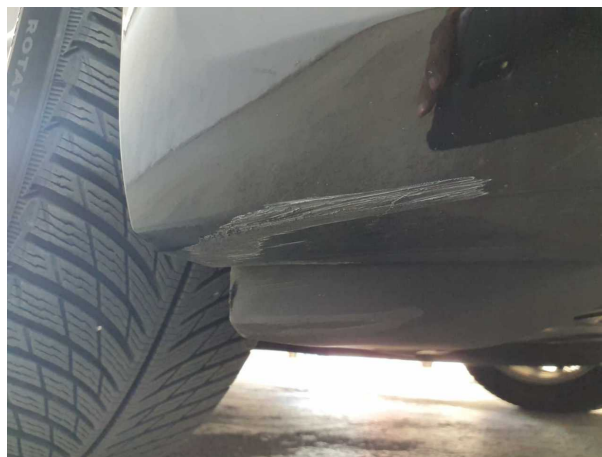
| No. | Component group | Description |
|---|---|---|
| 1 | Front bumper | Front bumper - Scratched - Smart repair |

**Damage #1:** Front bumper: Front bumper - Scratched - Smart repair

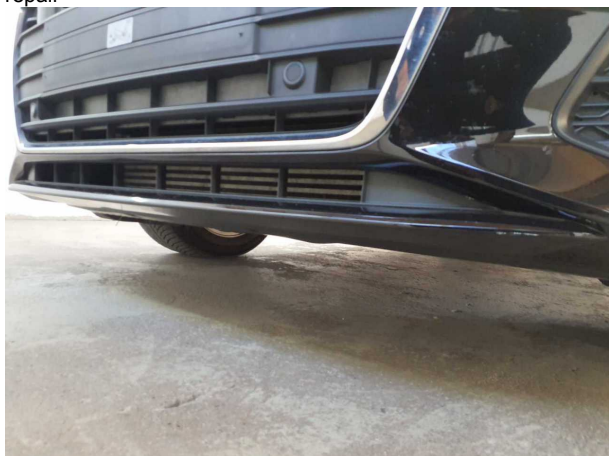
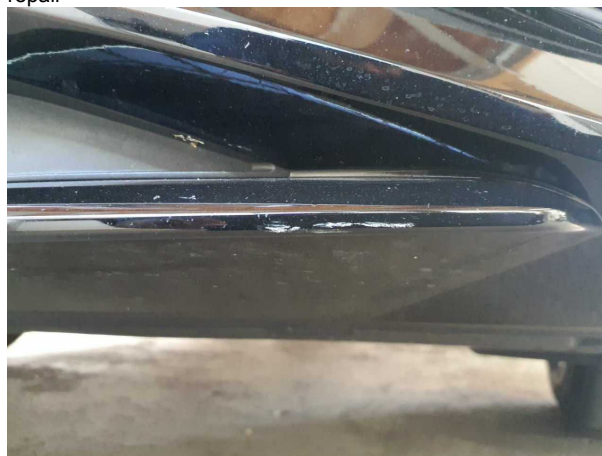
| No. | Component group | Description |
|---|---|---|
| 2 | Front bumper | Spoiler - Scratched - Smart repair |

**Damage #2:** Front bumper: Spoiler - Scratched - Smart repair

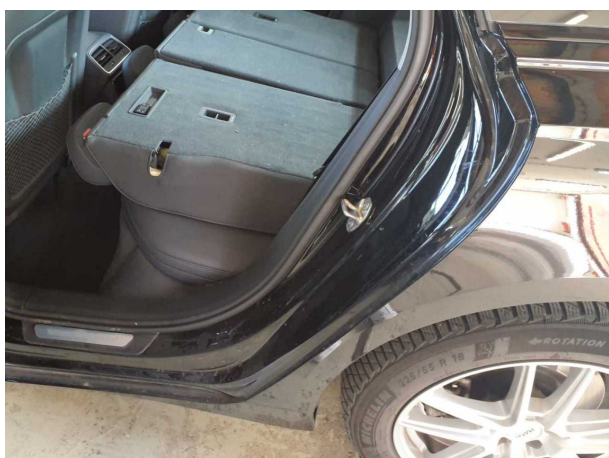
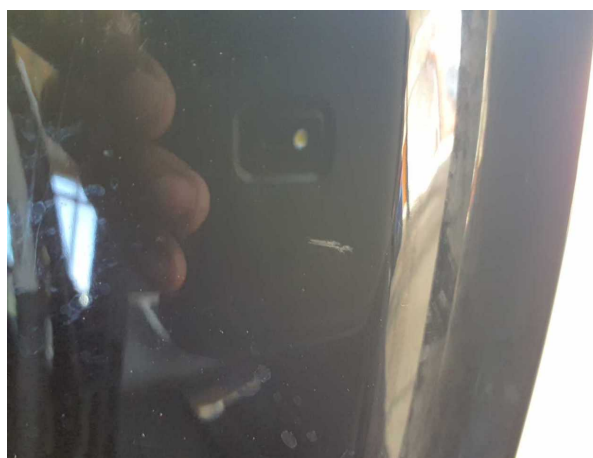
| No. | Component group | Description |
|---|---|---|
| 3 | Side panel - rear left side | Sill - Scratched - Smart repair |

**Damage #3:** Side panel - rear left side: Sill - Scratched - Smart repair

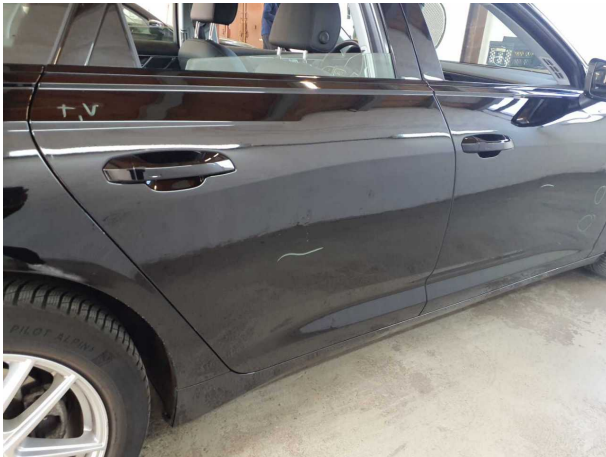
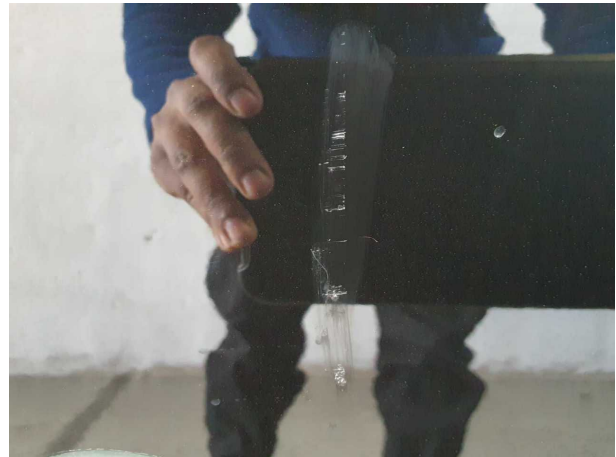
| No. | Component group | Description |
|---|---|---|
| 4 | Door - rear right side | Door - Scratched - Repair and paint |

**Damage #4:** Door - rear right side: Door - Scratched - Repair and paint

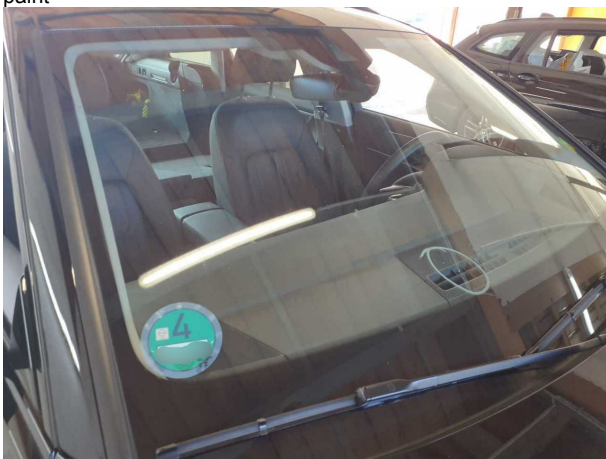
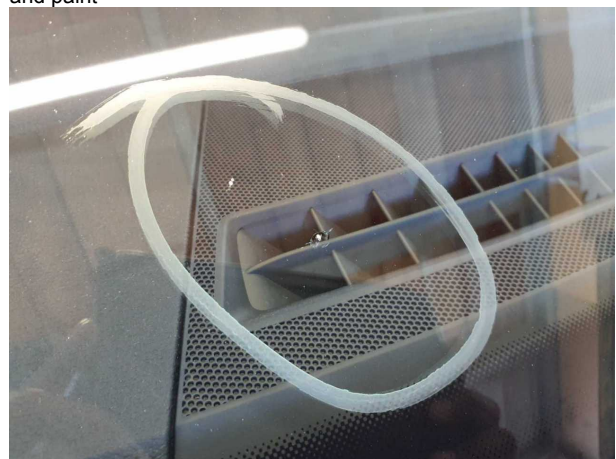
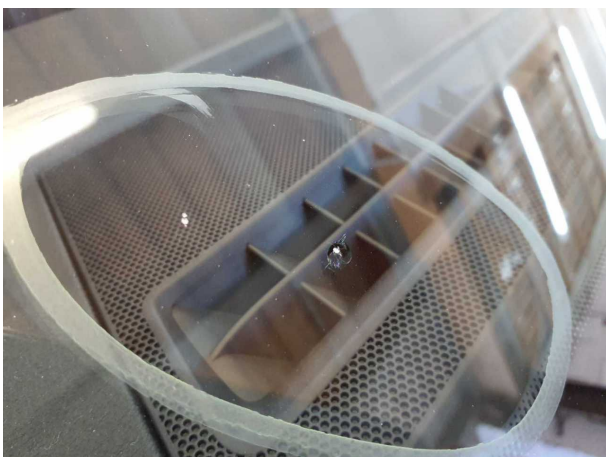
| No. | Component group | Description |
|---|---|---|
| 5 | Vehicle glazing | Windscreen - Stone chips - Replace |

**Damage #5:** Vehicle glazing: Windscreen - Stone chips - Replace

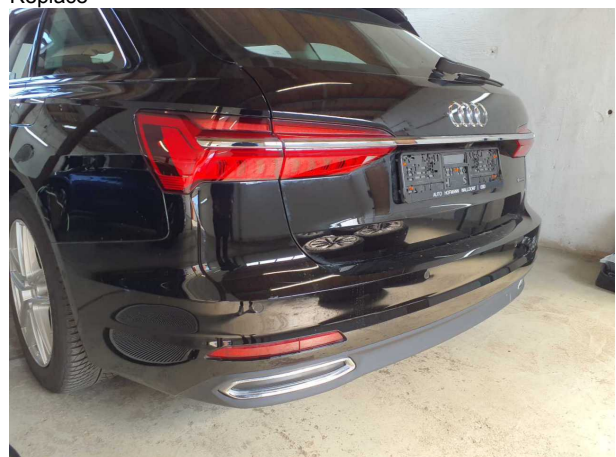
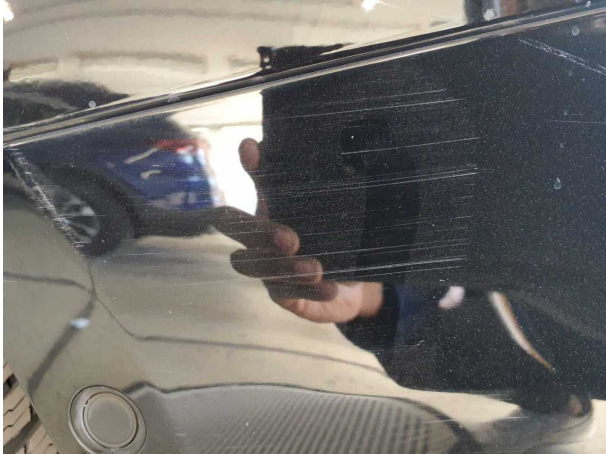
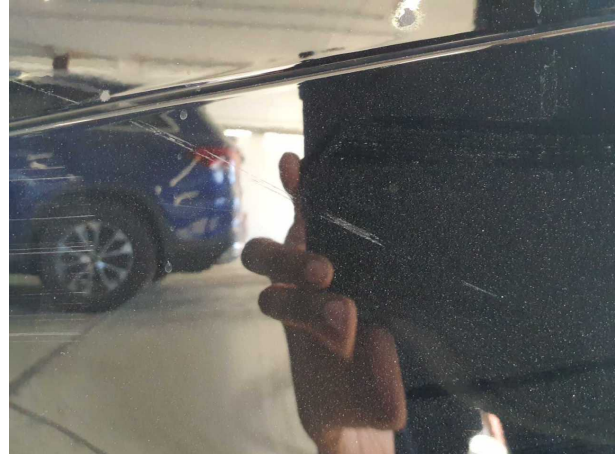
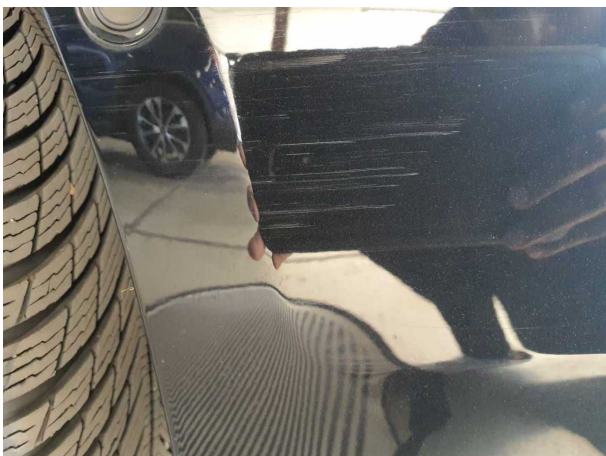
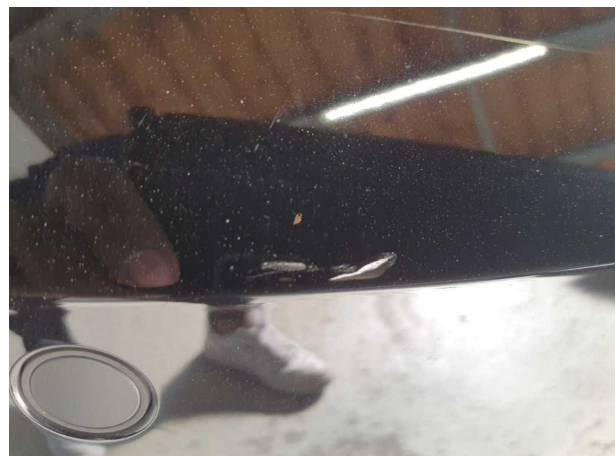
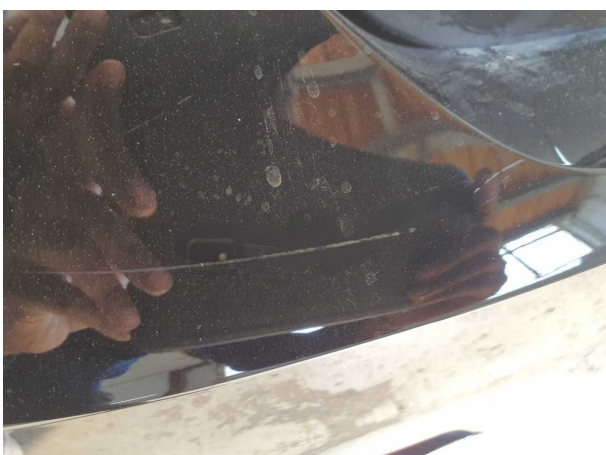
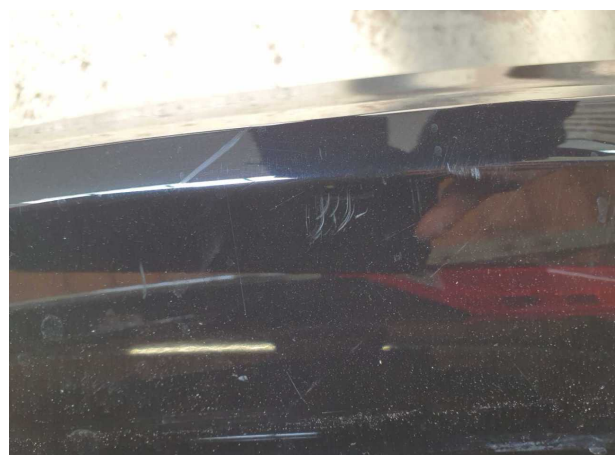
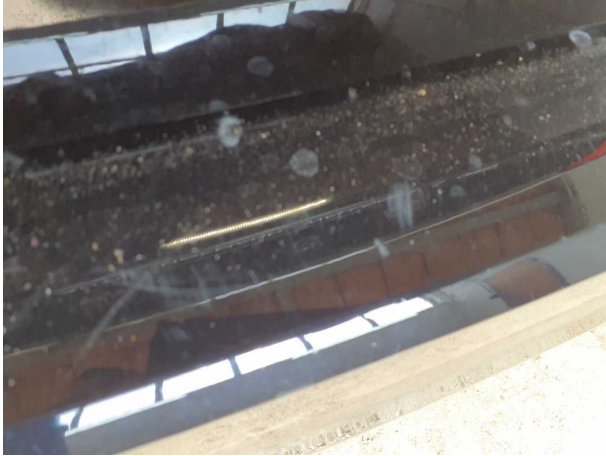
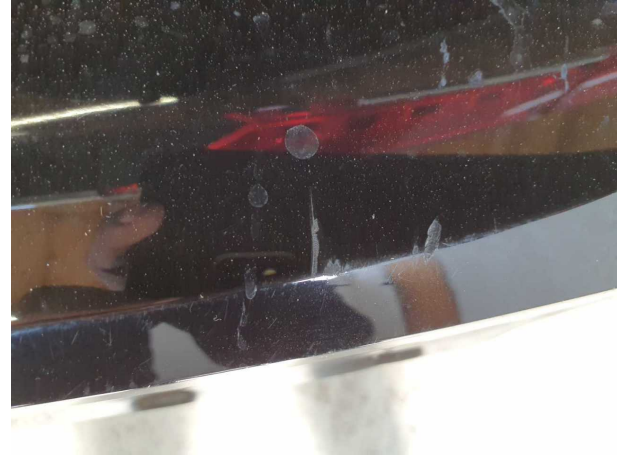
| No. | Component group | Description |
|---|---|---|
| 6 | Rear bumper | Rear bumper - Scratched - Paint |

**Damage #6:** Rear bumper: Rear bumper - Scratched - Paint

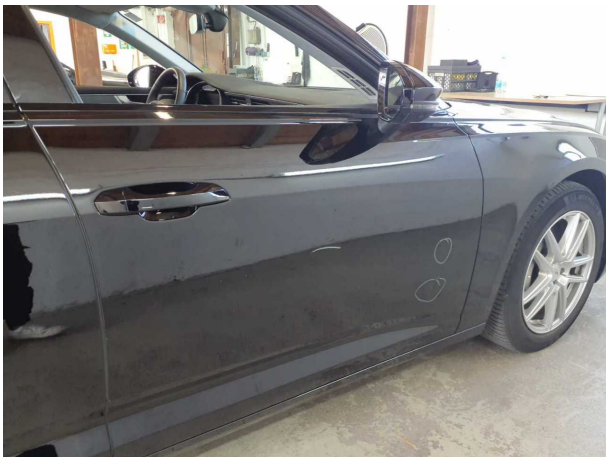
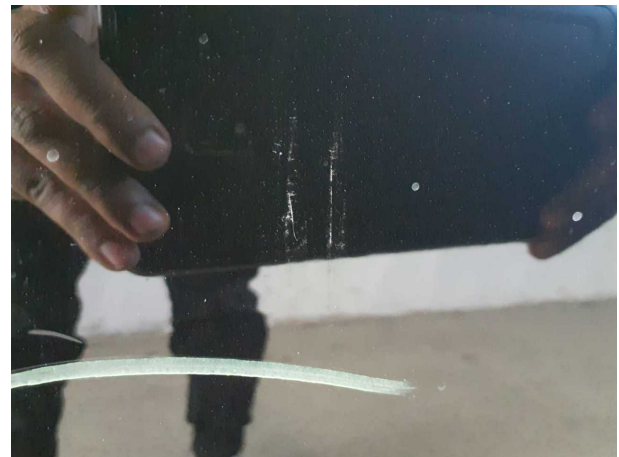
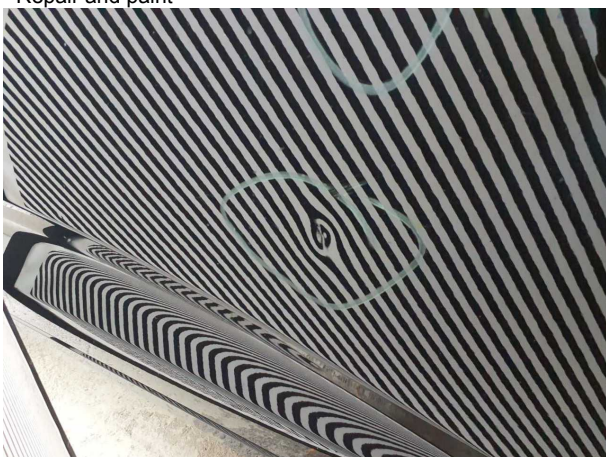
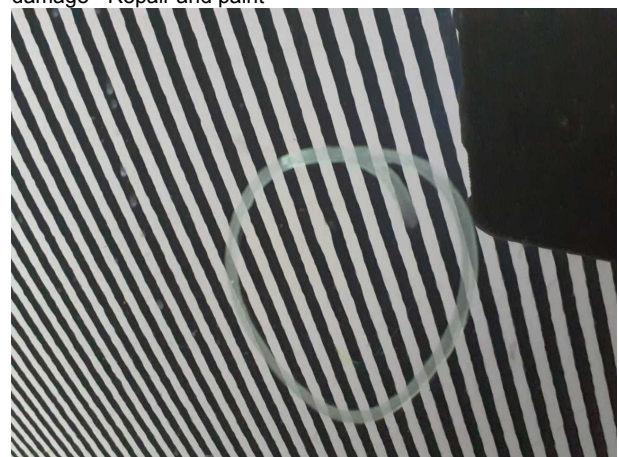
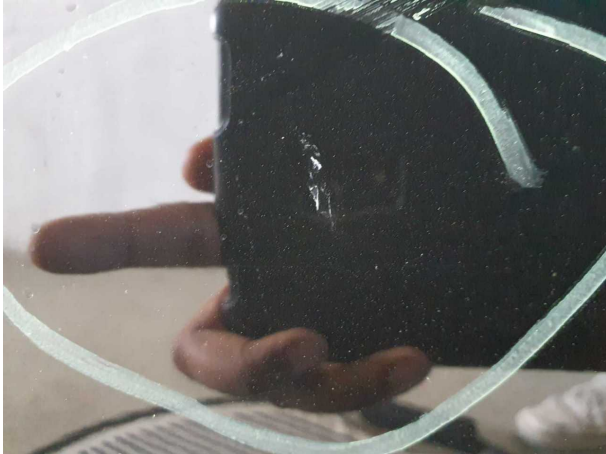
| No. | Component group | Description |
|---|---|---|
| 7 | Door - front right side | Door - Dent / paintcoat damage - Repair and paint |

**Damage #7:** Door - front right side: Door - Dent / paintcoat damage  
- Repair and paint

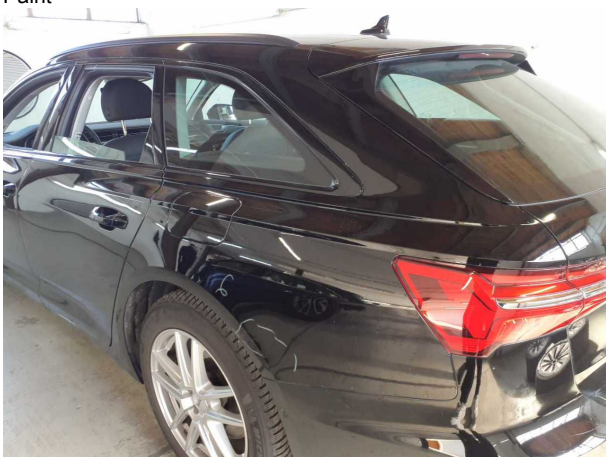
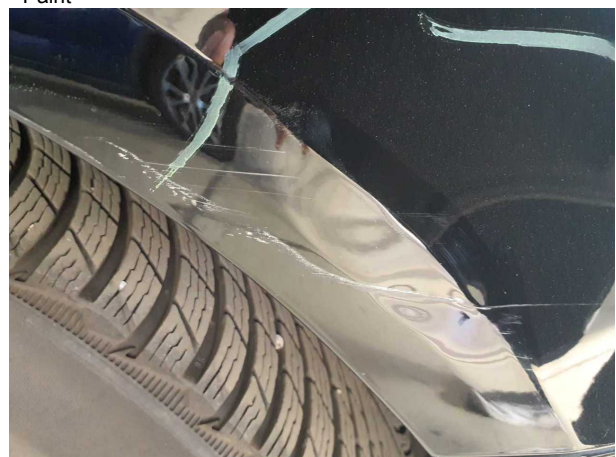
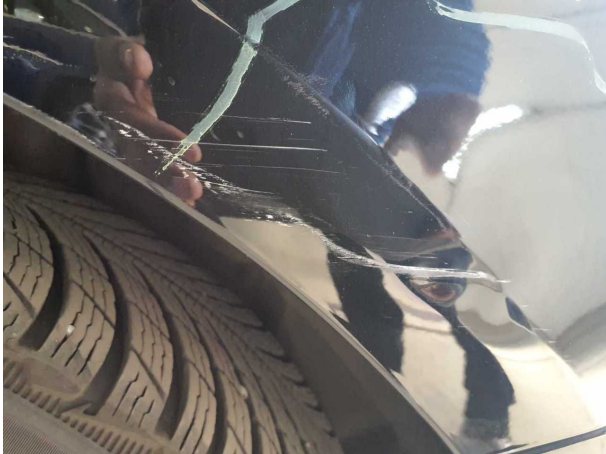
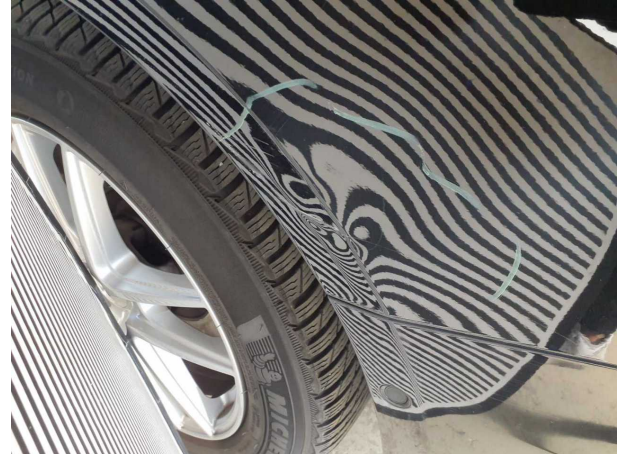
| No. | Component group | Description |
|---|---|---|
| 9 | Side panel - rear left side | Side panel - Dent / paintcoat damage - Repair and paint |

**Damage #9:** Side panel - rear left side: Side panel - Dent /  
paintcoat damage - Repair and paint

**Damage #9:** Side panel - rear left side: Side panel - Dent / paintcoat damage - Repair and paint
