**WAUZZZF8L2029234**

## Vehicle details

## Zustandsbericht

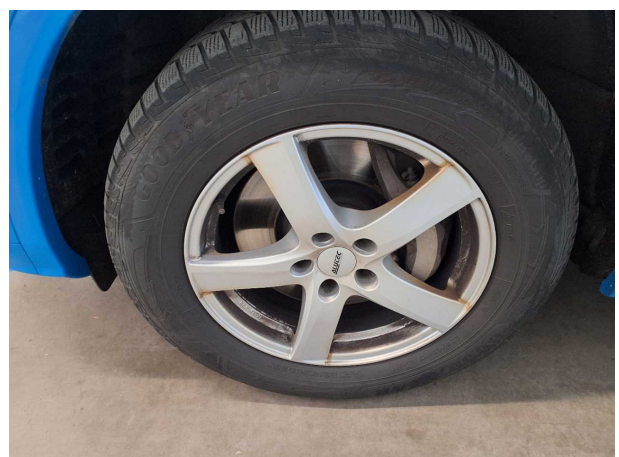
| Axle | Tyre size | Manufacturer | Type of tyre | Tread depth | Roadworthy | Permissibility |
|---|---|---|---|---|---|---|
| 1 | 235/55 R17 104H | Goodyear | Winter tyres | 5mm - 5mm | o.k. | o.k. |
| 2 | 235/55 R17 104H | Goodyear | Winter tyres | 6mm - 6mm | o.k. | o.k. |

**Figure 18: Mounted tyres**

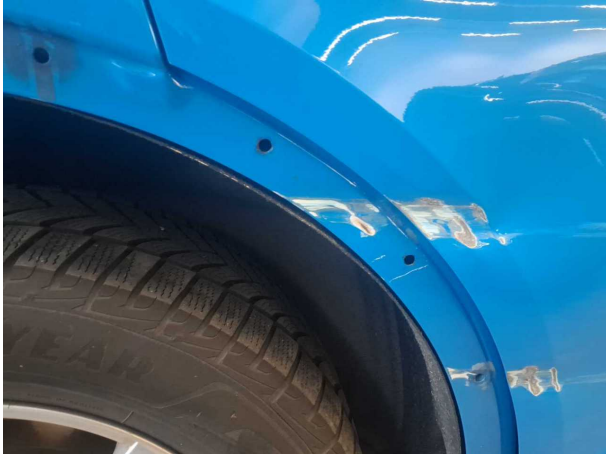
| No. | Component group | Description |
|---|---|---|
| 1 | Side panel - rear right side | Interior trim - Deformed - Replace |

**Damage #1:** Side panel - rear right side: Interior trim - Deformed - Replace

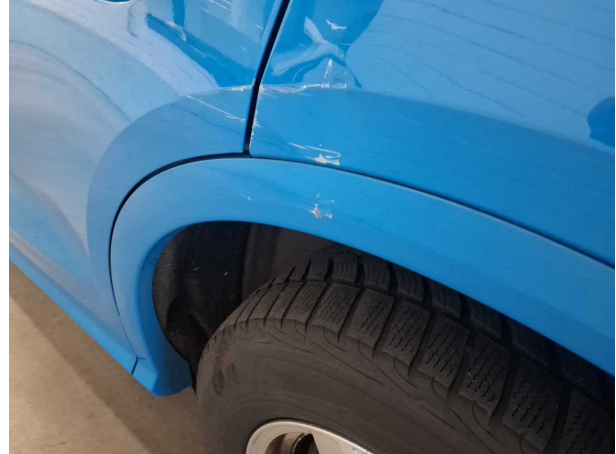
| No. | Component group | Description |
|---|---|---|
| 2 | Side panel - rear left side | Wheel well extension - Scratched - Repair and paint |

**Damage #2:** Side panel - rear left side: Wheel well extension - Scratched - Repair and paint

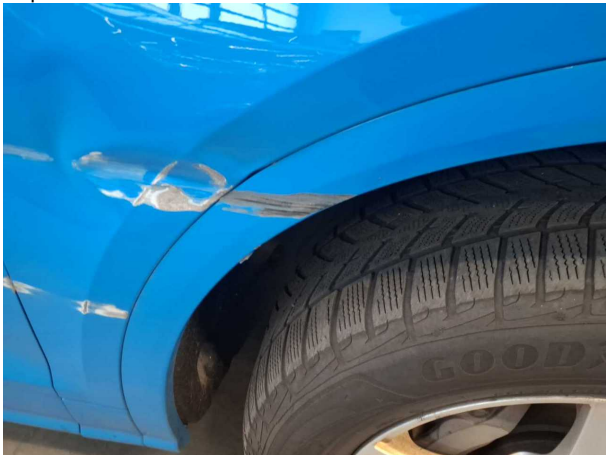
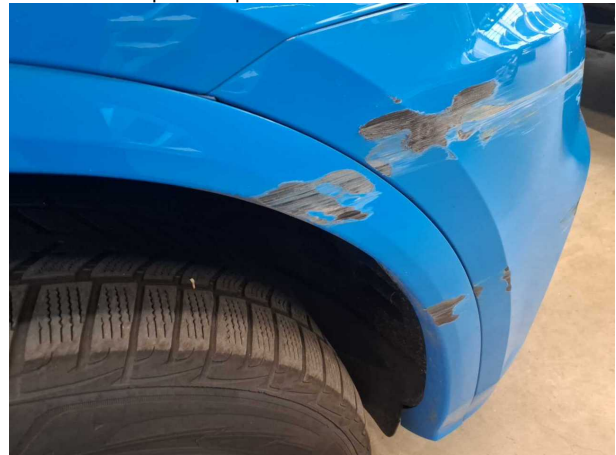
| No. | Component group | Description |
|---|---|---|
| 4 | Mudguard - right side | Wheel well extension - Scratched - Replace |

**Damage #4:** Mudguard - right side: Wheel well extension - Scratched - Replace

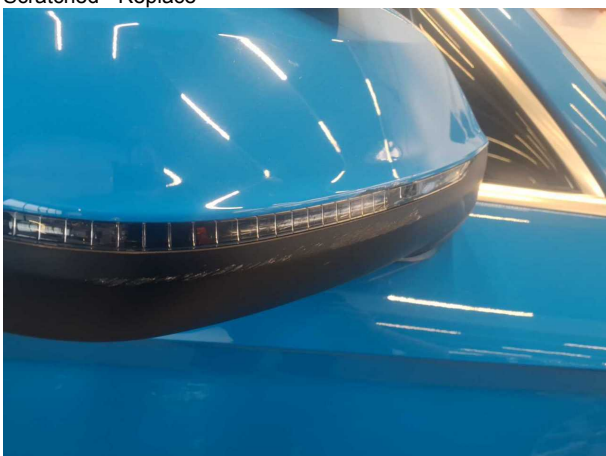
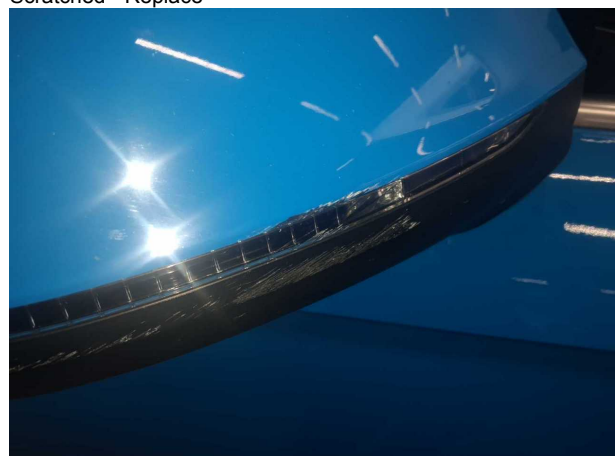
| No. | Component group | Description |
|---|---|---|
| 5 | Wing mirror - right side | Cap - Abrasion - Replace |

**Damage #5:** Wing mirror - right side: Cap - Abrasion - Replace

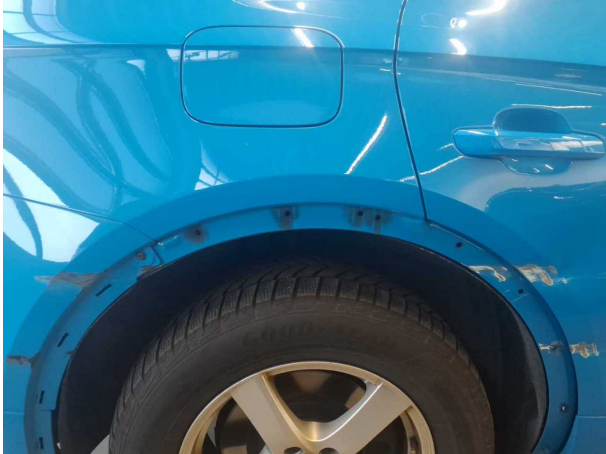
| No. | Component group | Description |
|---|---|---|
| 6 | Side panel - rear right side | Wheel well extension - Missing - Replace |

**Damage #6:** Side panel - rear right side: Wheel well extension - Missing - Replace

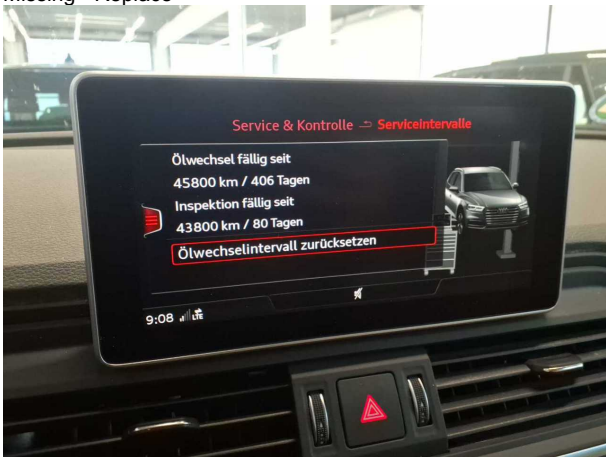
| No. | Component group | Description |
|---|---|---|
| 8 | Misc. | Inspection / maintenance - Due - Perform |

**Damage #8:** Misc.: Inspection / maintenance - Due - Perform

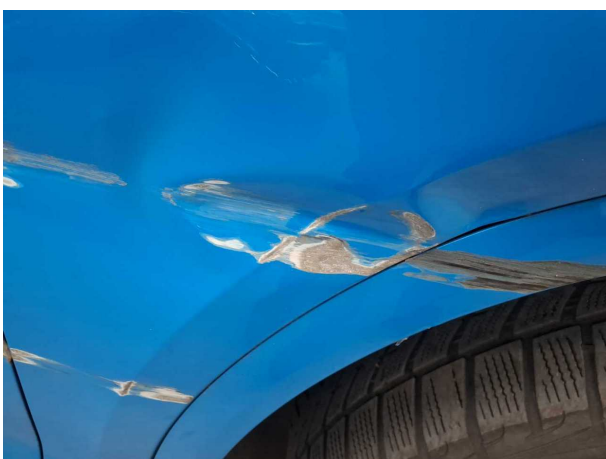
| No. | Component group | Description |
|---|---|---|
| 10 | Mudguard - right side | Mudguard - right side - Scratched - Replace |

**Damage #10:** Mudguard - right side: Mudguard - right side - Scratched - Replace

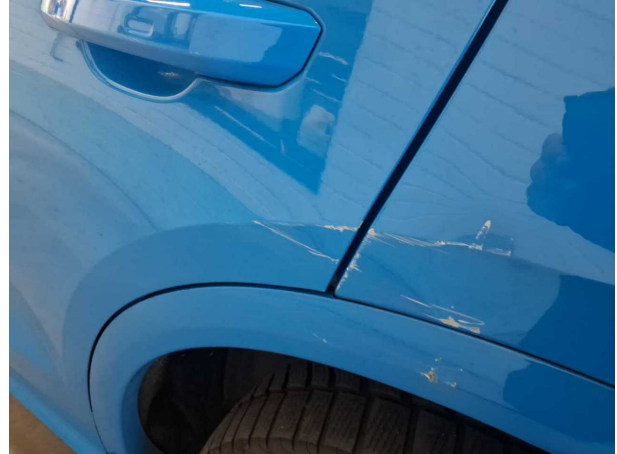
| No. | Component group | Description |
|---|---|---|
| 7 | Door - rear left side | Door - Scratched - Repair and paint |

**Damage #7:** Door - rear left side: Door - Scratched - Repair and paint

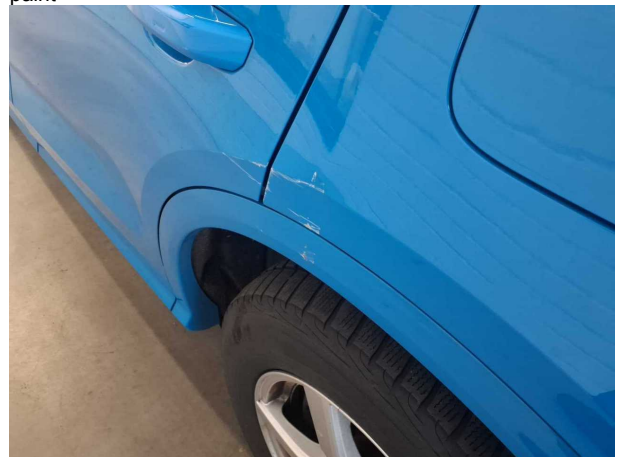
| No. | Component group | Description |
|---|---|---|
| 9 | Side panel - rear left side | Side panel - Scratched - Repair and paint |

**Damage #9:** Side panel - rear left side: Side panel - Scratched - Repair and paint

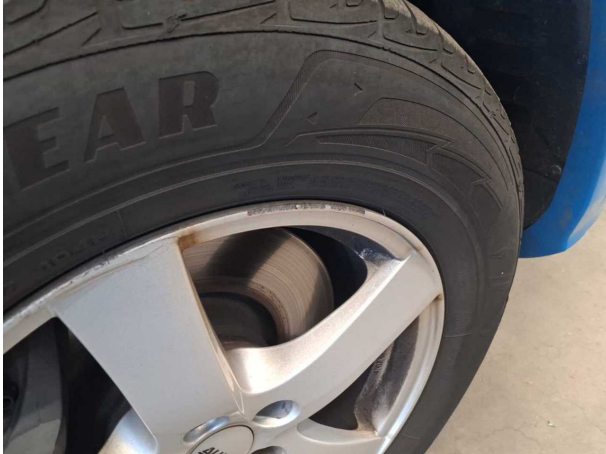
| No. | Component group | Description |
|---|---|---|
| 12 | Wheel / tyres | Alloy rim - front right side - Damaged - Replace |

**Damage #12:** Wheel / tyres: Alloy rim - front right side - Damaged - Replace

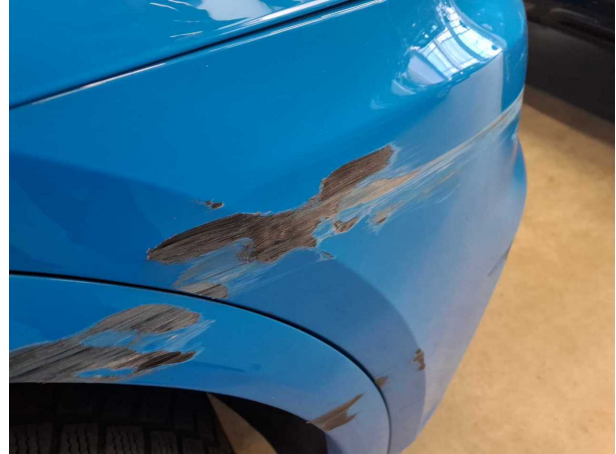
| No. | Component group | Description |
|---|---|---|
| 13 | Front bumper | Front bumper - Scratched - Replace |

**Damage #13:** Front bumper: Front bumper - Scratched - Replace

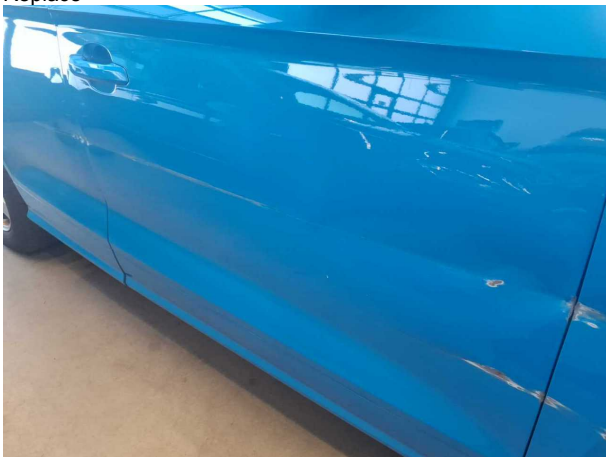
| No. | Component group | Description |
|---|---|---|
| 14 | Door - front right side | Door - Scratched - Replace |

**Damage #14:** Door - front right side: Door - Scratched - Replace

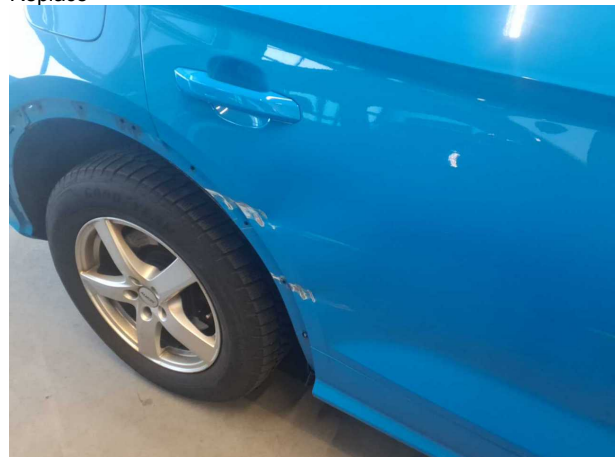
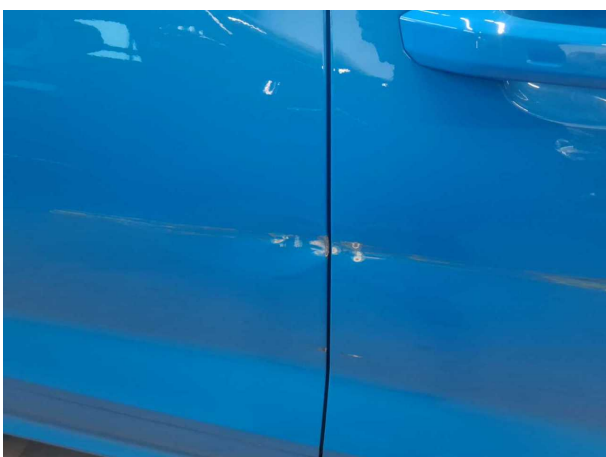
| No. | Component group | Description |
|---|---|---|
| 15 | Door - rear right side | Door - Scratched - Replace |

**Damage #15:** Door - rear right side: Door - Scratched - Replace

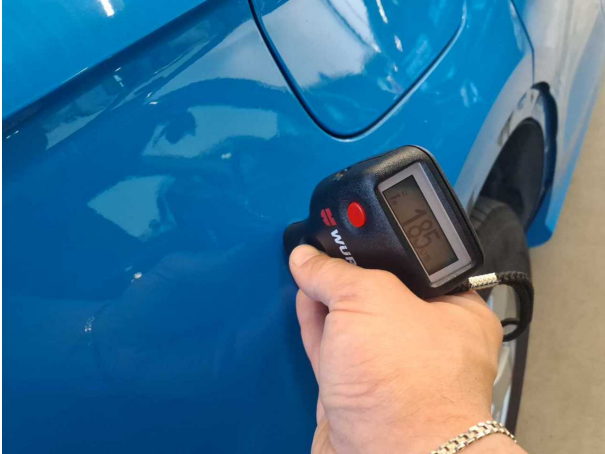
| No. | Location |
|---|---|
| 1 | Side panel - rear right side |

**Repainting 1:** Side panel - rear right side
