**WBA6V710105T80257**

| Type / Model | 218i Gran Tourer | Main inspection (Report on hand) | 06/2026 |

## Zustandsbericht

**Protocol number:** 39752325

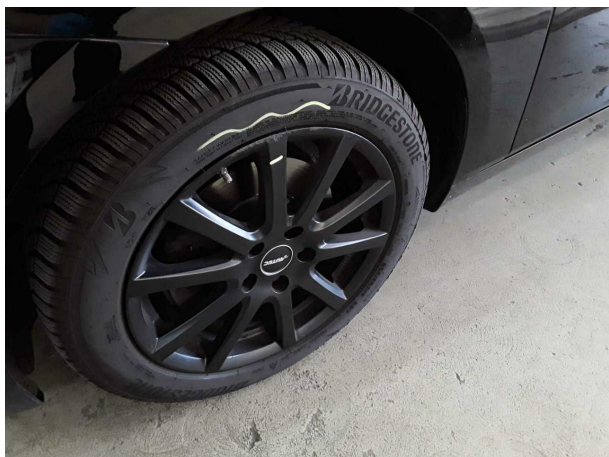
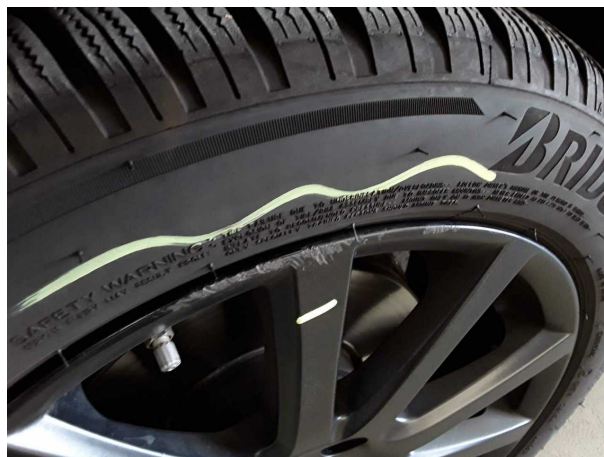
| No. | Component group | Description |
|---|---|---|
| 1 | Wheel / tyres | Alloy rim - front left side - Scratched - No deduction |

**Damage #1:** Wheel / tyres: Alloy rim - front left side - Scratched - No deduction

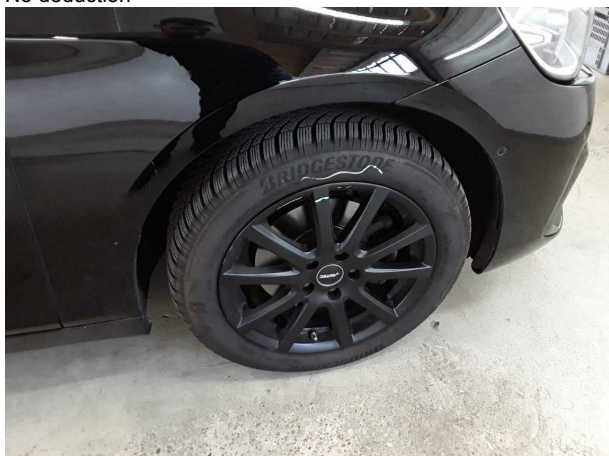
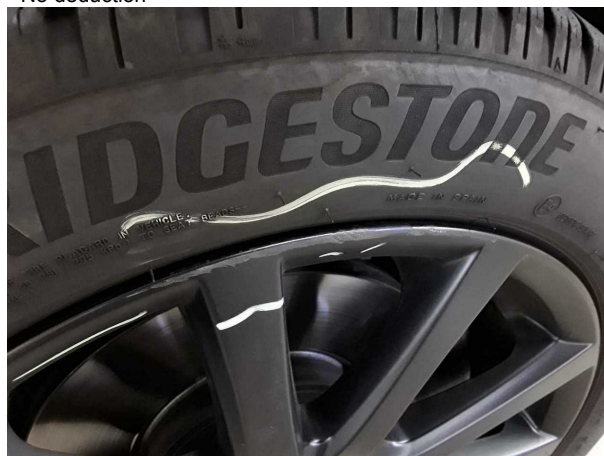
| No. | Component group | Description |
|---|---|---|
| 2 | Wheel / tyres | Alloy rim - front right side - Scratched - No deduction |

**Damage #2:** Wheel / tyres: Alloy rim - front right side - Scratched - No deduction

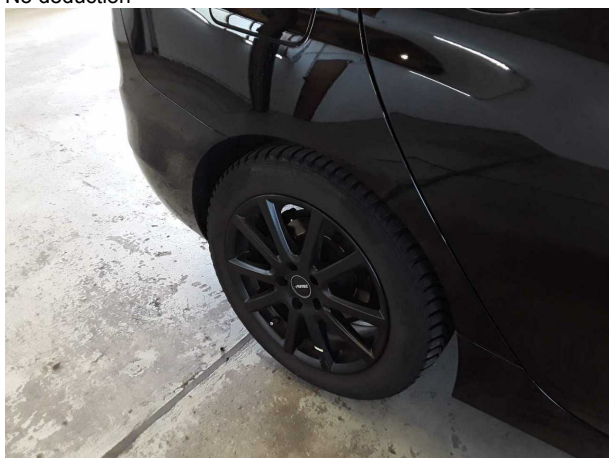
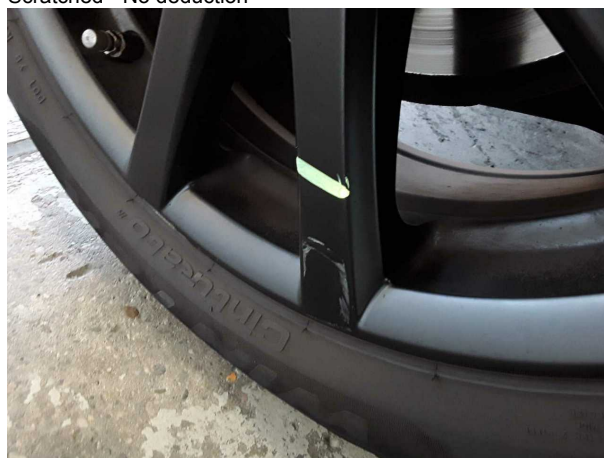
| No. | Component group | Description |
|---|---|---|
| 3 | Wheel / tyres | Alloy rim - rear right side - Scratched - No deduction |

**Damage #3:** Wheel / tyres: Alloy rim - rear right side - Scratched - No deduction

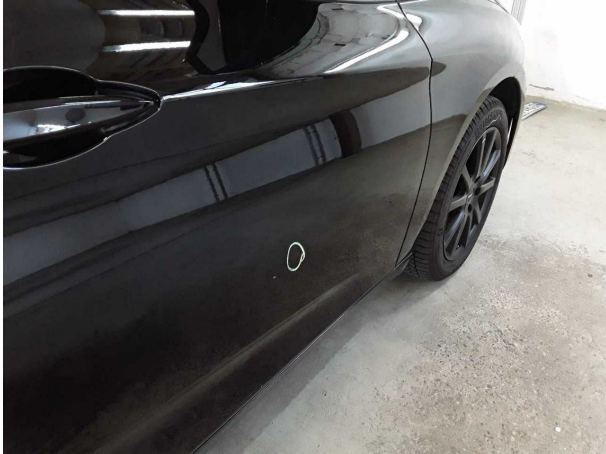
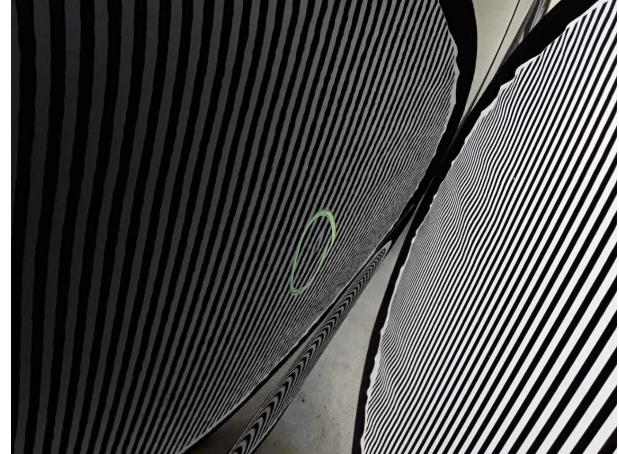
| No. | Component group | Description |
|---|---|---|
| 4 | Door - front right side | Door - dent(s) - Smooth repair work |

**Damage #4:** Door - front right side: Door - dent(s) - Smooth repair work

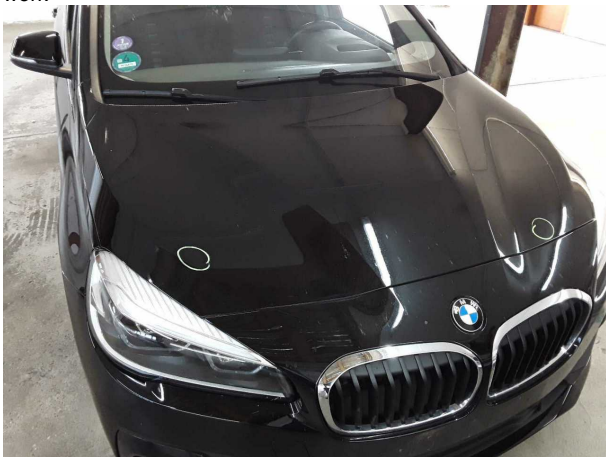
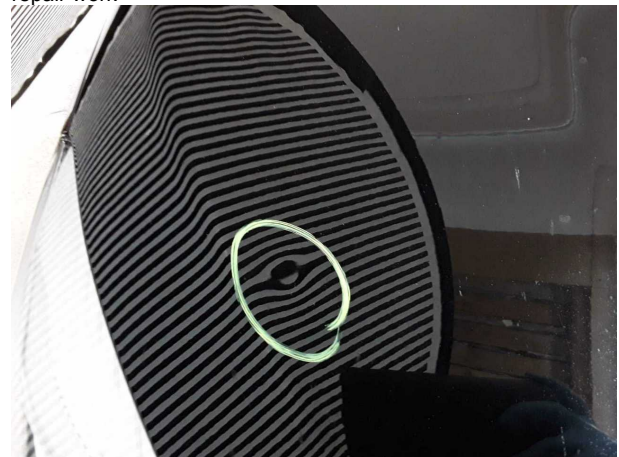
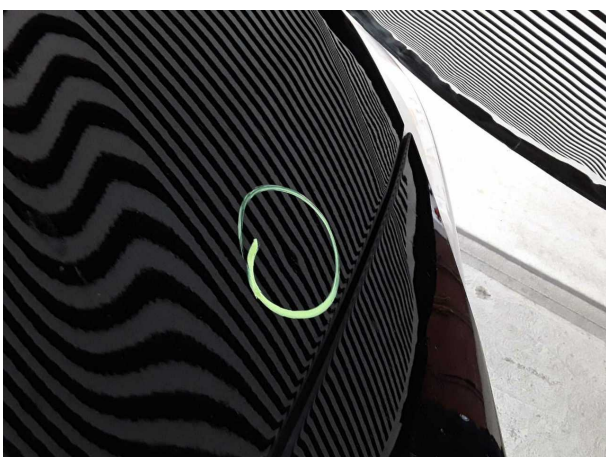
| No. | Component group | Description |
|---|---|---|
| 5 | Bonnet | Bonnet - dent(s) - Smooth repair work |

**Damage #5:** Bonnet: Bonnet - dent(s) - Smooth repair work

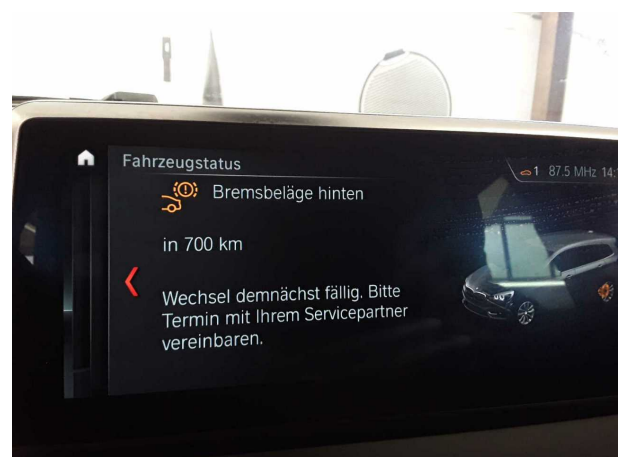
| No. | Component group | Description |
|---|---|---|
| 6 | Braking system | Brake discs and pads - rear (Laut Anzeige) - Worn - Replace |

**Damage #6:** Braking system: Brake discs and pads - rear (Laut Anzeige) - Worn - Replace

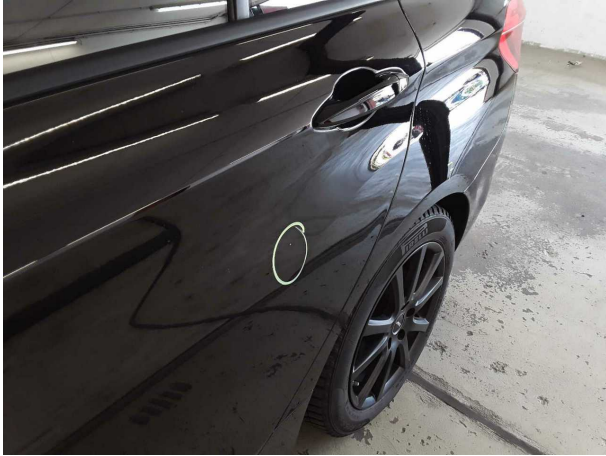
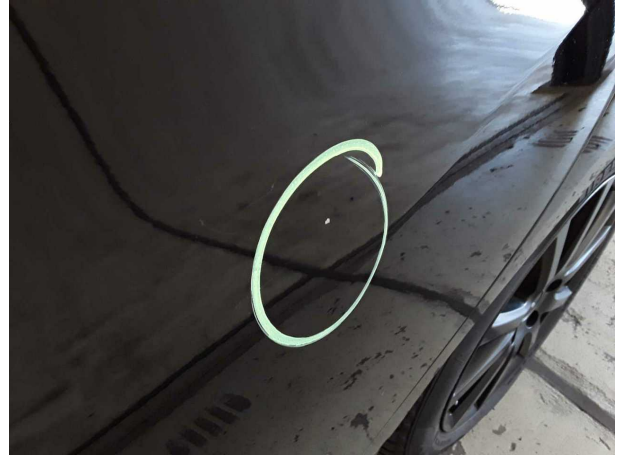
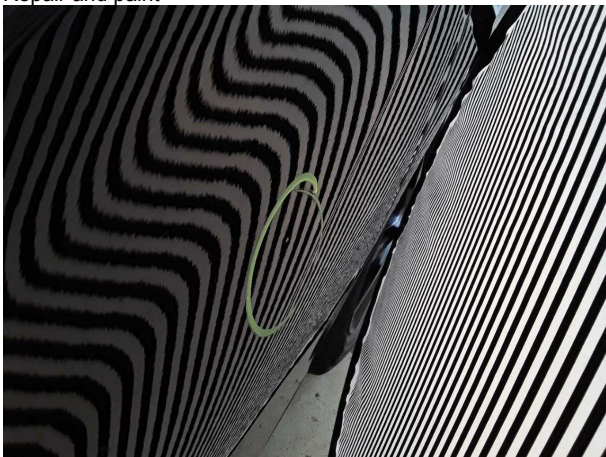
| No. | Component group | Description |
|---|---|---|
| 7 | Door - rear left side | Door - Dent / paintcoat damage - Repair and paint |

**Damage #7:** Door - rear left side: Door - Dent / paintcoat damage - Repair and paint
