WBA5Y11080FL27243

## Zustandsbericht

Inspection date: 7 May 2025

**Protocol number:** 39594657

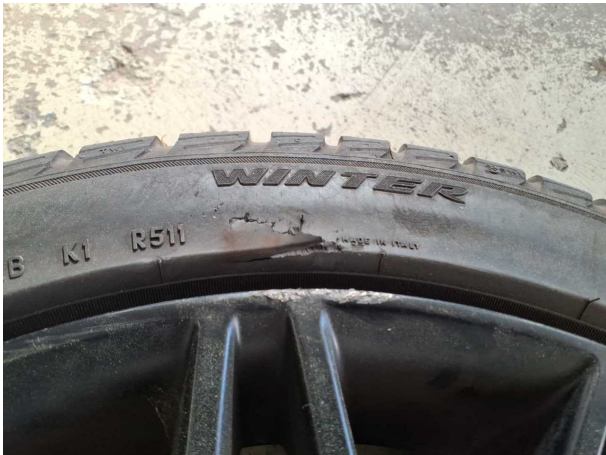
| No. | Component group | Description |
|---|---|---|
| 1 | 2nd wheel set | 1 tyre - Damaged - No deduction |

**Damage #1:** 2nd wheel set: 1 tyre - Damaged - No deduction

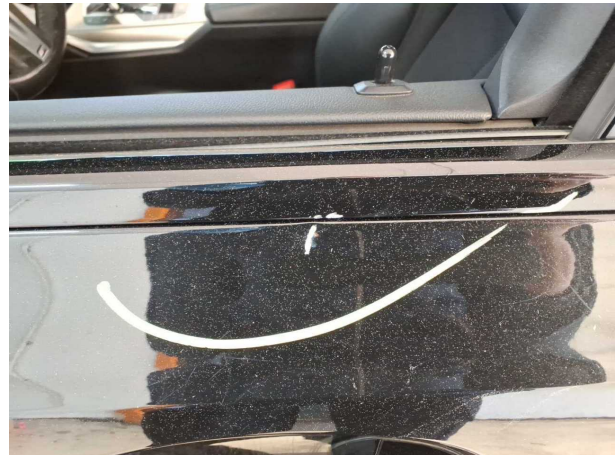
| No. | Component group | Description |
|---|---|---|
| 2 | Door - front left side | Brightware - upper - Damaged - Replace |

**Damage #2:** Door - front left side: Brightware - upper - Damaged - Replace

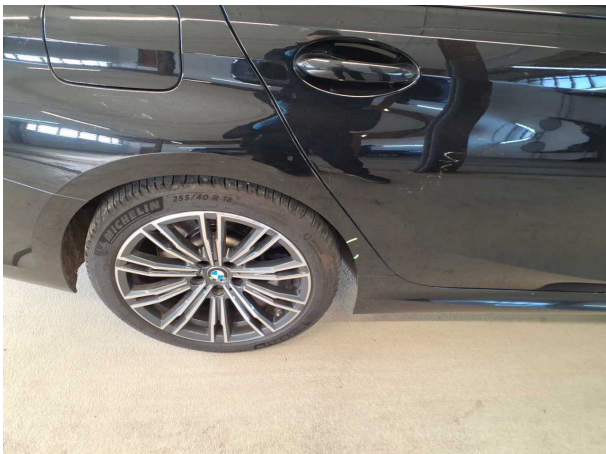
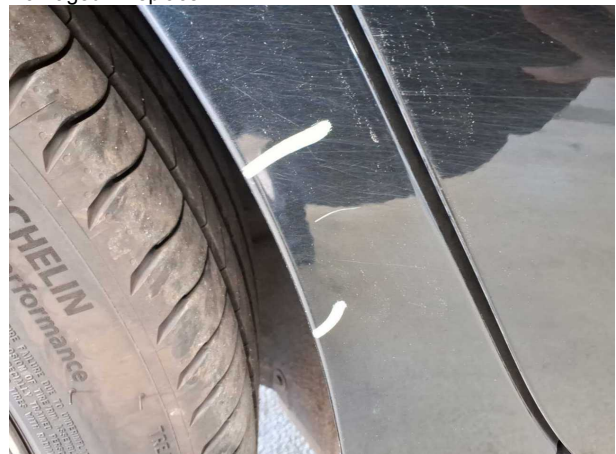
| No. | Component group | Description |
|---|---|---|
| 3 | Side panel - rear right side | Side panel - Scratch(es) - Smart repair |

**Damage #3:** Side panel - rear right side: Side panel - Scratch(es) - Smart repair

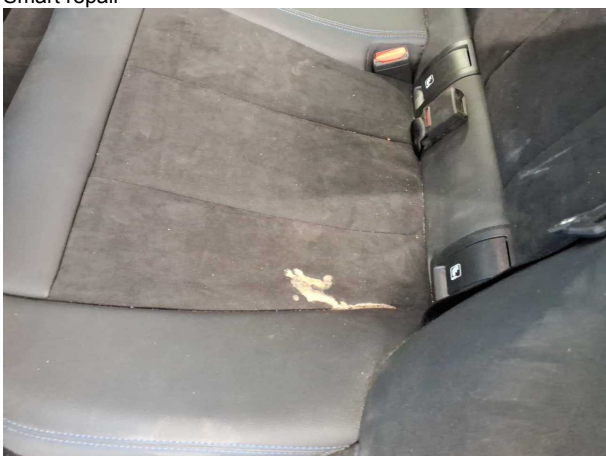
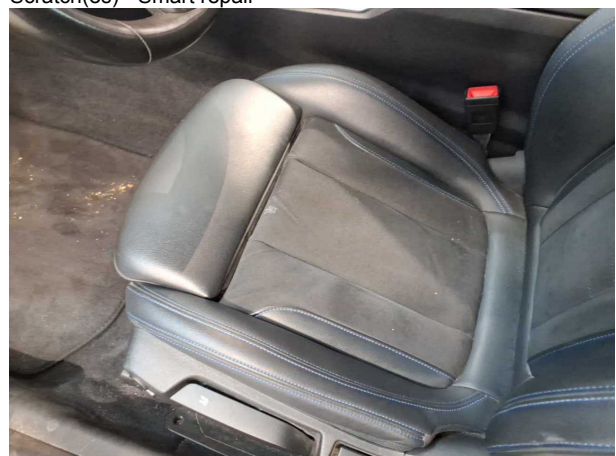
| No. | Component group | Description |
|---|---|---|
| 4 | Interior | Interior - Soiled - Clean |

**Damage #4:** Interior: Interior - Soiled - Clean

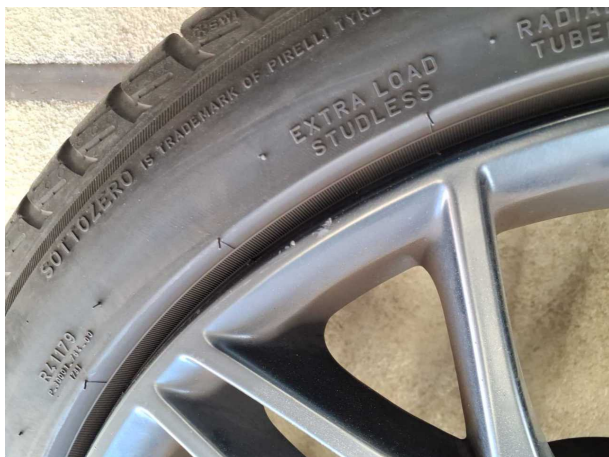
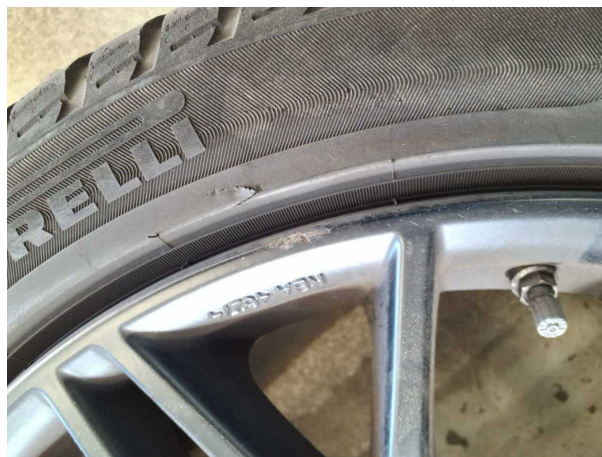
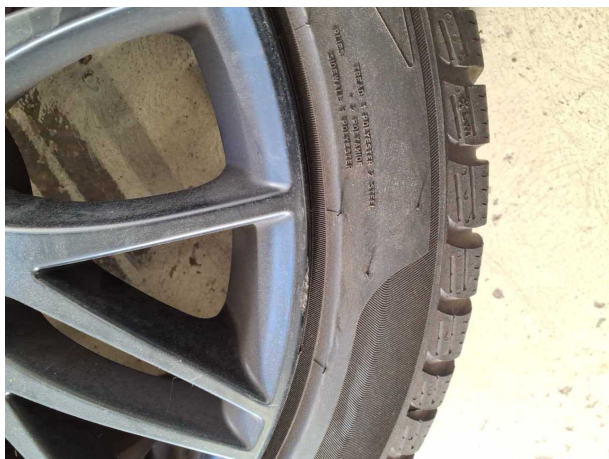
| No. | Component group | Description |
|---|---|---|
| 5 | 2nd wheel set | 3 alloy rims - Scratched - Loss in value |

**Damage #5:** 2nd wheel set: 3 alloy rims - Scratched - Loss in value

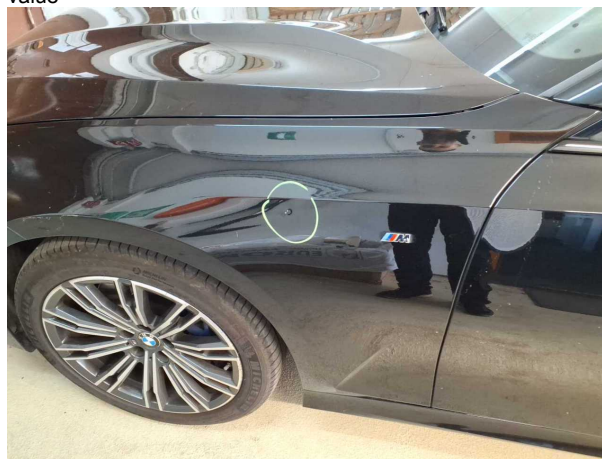
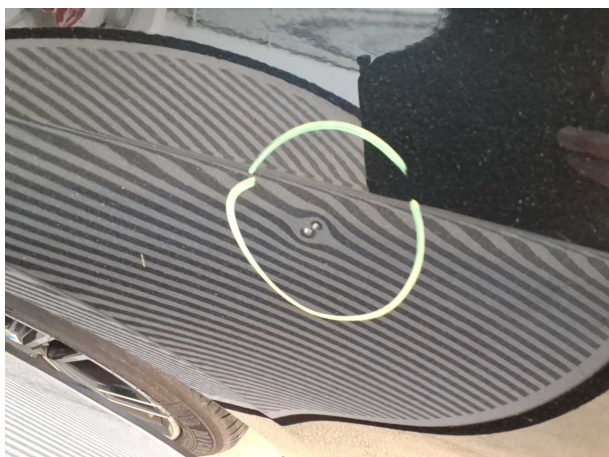
| No. | Component group | Description |
|---|---|---|
| 6 | Mudguard - left side | Mudguard - left side - Dent / paintcoat damage - Repair and paint |

**Damage #6:** Mudguard - left side: Mudguard - left side - Dent / paintcoat damage - Repair and paint

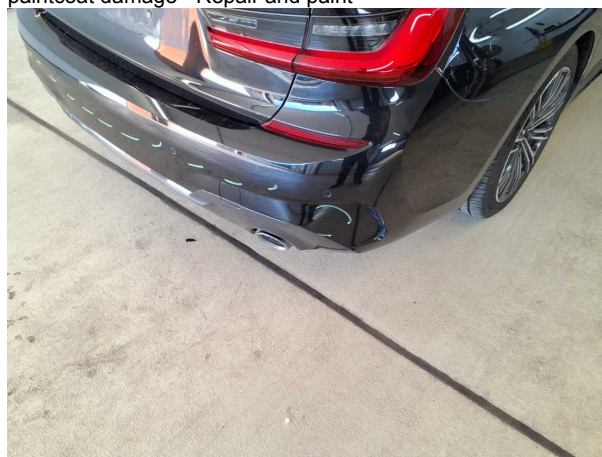
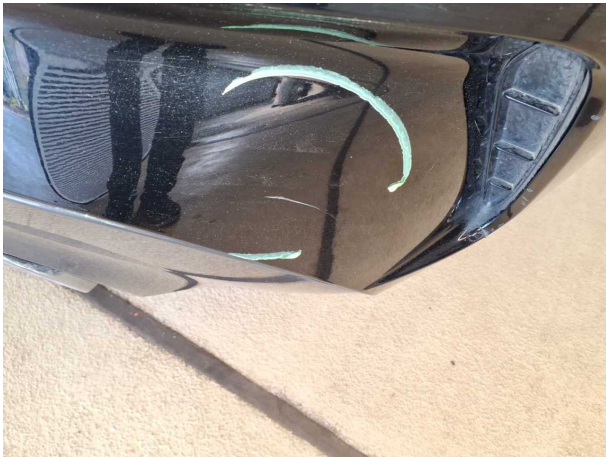
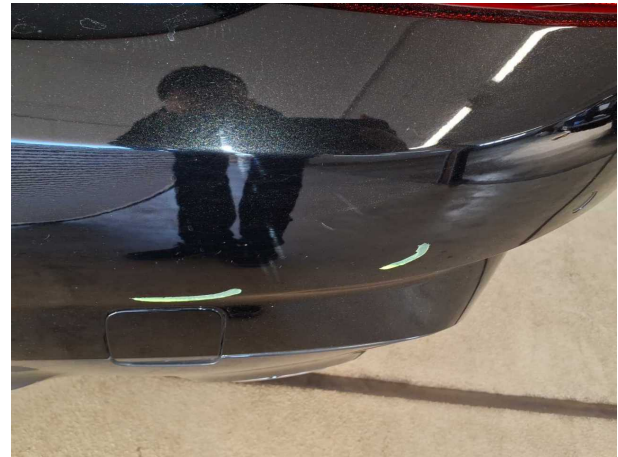
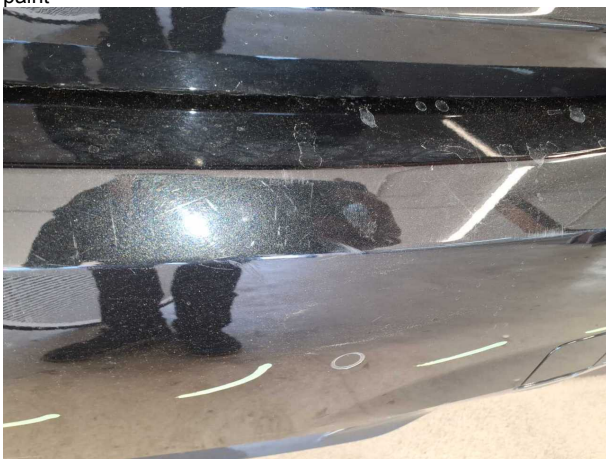
| No. | Component group | Description |
|---|---|---|
| 7 | Rear bumper | Rear bumper - Scratched - Repair and paint |

**Damage #7:** Rear bumper: Rear bumper - Scratched - Repair and paint

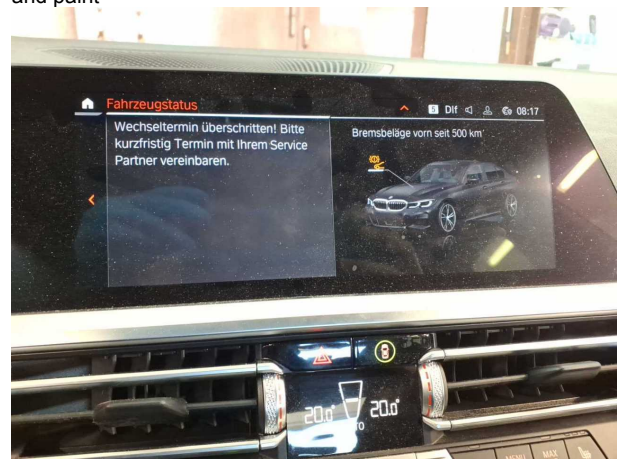
| No. | Component group | Description |
|---|---|---|
| 8 | Braking system | Brake discs and brake pads - front - Due - Replace |

**Damage #8:** Braking system: Brake discs and brake pads - front - Due - Replace

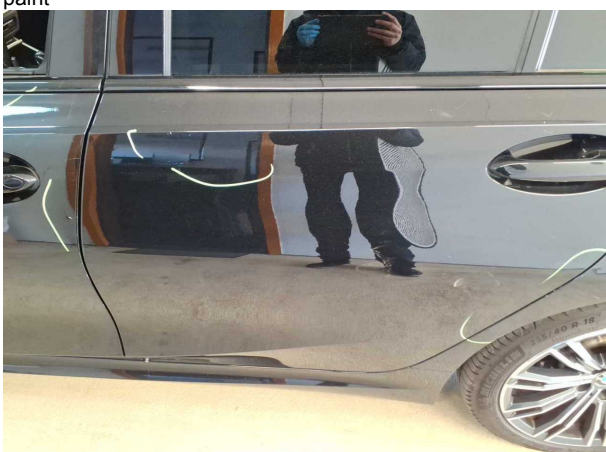
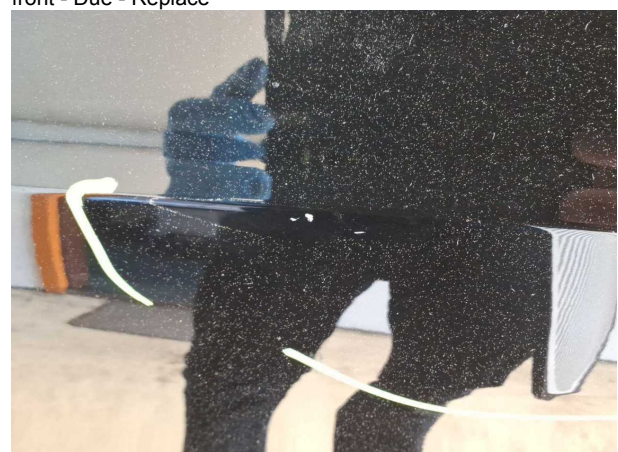
| No. | Component group | Description |
|---|---|---|
| 9 | Door - rear left side | Door - Scratch(es) - Repair and paint |

**Damage #9:** Door - rear left side: Door - Scratch(es) - Repair and paint

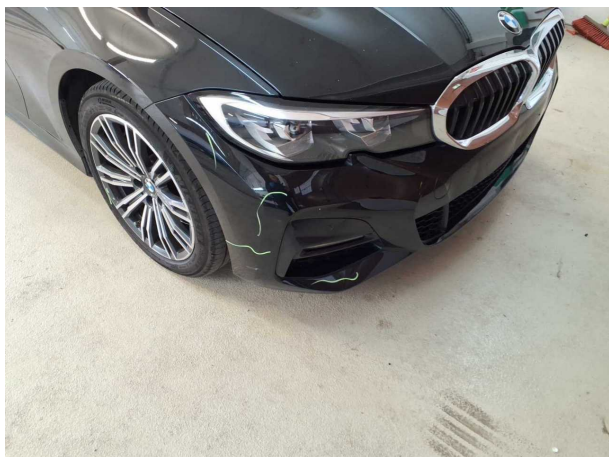
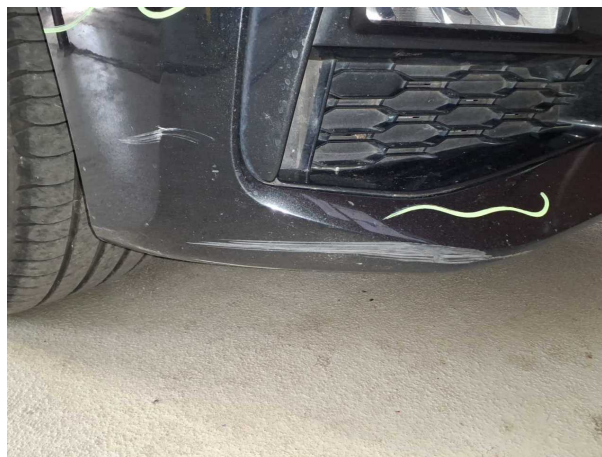
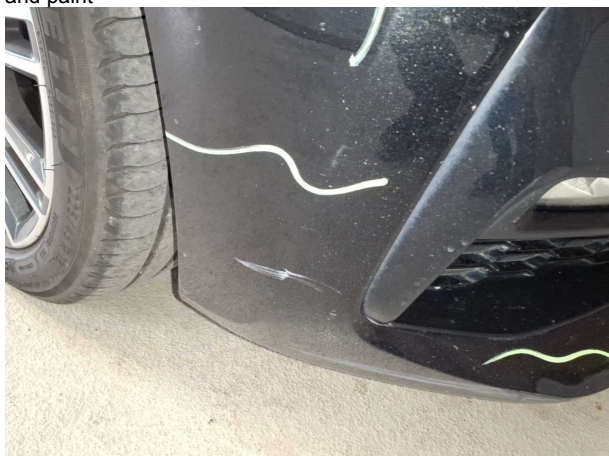
| No. | Component group | Description |
|---|---|---|
| 10 | Front bumper | Front bumper - Scratched - Repair and paint |

**Damage #10:** Front bumper: Front bumper - Scratched - Repair and paint

**Damage #10:** Front bumper: Front bumper - Scratched - Rep... and paint

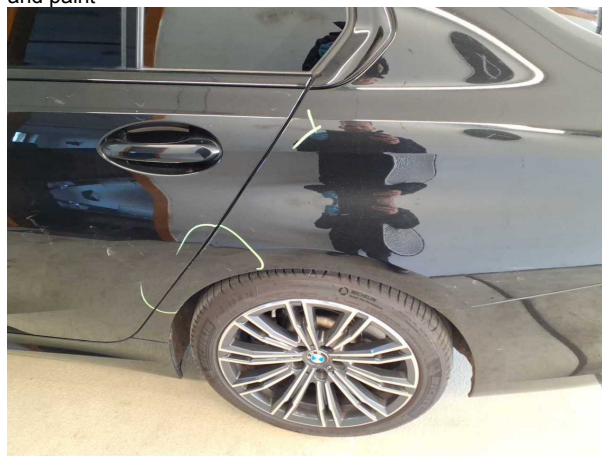
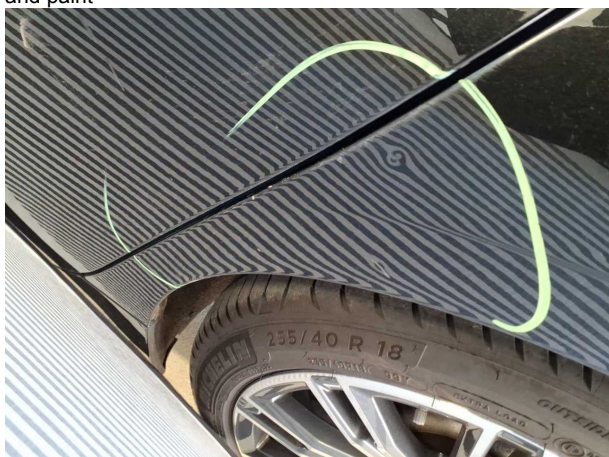
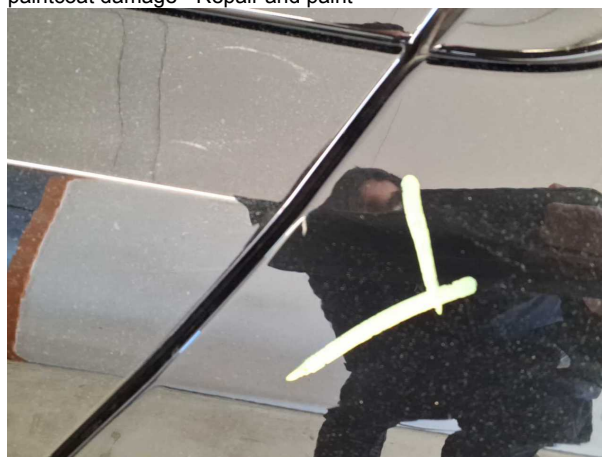
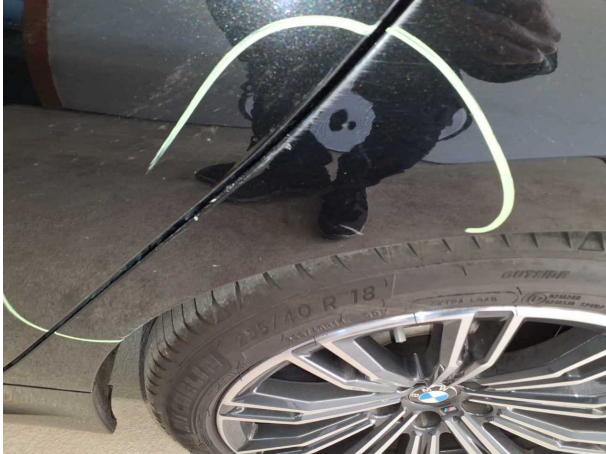
| No. | Component group | Description |
|---|---|---|
| 11 | Side panel - rear left side | Side panel - Dent / paintcoat damage - Repair and paint |

**Damage #11:** Side panel - rear left side: Side panel - Dent / paintcoat damage - Repair and paint

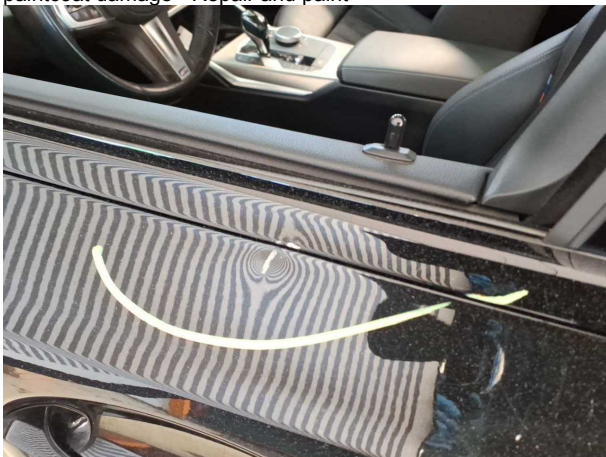
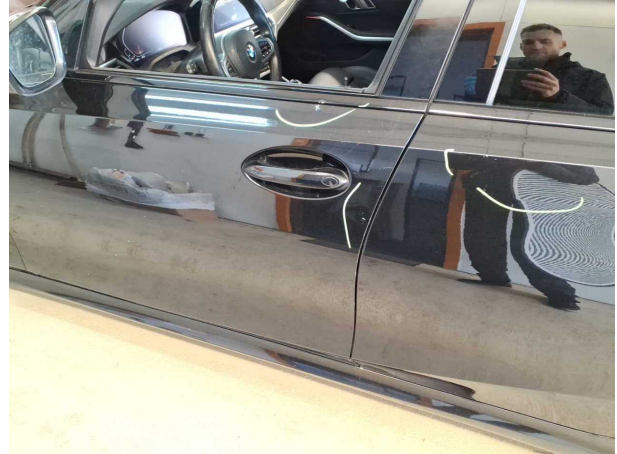
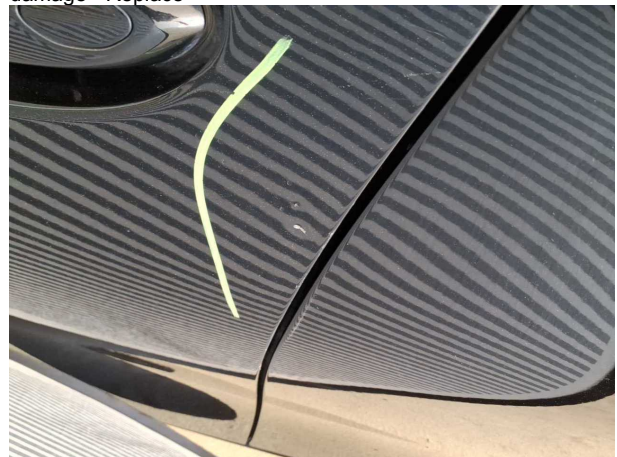
| No. | Component group | Description |
|---|---|---|
| 12 | Door - front left side | Door - Dent / paintcoat damage - Replace |

**Damage #12:** Door - front left side: Door - Dent / paintcoat damage - Replace
