WBA6N71070FL31039

## Zustandsbericht

Inspection date: 13 May 2025

**Protocol number:** 39676458

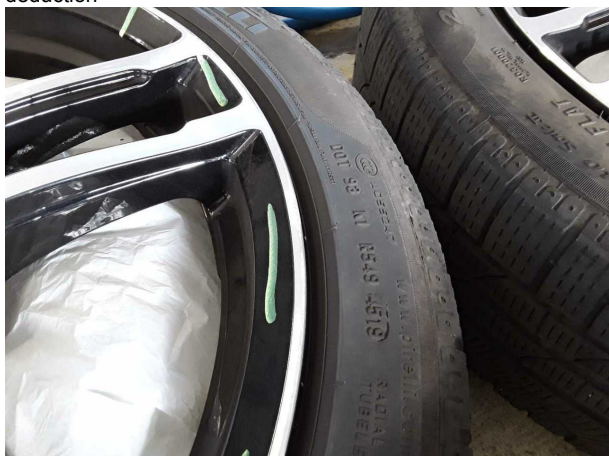
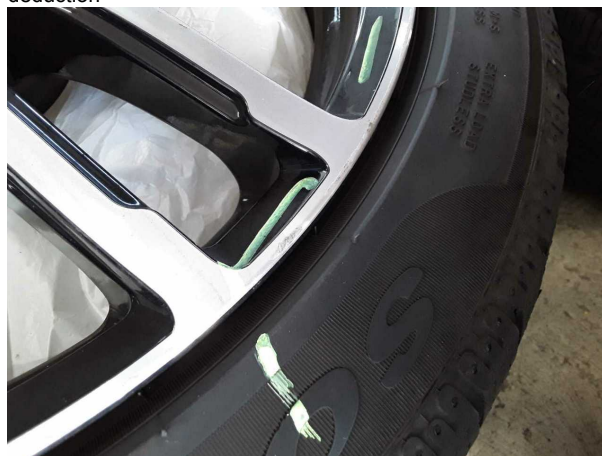
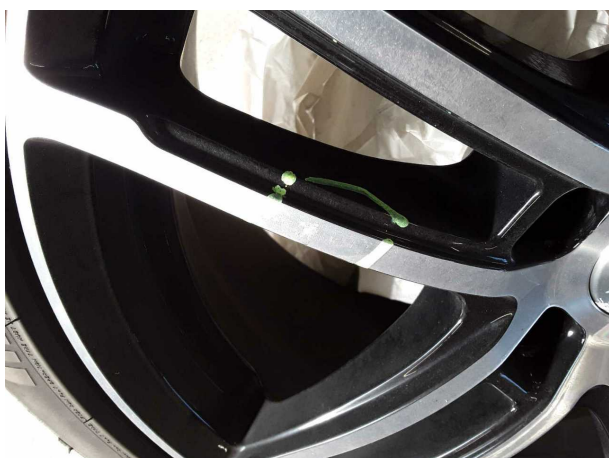
| No. | Component group | Description |
|---|---|---|
| 2 | 2nd wheel set | 2 alloy rims - Scratched - No deduction |

**Damage #2:** 2nd wheel set: 2 alloy rims - Scratched - No deduction

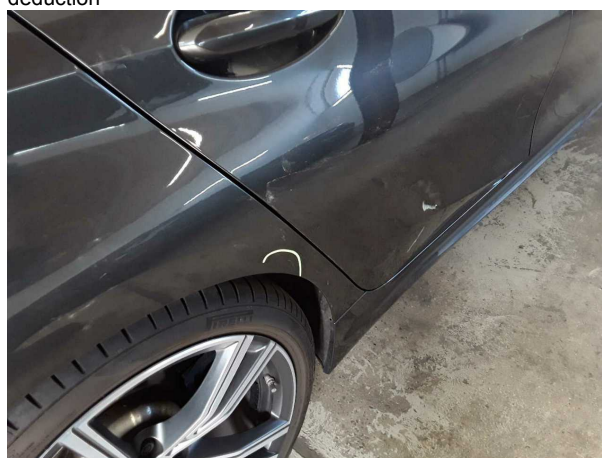
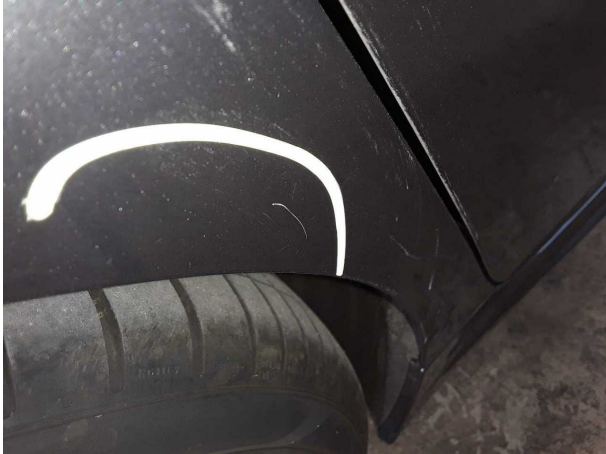
| No. | Component group | Description |
|---|---|---|
| 3 | Side panel - rear right side | Side panel - Scratch(es) - Cover / polish |

**Damage #3:** Side panel - rear right side: Side panel - Scratch(es) - Cover / polish

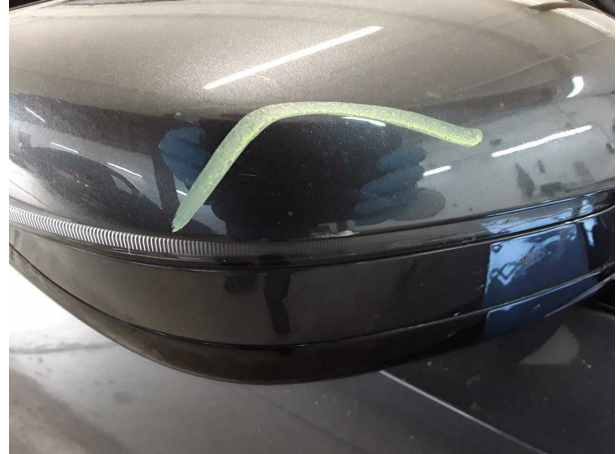
| No. | Component group | Description |
|---|---|---|
| 5 | Wing mirror - right side | Cap - Scratched - Smart repair |

**Damage #5:** Wing mirror - right side: Cap - Scratched - Smart repair

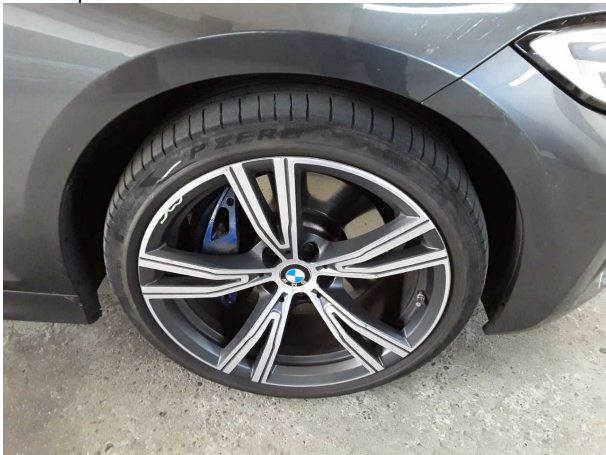
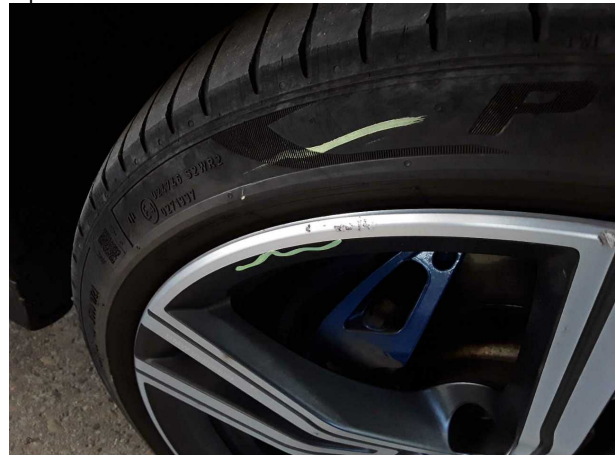
| No. | Component group | Description |
|---|---|---|
| 6 | Wheel / tyres | Alloy rim - front right side - Scratched - Loss in value |

**Damage #6:** Wheel / tyres: Alloy rim - front right side - Scratched - Loss in value

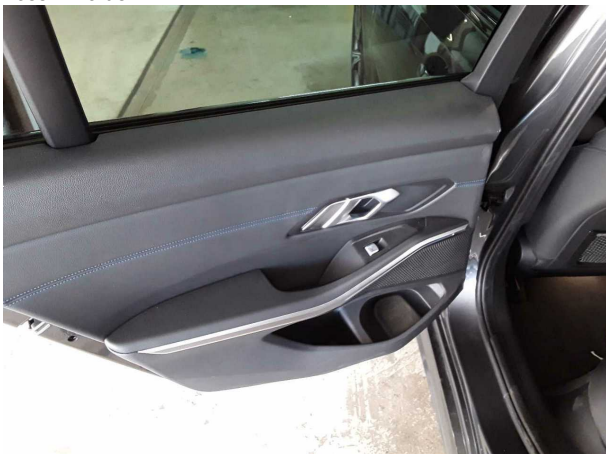
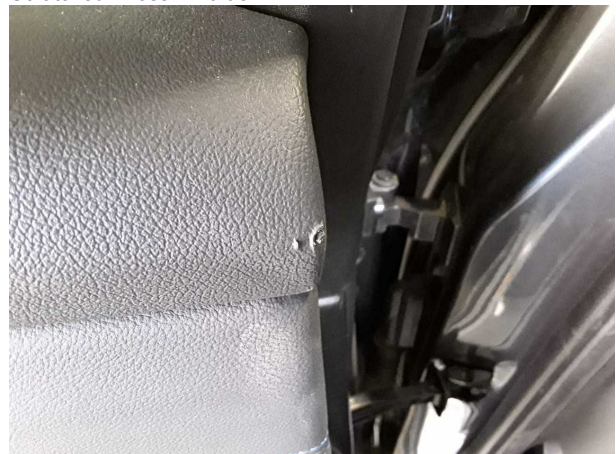
| No. | Component group | Description |
|---|---|---|
| 8 | Trim / covers | Door trim - rear left side - Damaged - Replace |

**Damage #8:** Trim / covers: Door trim - rear left side - Damaged - Replace

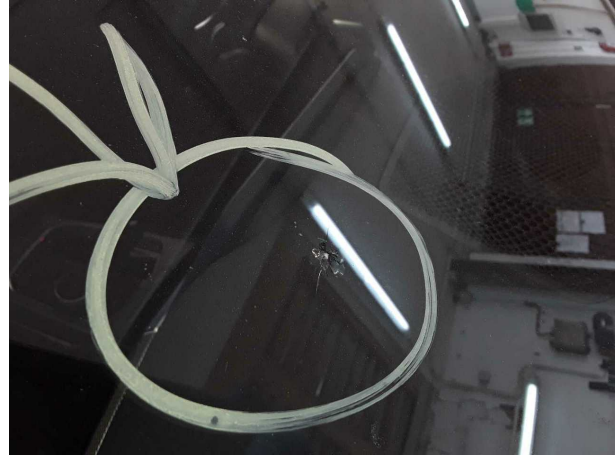
| No. | Component group | Description |
|---|---|---|
| 9 | Vehicle glazing | Windscreen (Rissbildung) - Stone chips - Replace |

**Damage #9:** Vehicle glazing: Windscreen (Rissbildung) - Stone chips - Replace
