WAUZZZF54LA020770

| Type / Model | A5 Sportback | Main inspection (Read from ZBI) | 08/2025 |

## Zustandsbericht

Inspection date: 28 Apr 2025

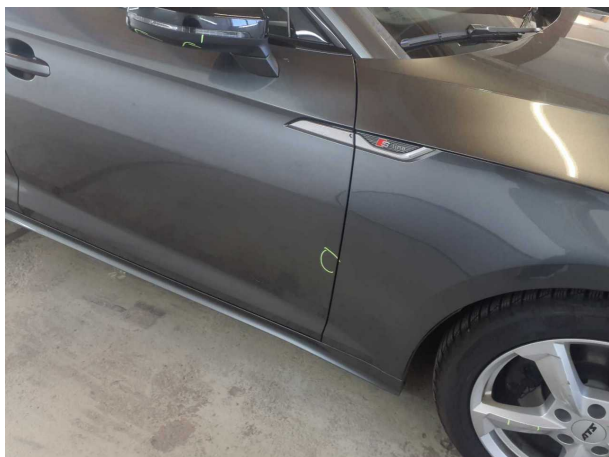
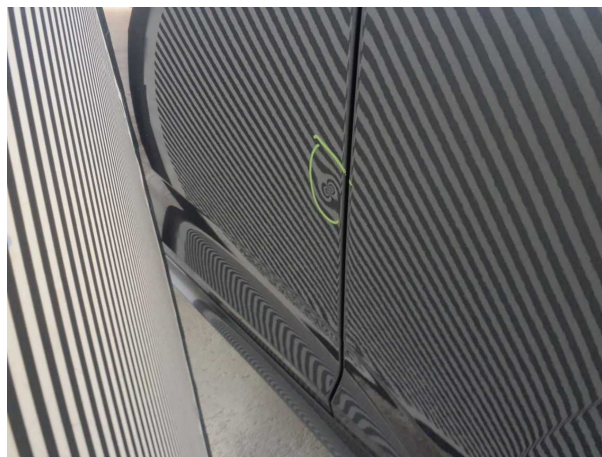
| No. | Component group | Description |
|---|---|---|
| 1 | Door - front right side | Door - dent(s) - Smooth repair work |

**Damage #1:** Door - front right side: Door - dent(s) - Smooth repair work

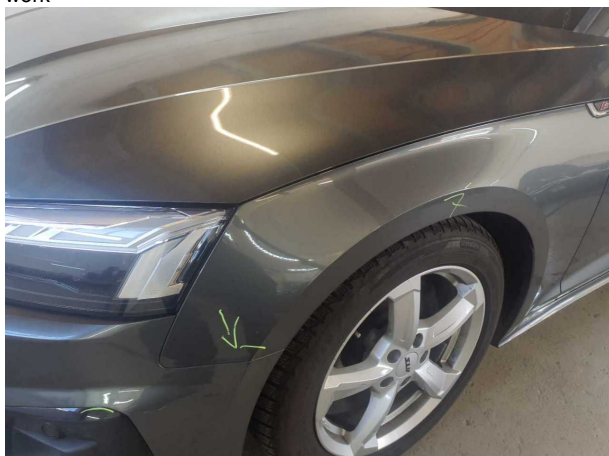
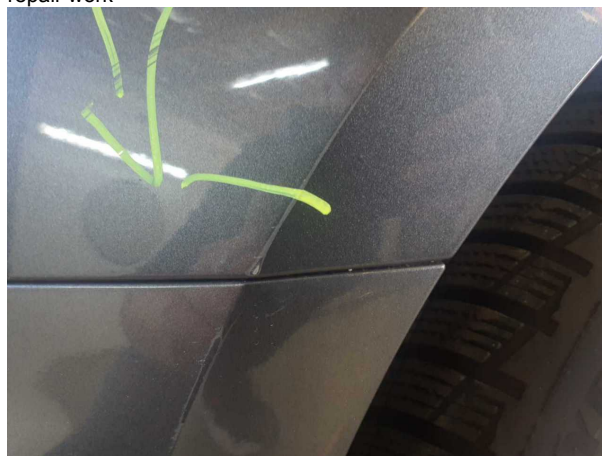
| No. | Component group | Description |
|---|---|---|
| 2 | Mudguard - left side | Mudguard - left side - Scratched - Smart repair |

**Damage #2:** Mudguard - left side: Mudguard - left side - Scratched... Smart repair

**Damage #2:** Mudguard - left side: Mudguard - left side - Scratched - Smart repair

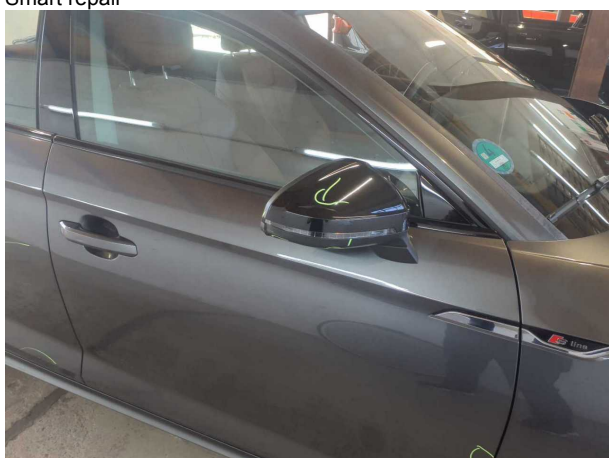
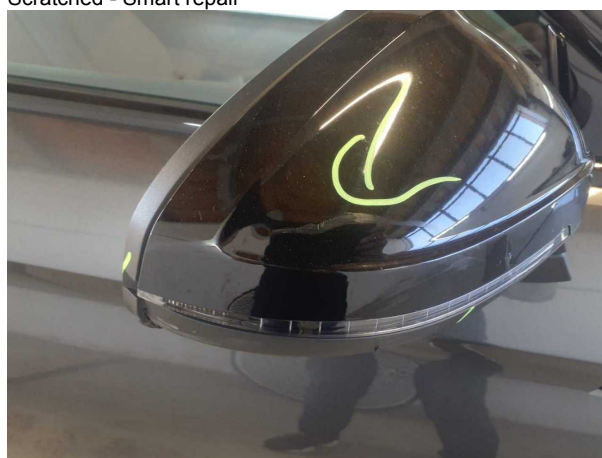
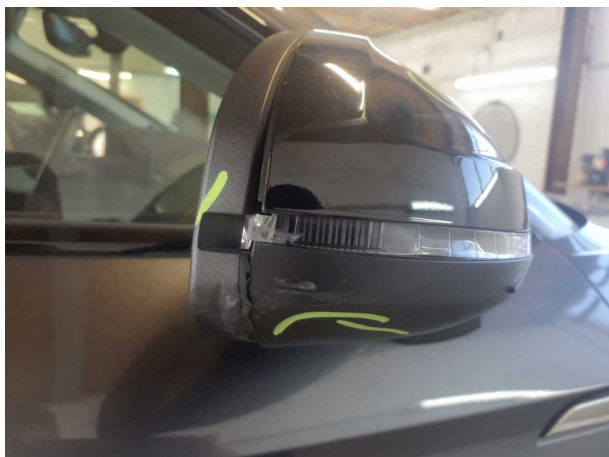
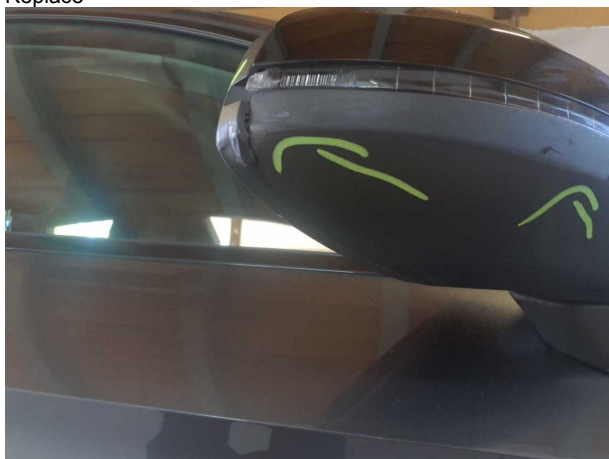
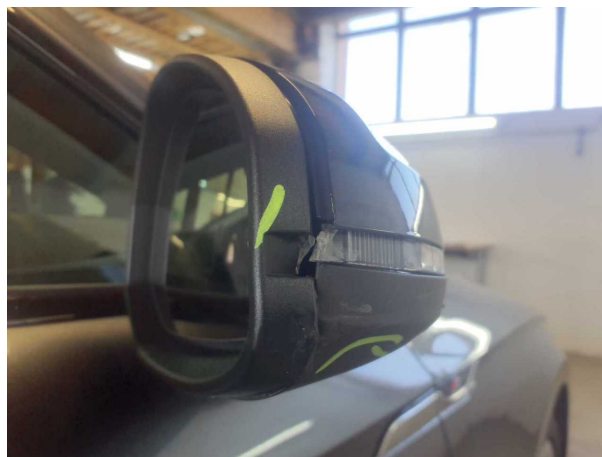
| No. | Component group | Description |
|---|---|---|
| 4 | Wing mirror - right side | Mirror housing - Damaged - Replace |

**Damage #4:** Wing mirror - right side: Mirror housing - Damaged - Replace

**Damage #4:** Wing mirror - right side: Mirror housing - Damag... - Replace

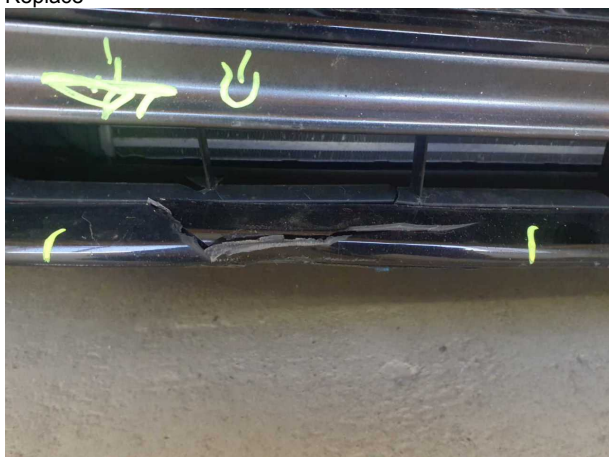
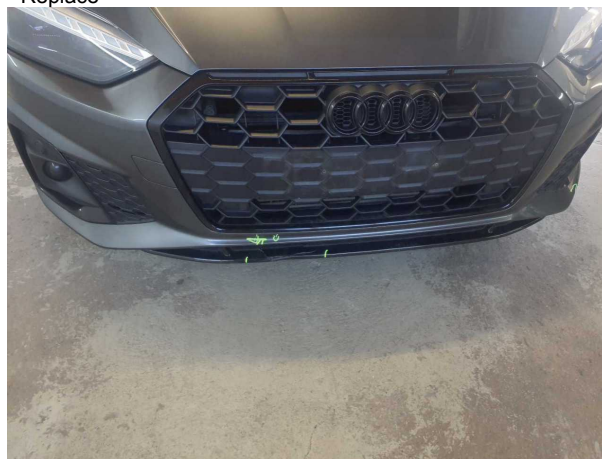
| No. | Component group | Description |
|---|---|---|
| 5 | Front bumper | Spoiler - Damaged - Replace |

**Damage #5:** Front bumper: Spoiler - Damaged - Replace

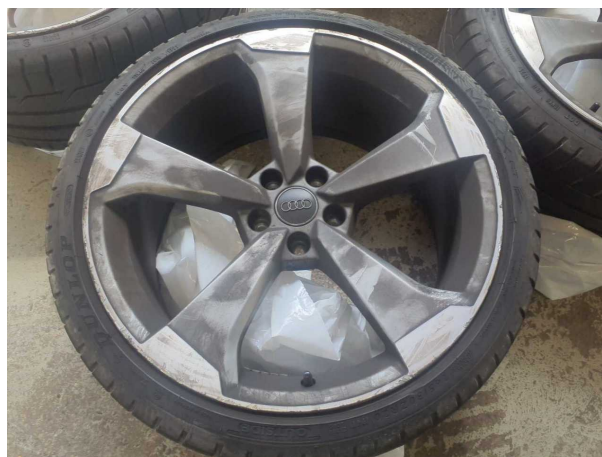
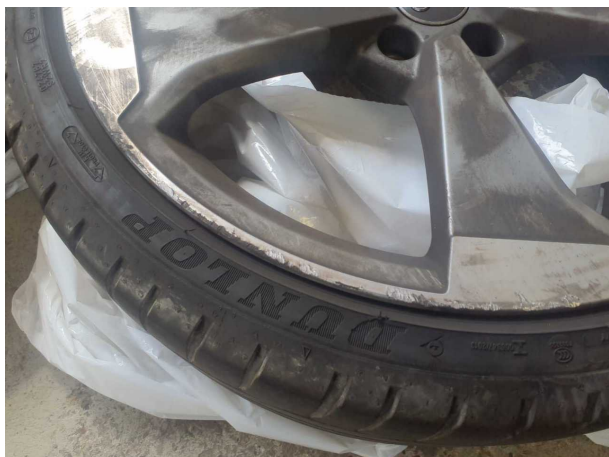
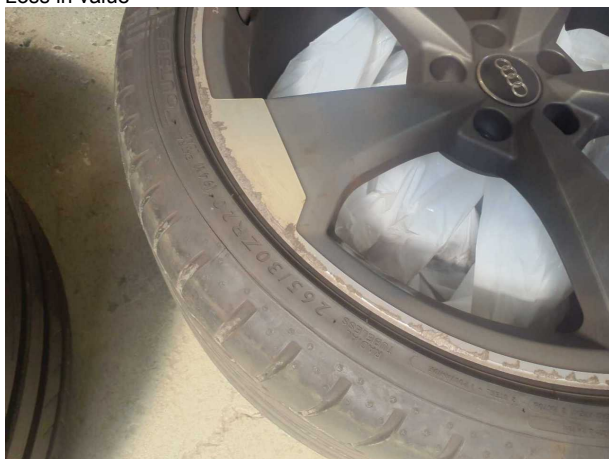
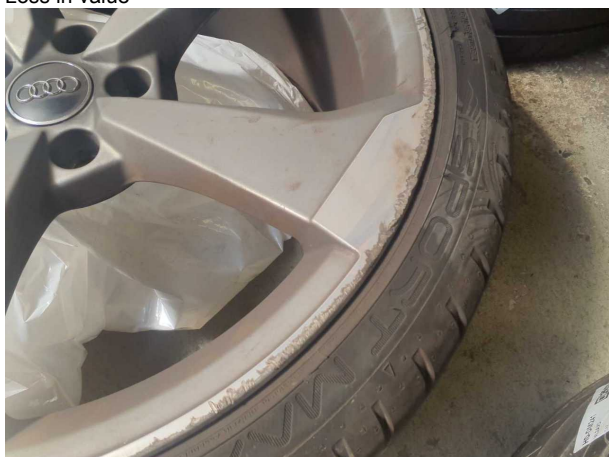
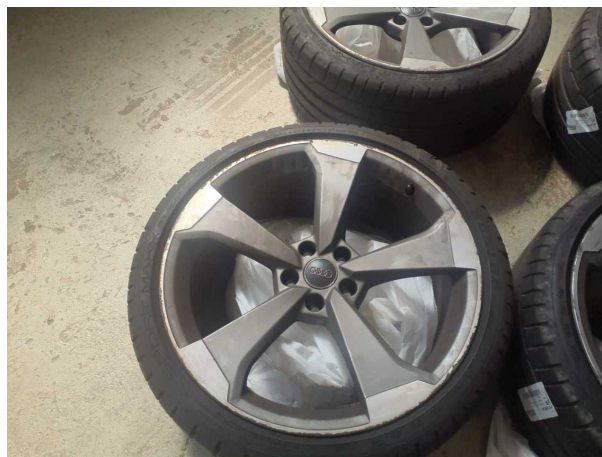
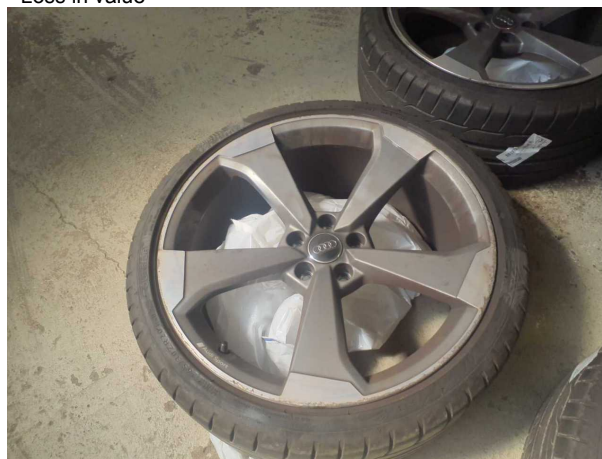
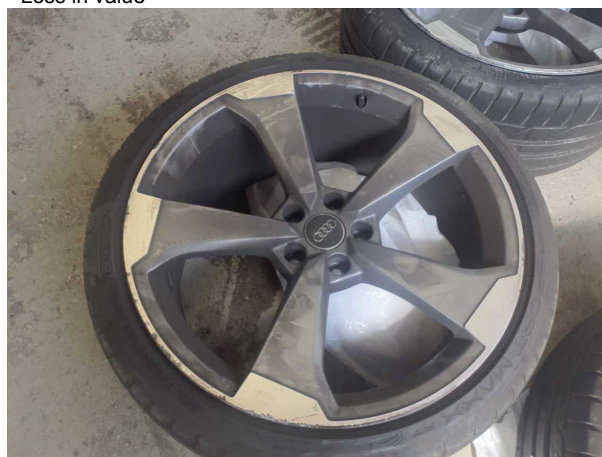
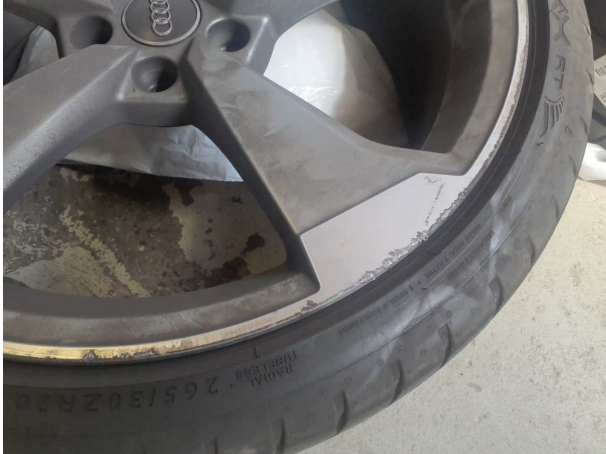
| No. | Component group | Description |
|---|---|---|
| 6 | 2nd wheel set | Alloy rim set - complete - Scratched - Loss in value |

**Damage #6:** 2nd wheel set: Alloy rim set - complete - Scratch... - Loss in value

**Damage #6:** 2nd wheel set: Alloy rim set - complete - Scratched - Loss in value

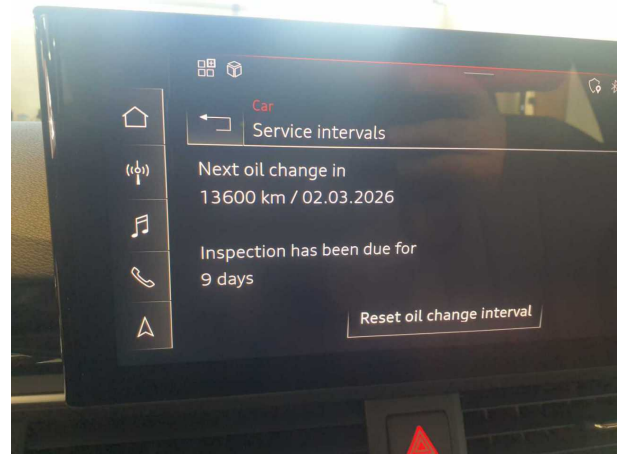
| No. | Component group | Description |
|---|---|---|
| 7 | Misc. | Inspection / maintenance - Due - Perform |

**Damage #7:** Misc.: Inspection / maintenance - Due - Perform

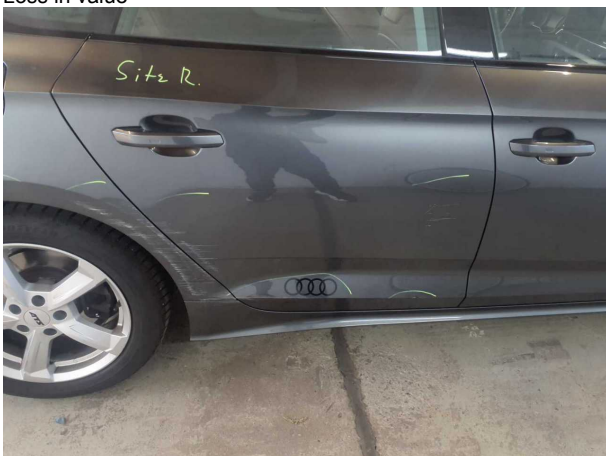
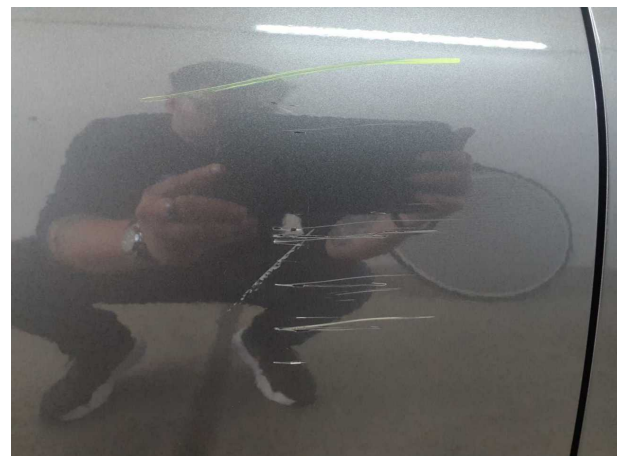
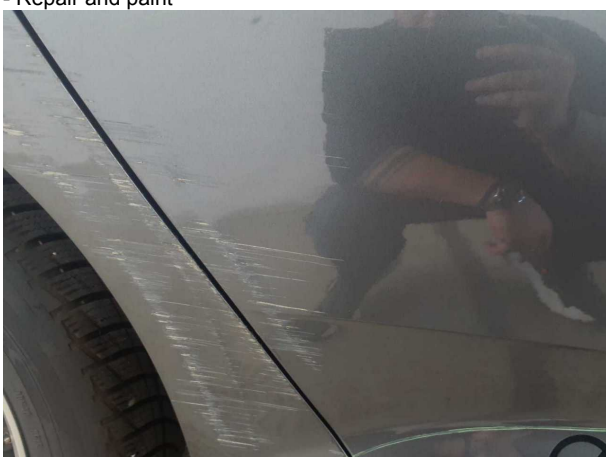
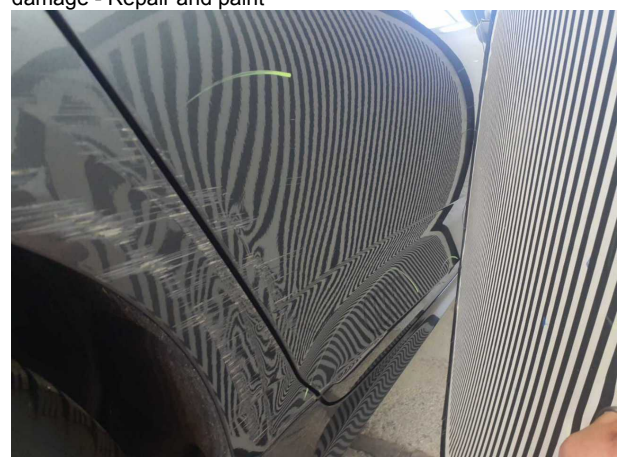
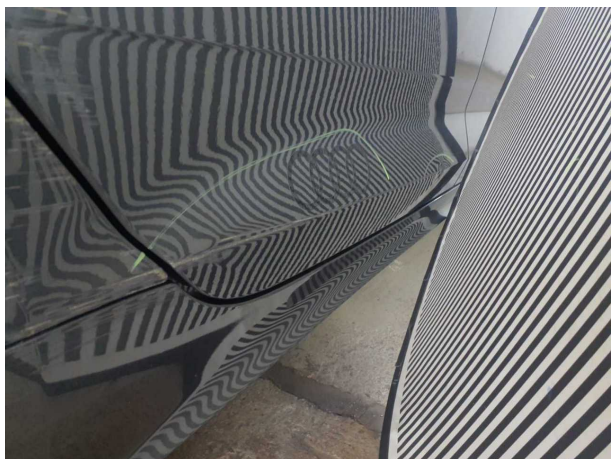
| No. | Component group | Description |
|---|---|---|
| 8 | Door - rear right side | Door - Dent / paintcoat damage - Repair and paint |

**Damage #8:** Door - rear right side: Door - Dent / paintcoat damage - Repair and paint

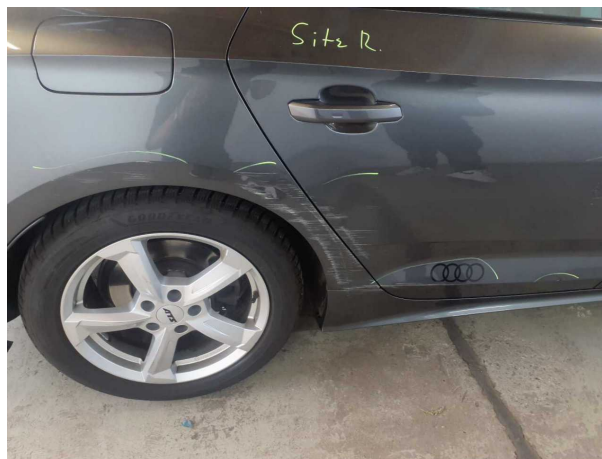
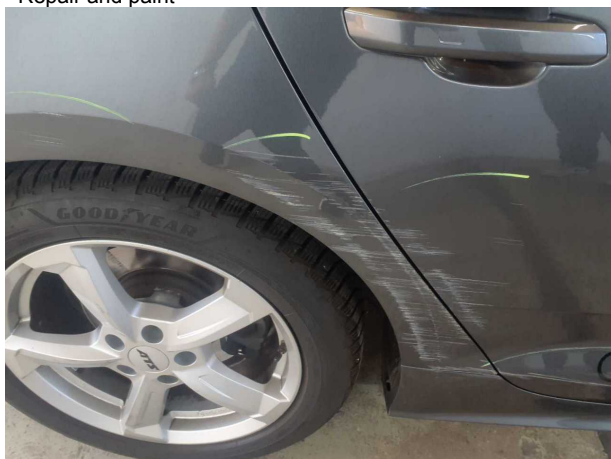
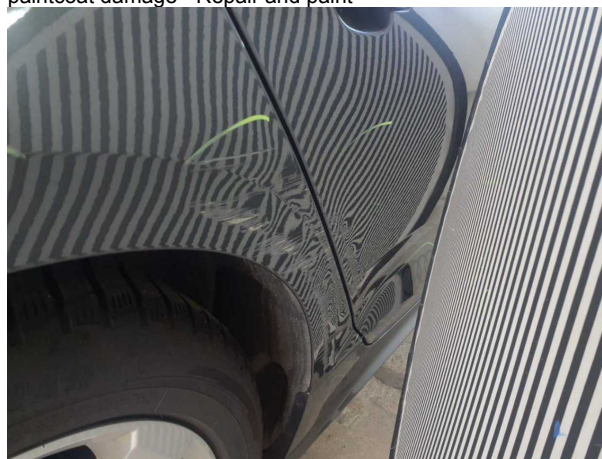
| No. | Component group | Description |
|---|---|---|
| 9 | Side panel - rear right side | Side panel - Dent / paintcoat damage - Repair and paint |

**Damage #9:** Side panel - rear right side: Side panel - Dent / paintcoat damage - Repair and paint

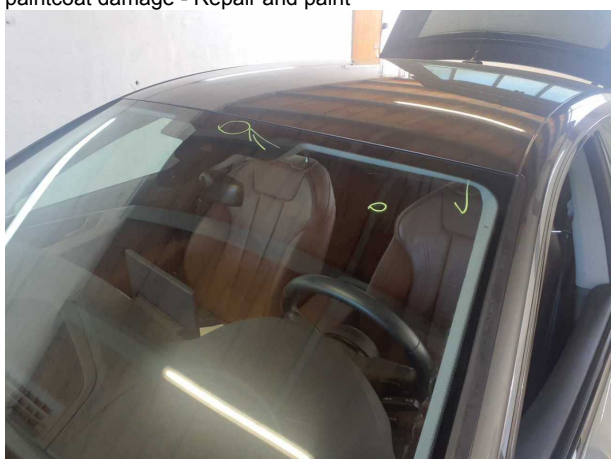
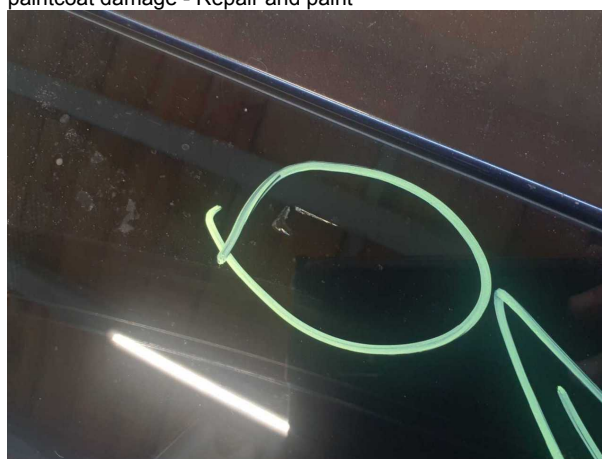
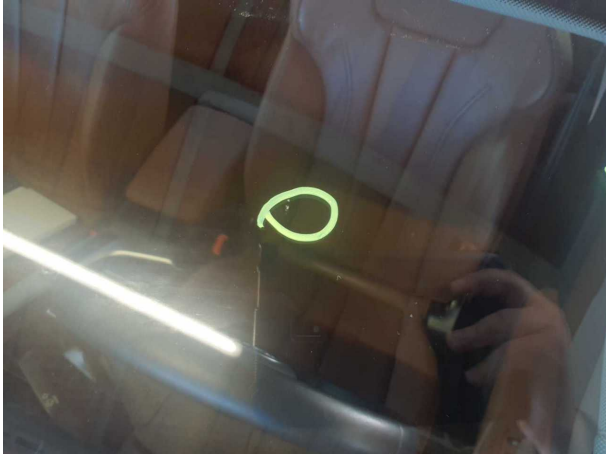
| No. | Component group | Description |
|---|---|---|
| 10 | Vehicle glazing | Windscreen with lane departure assistant (Mit Rissbildung) - Stone chips - Replace |

**Damage #10:** Vehicle glazing: Windscreen with lane departure assistant (Mit Rissbildung) - Stone chips - Replace

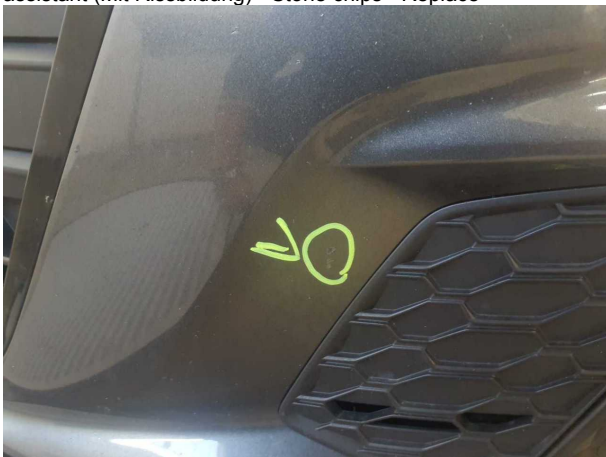
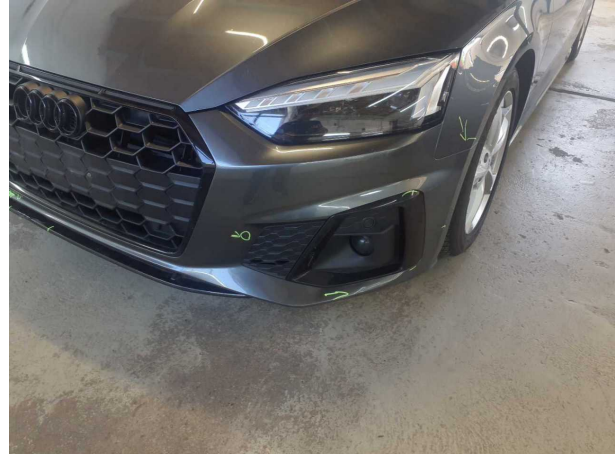
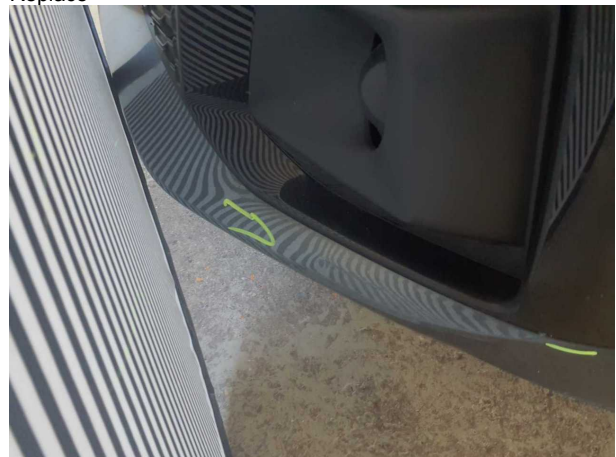
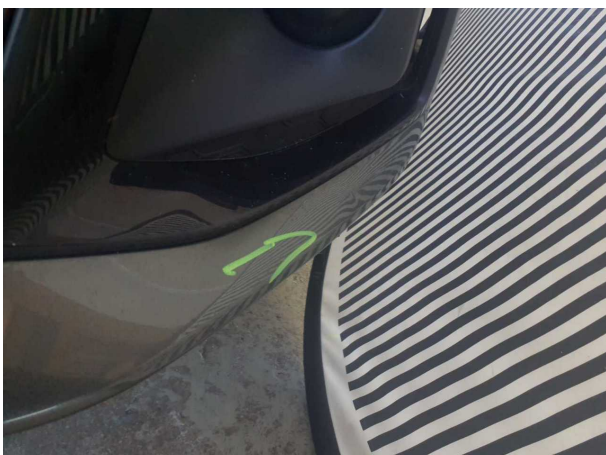
| No. | Component group | Description |
|---|---|---|
| 11 | Front bumper | Front bumper - Deformed - Replace |

**Damage #11:** Front bumper: Front bumper - Deformed - Replace
