**WAUZZZFY5N2010658**

## Vehicle details

## Zustandsbericht

**Protocol number:** 39500964

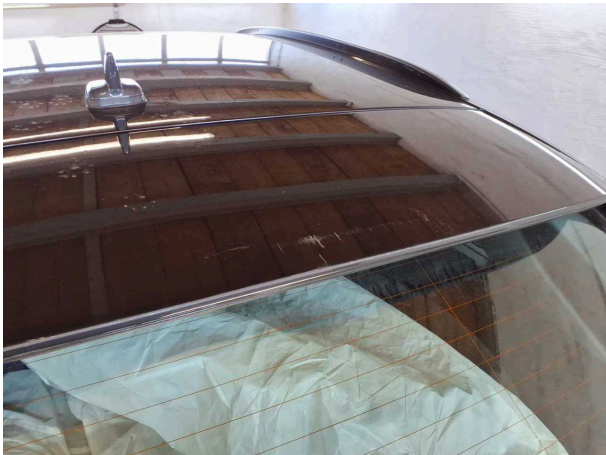
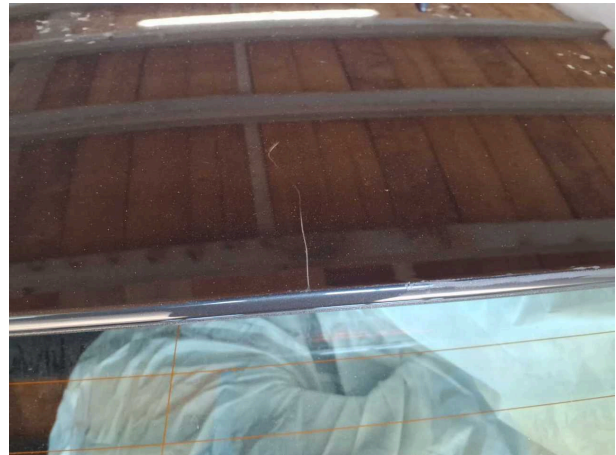
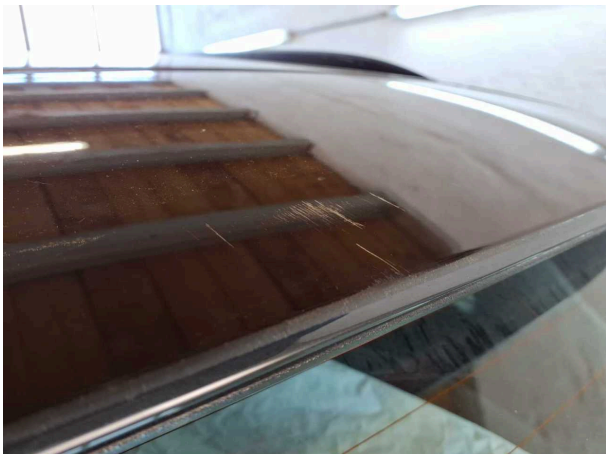
| No. | Component group | Description |
|---|---|---|
| 2 | Boot lid / rear door | Rear spoiler - Scratch(es) - Paint |

**Damage #2:** Boot lid / rear door: Rear spoiler - Scratch(es) - Paint

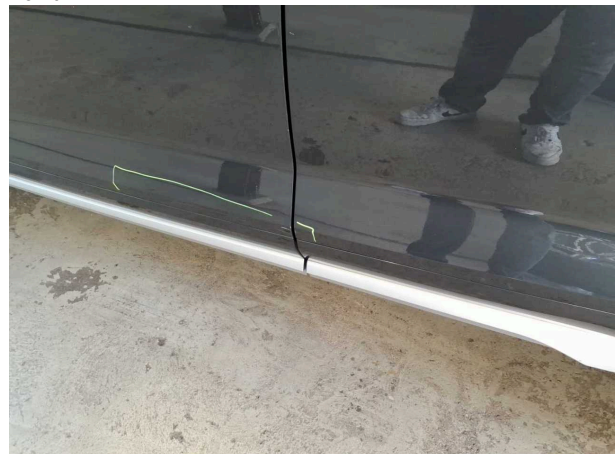
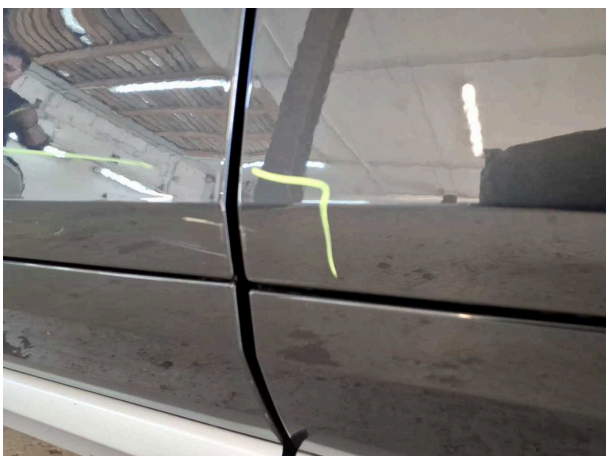
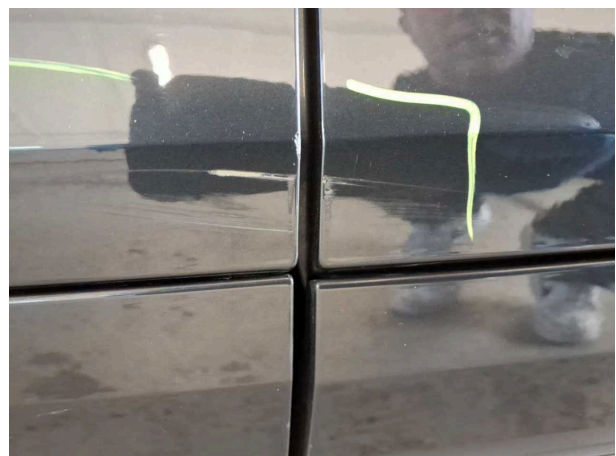
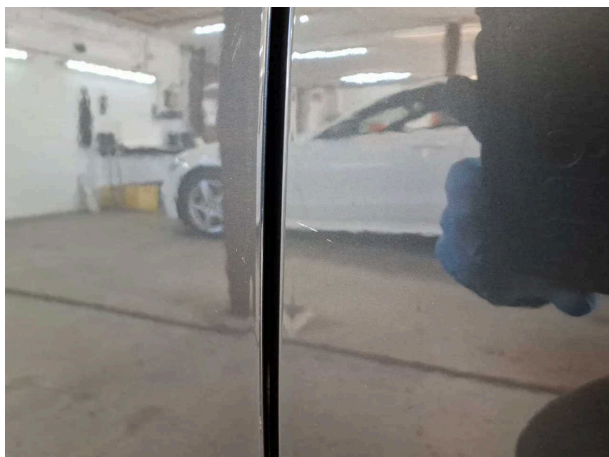
| No. | Component group | Description |
|---|---|---|
| 3 | Door - rear left side | Door - Scratch(es) - Paint |

**Damage #3:** Door - rear left side: Door - Scratch(es) - Paint

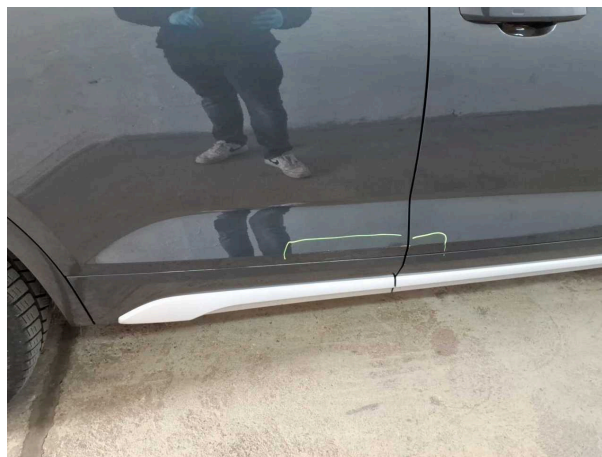
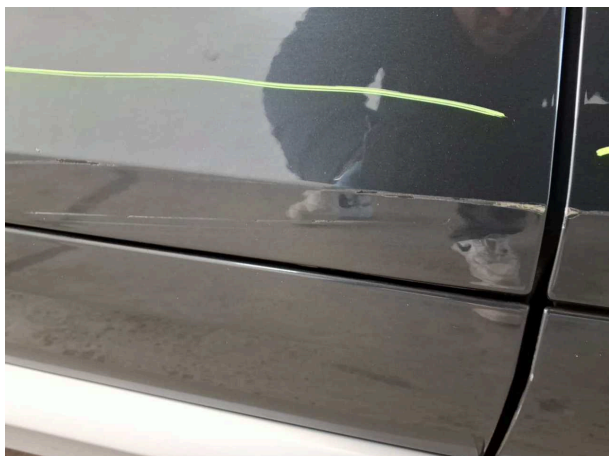
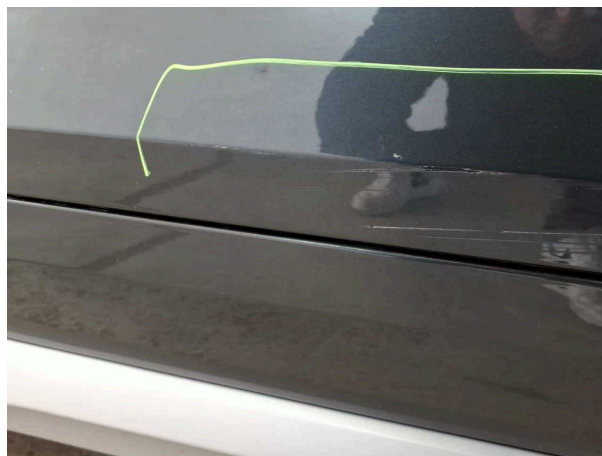
| No. | Component group | Description |
|---|---|---|
| 4 | Door - rear right side | Door - Scratch(es) - Paint |

**Damage #4:** Door - rear right side: Door - Scratch(es) - Paint

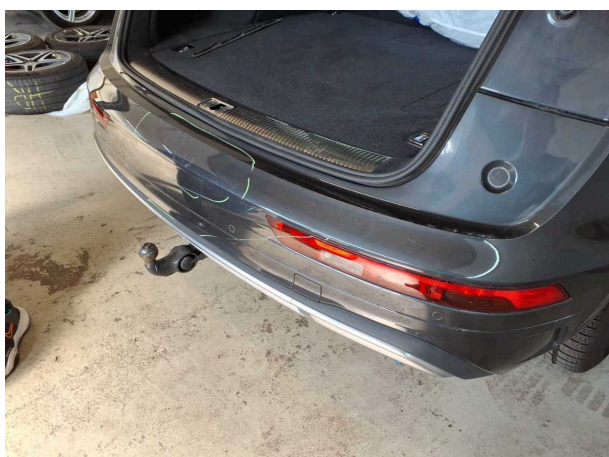
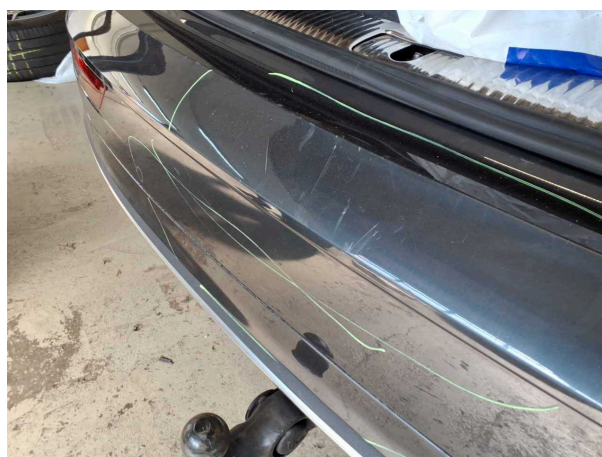
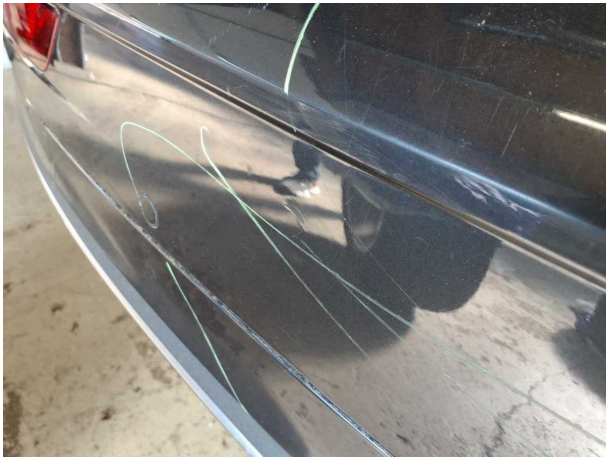
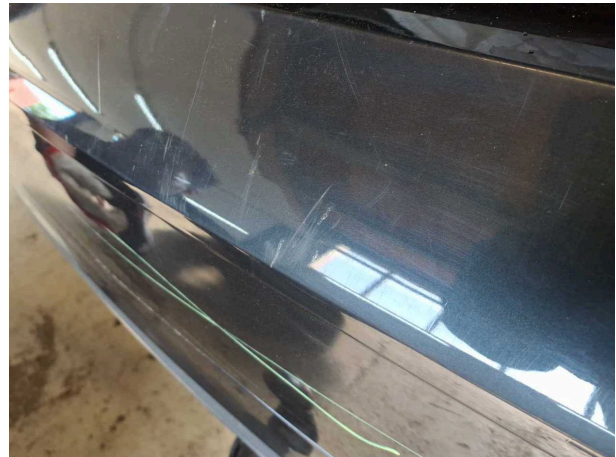
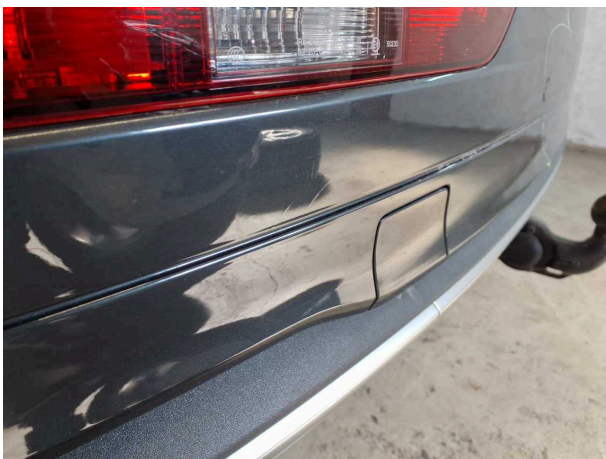
| No. | Component group | Description |
|---|---|---|
| 5 | Rear bumper | Rear bumper - Scratch(es) - Paint |

**Damage #5:** Rear bumper: Rear bumper - Scratch(es) - Paint

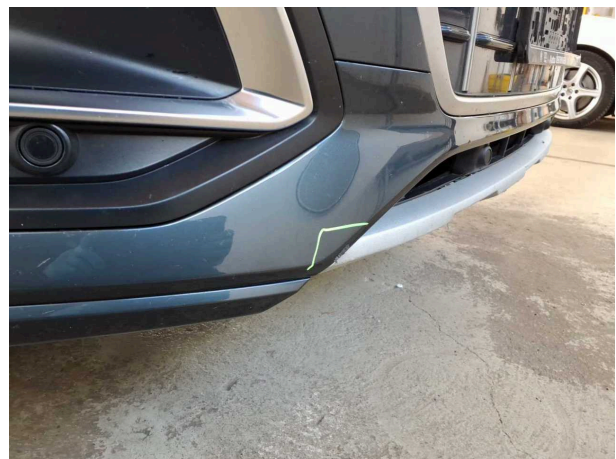
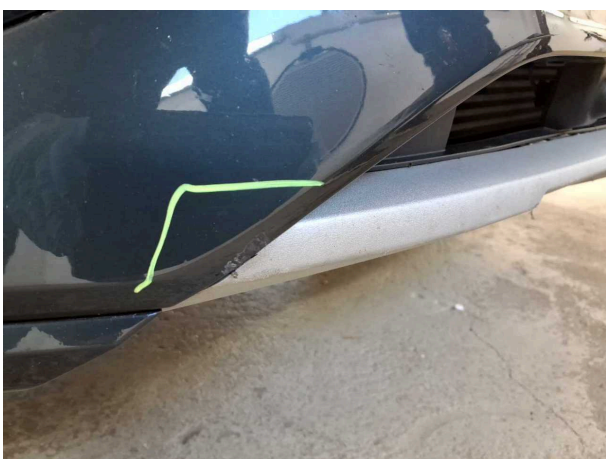
| No. | Component group | Description |
|---|---|---|
| 6 | Front bumper | Front bumper - Scratch(es) - Paint |

**Damage #6:** Front bumper: Front bumper - Scratch(es) - Paint

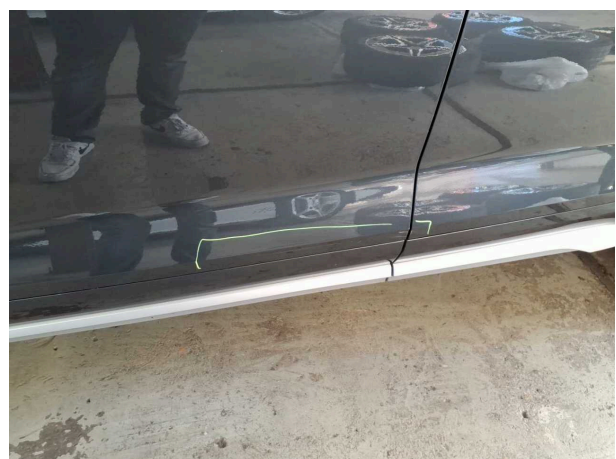
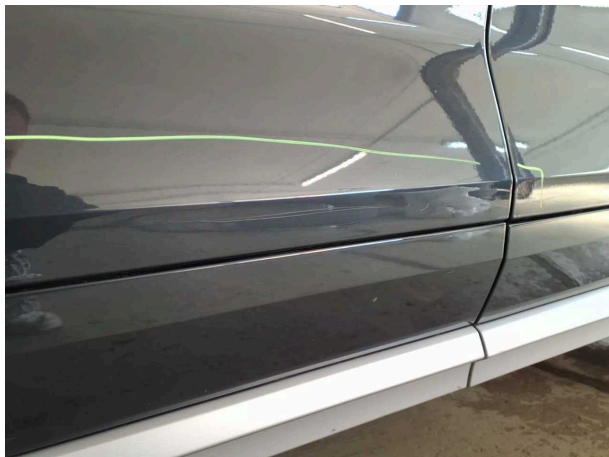
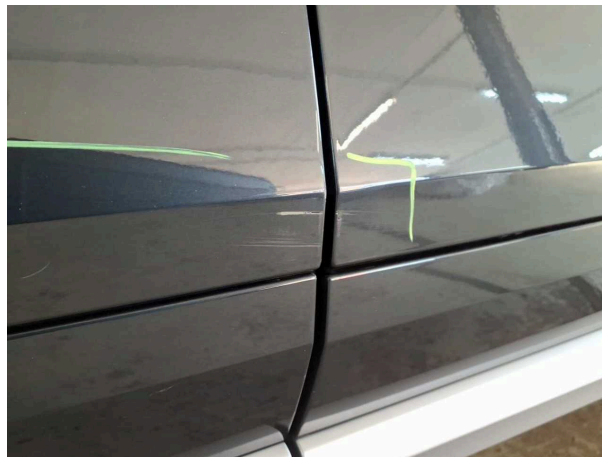
| No. | Component group | Description |
|---|---|---|
| 7 | Door - front left side | Door - Scratch(es) - Paint |

**Damage #7:** Door - front left side: Door - Scratch(es) - Paint

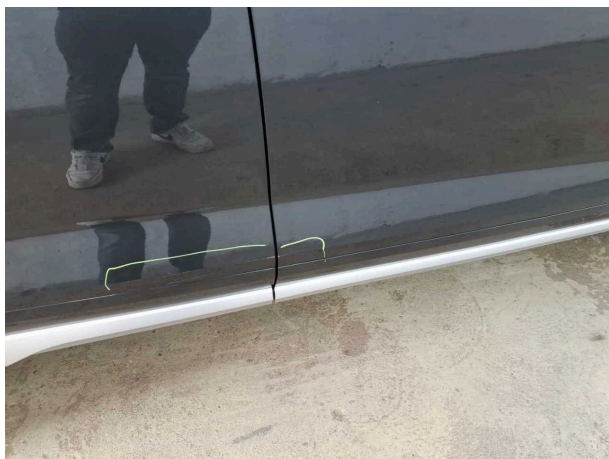
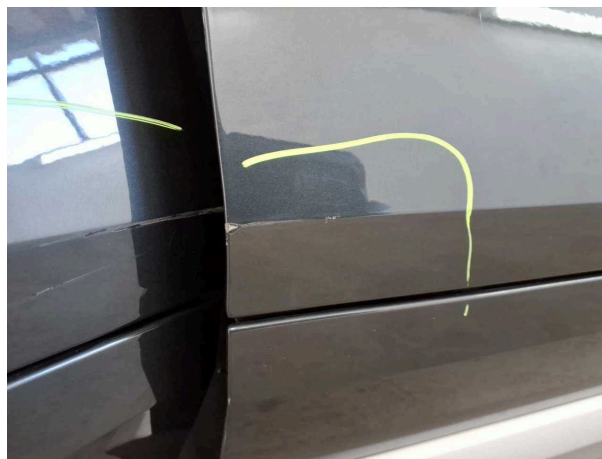
| No. | Component group | Description |
|---|---|---|
| 8 | Door - front right side | Door - Scratch(es) - Paint |

**Damage #8:** Door - front right side: Door - Scratch(es) - Paint

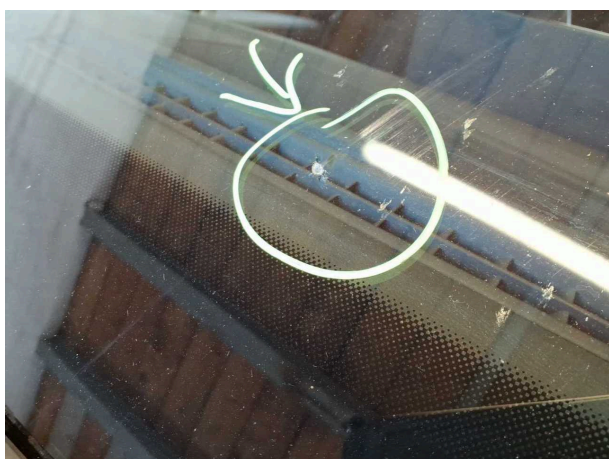
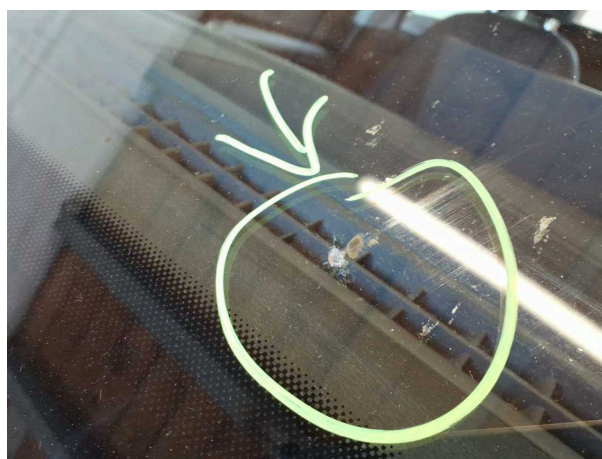
| No. | Component group | Description |
|---|---|---|
| 9 | Vehicle glazing | Windscreen with lane departure assistant - Broken / torn - Replace |

**Damage #9:** Vehicle glazing: Windscreen with lane departure assistant - Broken / torn - Replace
