WAUZZZFZXPP069543

## Vehicle details

## Zustandsbericht

Inspection date: 16 May 2025  
**Protocol number:** 39749977  
Delivery date: 16 May 2025

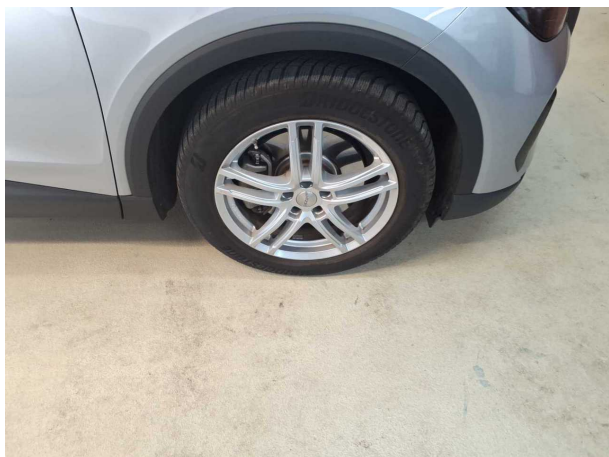
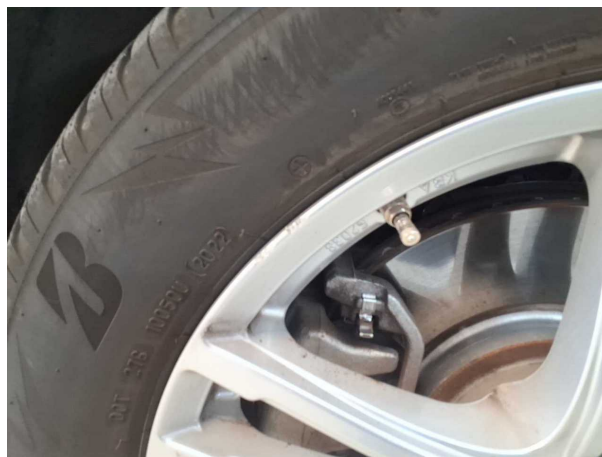
| No. | Component group | Description |
|---|---|---|
| 2 | Wheel / tyres | Alloy rim - front right side - Scratched - No deduction |

**Damage #2:** Wheel / tyres: Alloy rim - front right side - Scratched - No deduction

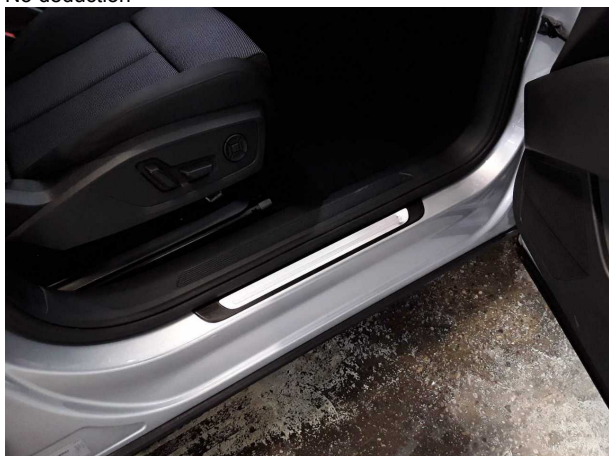
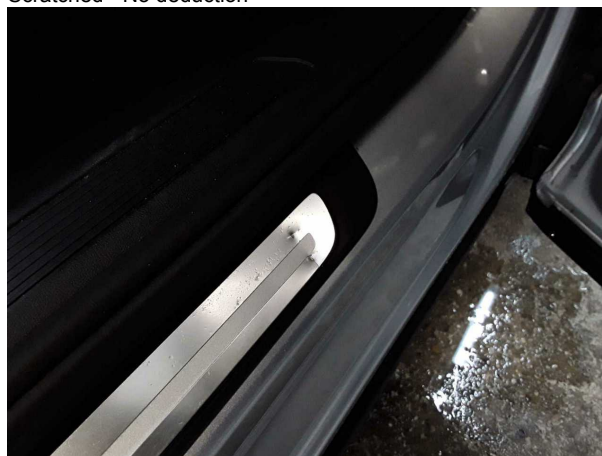
| No. | Component group | Description |
|---|---|---|
| 3 | Trim / covers | Sill - front right side - dent(s) - Replace |

**Damage #3:** Trim / covers: Sill - front right side - dent(s) - Replace

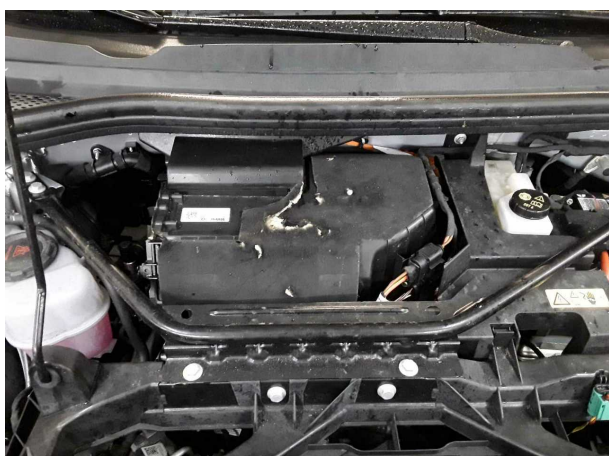
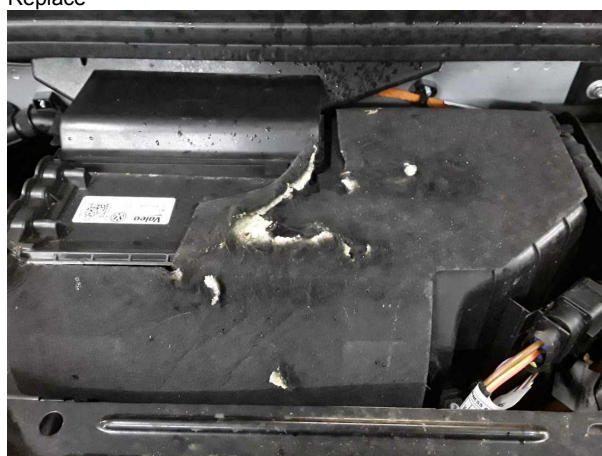
| No. | Component group | Description |
|---|---|---|
| 4 | Engine | Engine cover - top / cover - Damage caused by marten / rodent - Replace |

**Damage #4:** Engine: Engine cover - top / cover - Damage caused by marten / rodent - Replace

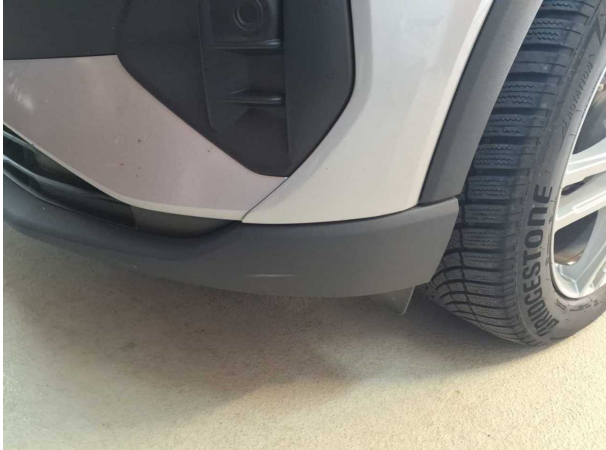
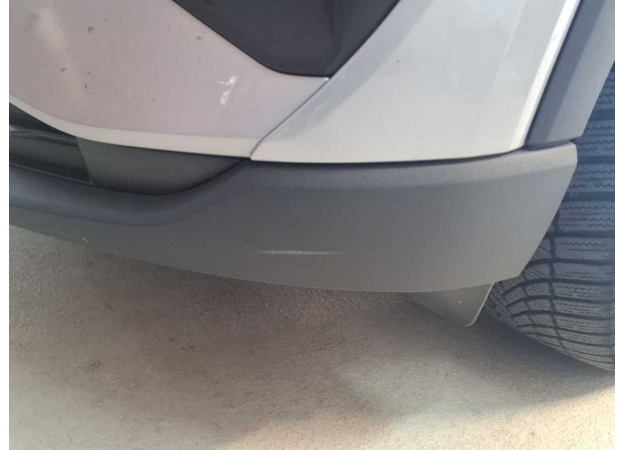
| No. | Component group | Description |
|---|---|---|
| 5 | Front bumper | Spoiler - Scratch(es) - Loss in value |

**Damage #5:** Front bumper: Spoiler - Scratch(es) - Loss in value

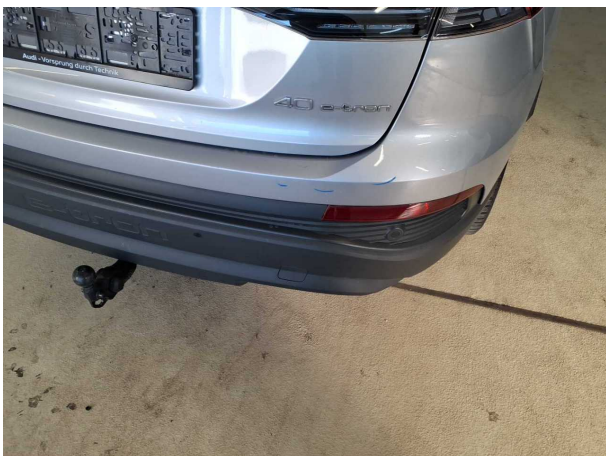
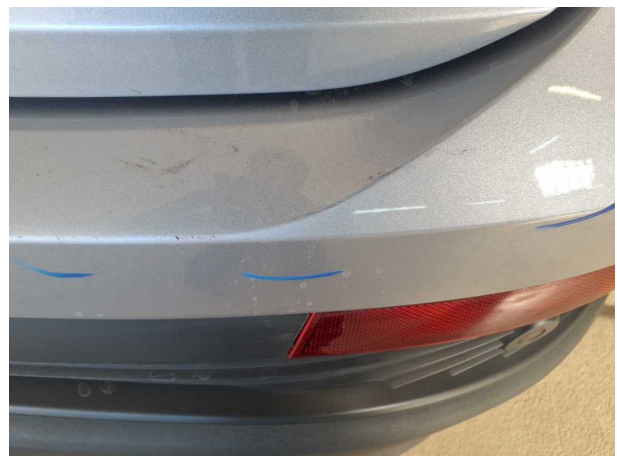
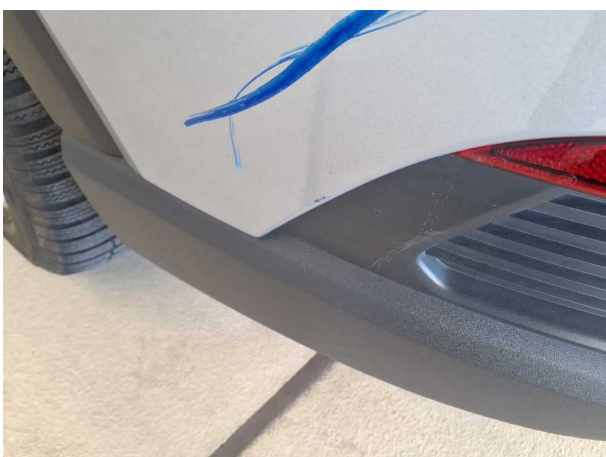
| No. | Component group | Description |
|---|---|---|
| 6 | Rear bumper | Rear bumper - Scratched - Smart repair |

**Damage #6:** Rear bumper: Rear bumper - Scratched - Smart repair
