WBA6K51030FJ86093

## Vehicle details

## Zustandsbericht

Inspection date: 6 May 2025  
**Protocol number: 39579892**  
Delivery date: 6 May 2025

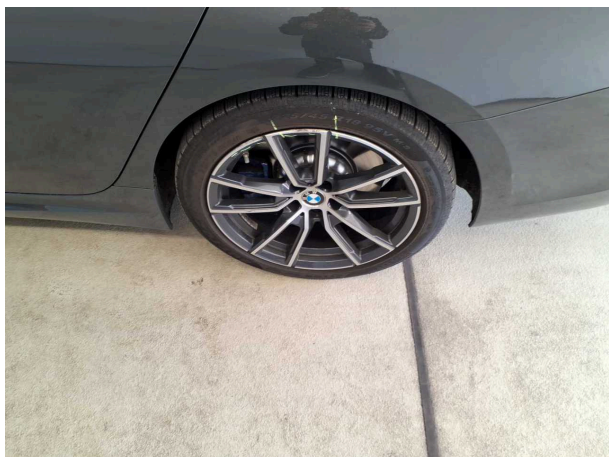
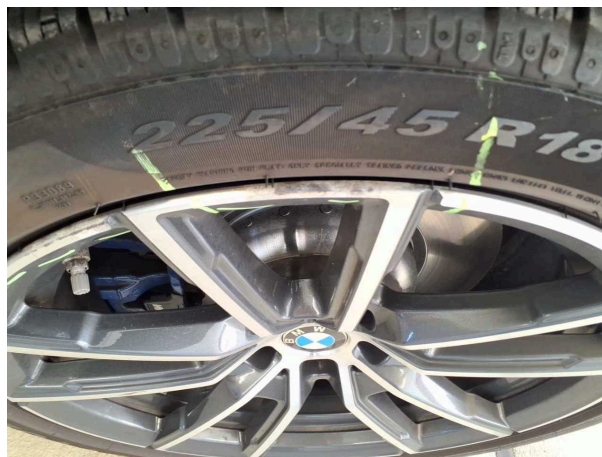
**Damage #2:** Wheel / tyres: Alloy rim - rear left side - Scratched - ...  
deduction

**Damage #2:** Wheel / tyres: Alloy rim - rear left side - Scratched  
- No deduction

| No. | Component group | Description |
|---|---|---|
| 2 | Wheel / tyres | Alloy rim - rear left side - Scratched - No deduction |

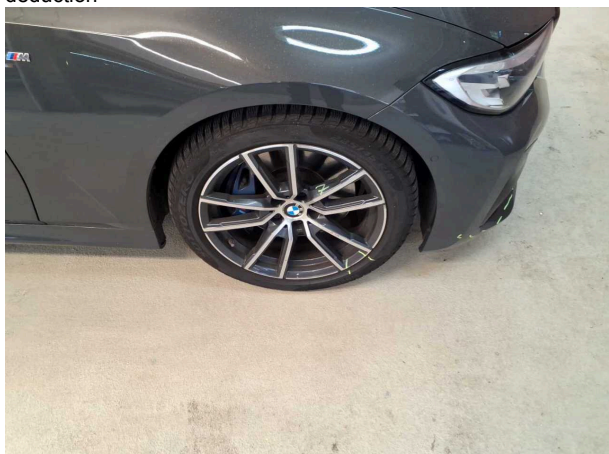
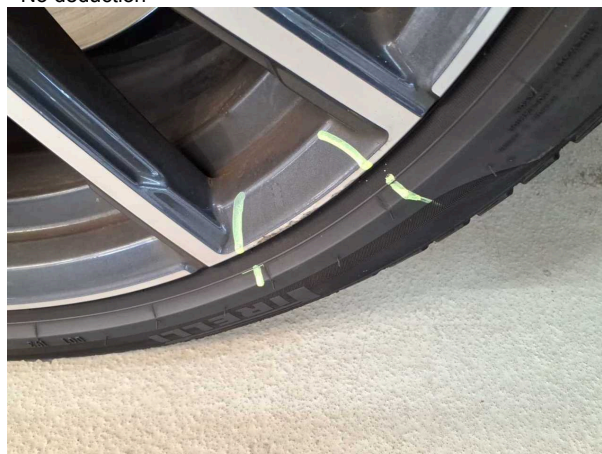
**Damage #3:** Wheel / tyres: Alloy rim - front right side - Scratched -  
No deduction

**Damage #3:** Wheel / tyres: Alloy rim - front right side -  
Scratched - No deduction

| No. | Component group | Description |
|---|---|---|
| 3 | Wheel / tyres | Alloy rim - front right side - Scratched - No deduction |

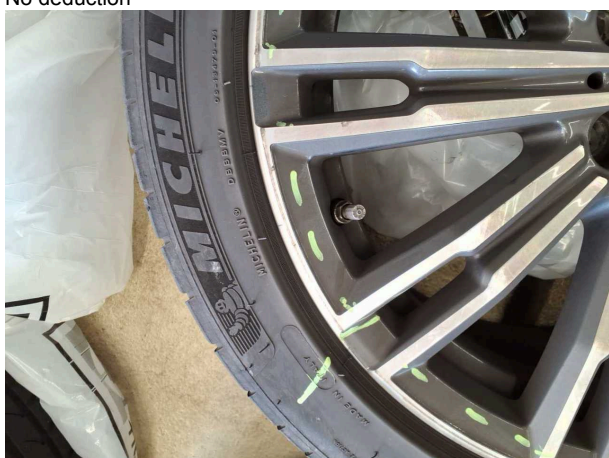
**Damage #6:** 2nd wheel set: 1 alloy rim - Scratched - Loss in value

| No. | Component group | Description |
|---|---|---|
| 6 | 2nd wheel set | 1 alloy rim - Scratched - Loss in value |

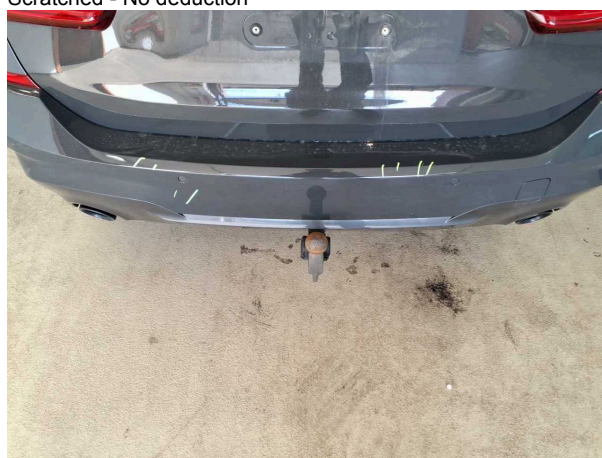
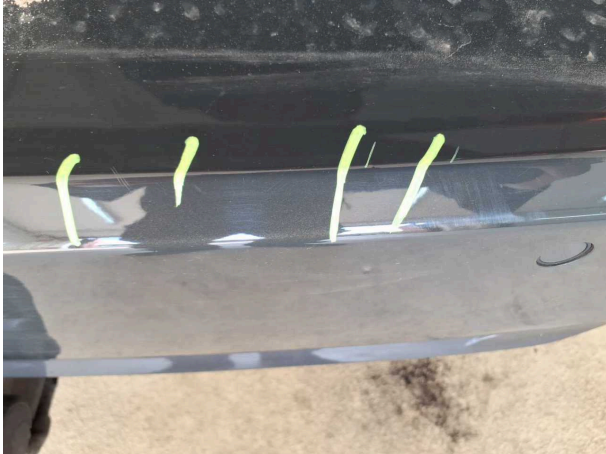
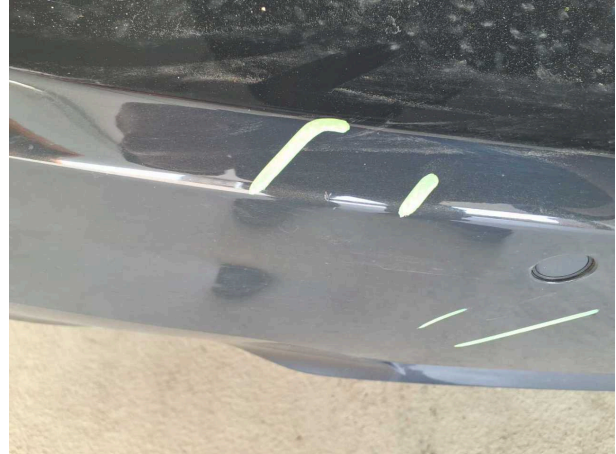
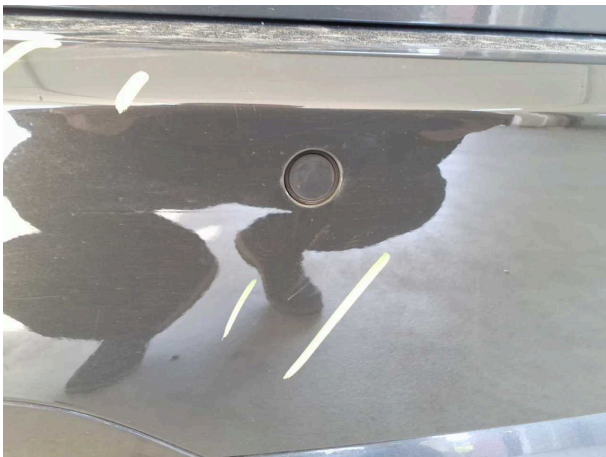
**Damage #7:** Rear bumper: Rear bumper - Scratched - Smart  
repair

**Damage #7:** Rear bumper: Rear bumper - Scratched - Smart repair

| No. | Component group | Description |
|---|---|---|
| 7 | Rear bumper | Rear bumper - Scratched - Smart repair |

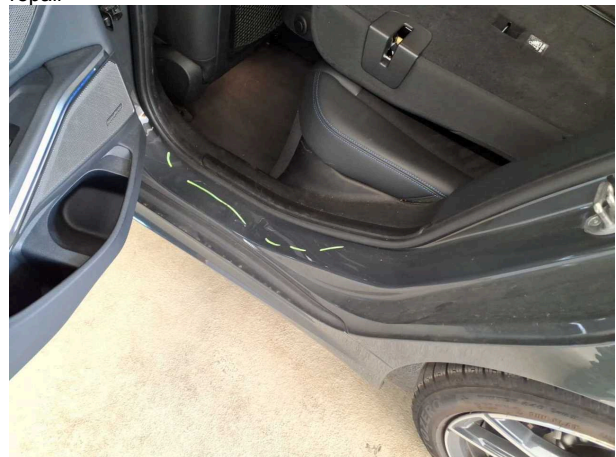
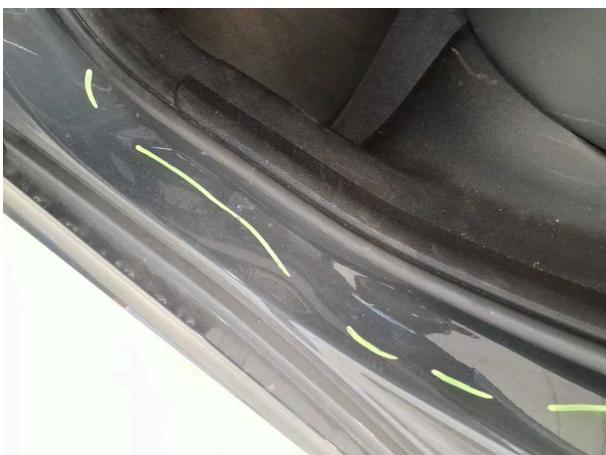
**Damage #8:** Side panel - rear left side: Sill - Scratched - Smart repair

| No. | Component group | Description |
|---|---|---|
| 8 | Side panel - rear left side | Sill - Scratched - Smart repair |

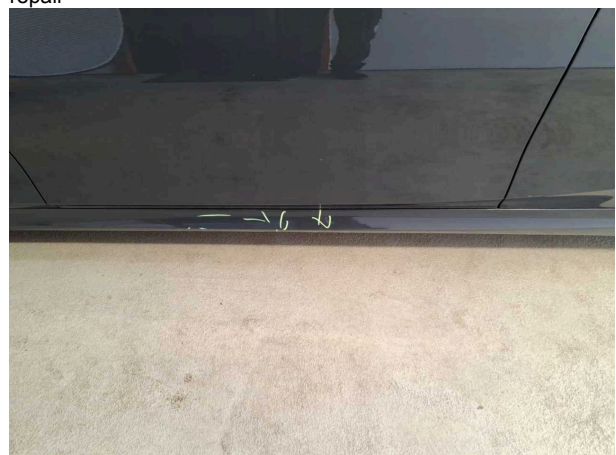
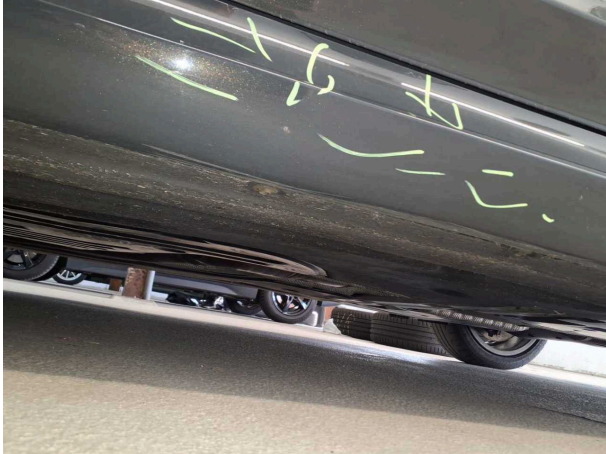
**Damage #9:** Sill - left side: Trim - Scratched - Smart repair

| No. | Component group | Description |
|---|---|---|
| 9 | Sill - left side | Trim - Scratched - Smart repair |

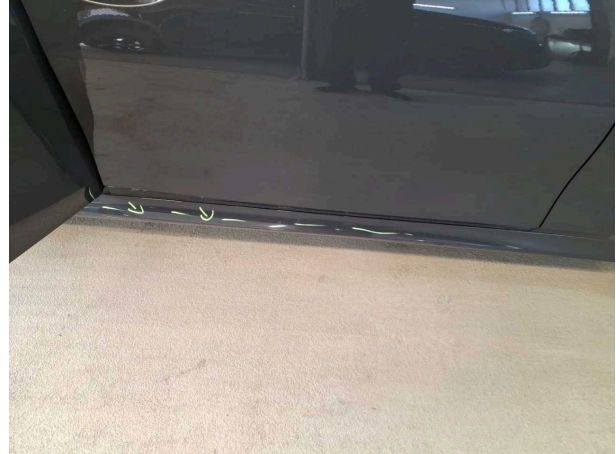
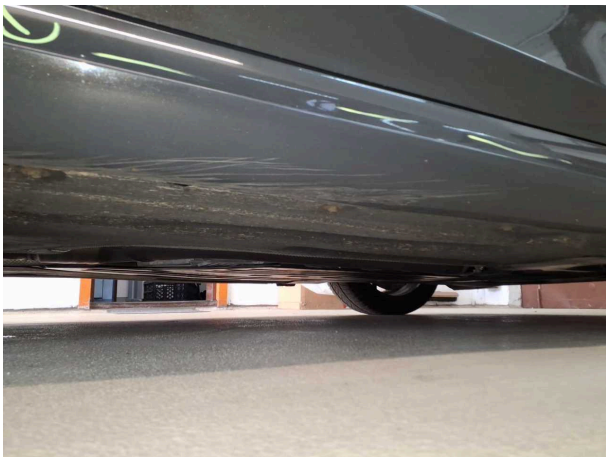
**Damage #10:** Sill - right side: Trim - Scratched - Smart repair

| No. | Component group | Description |
|---|---|---|
| 10 | Sill - right side | Trim - Scratched - Smart repair |

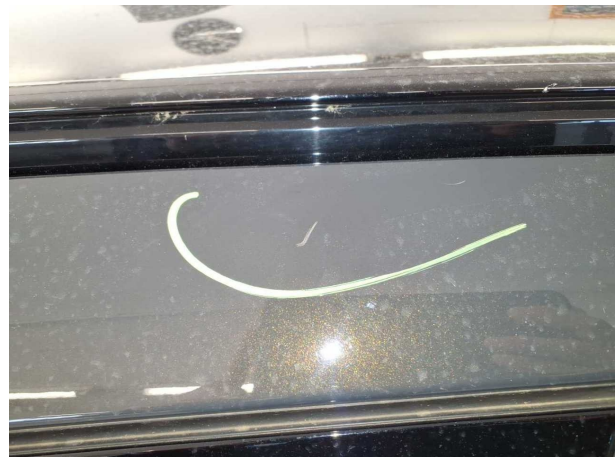
**Damage #11:** Roof: Roof rail - right side - Scratched - Smart repair

| No. | Component group | Description |
|---|---|---|
| 11 | Roof | Roof rail - right side - Scratched - Smart repair |

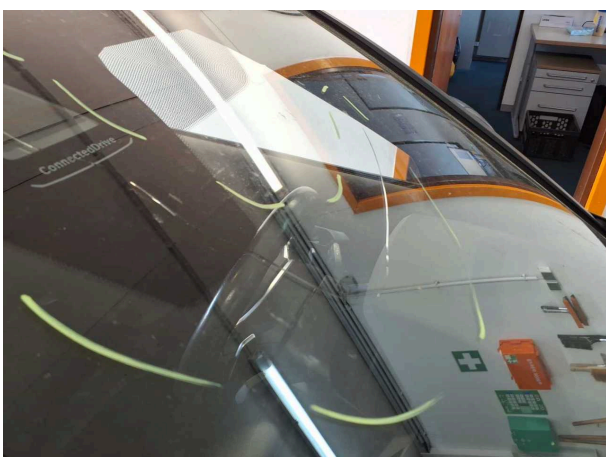
**Damage #12:** Vehicle glazing: Windscreen - Damaged - Replace

| No. | Component group | Description |
|---|---|---|
| 12 | Vehicle glazing | Windscreen - Damaged - Replace |

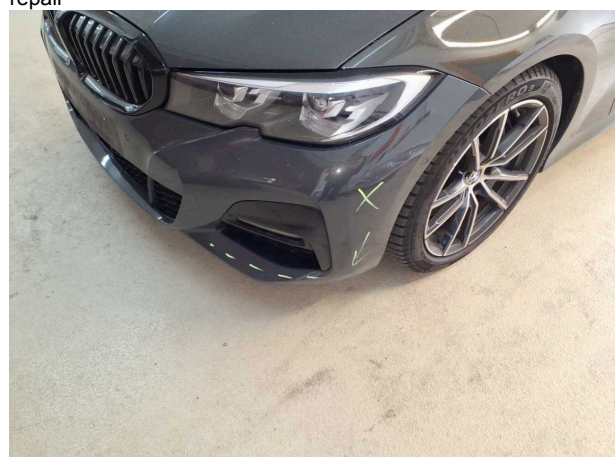
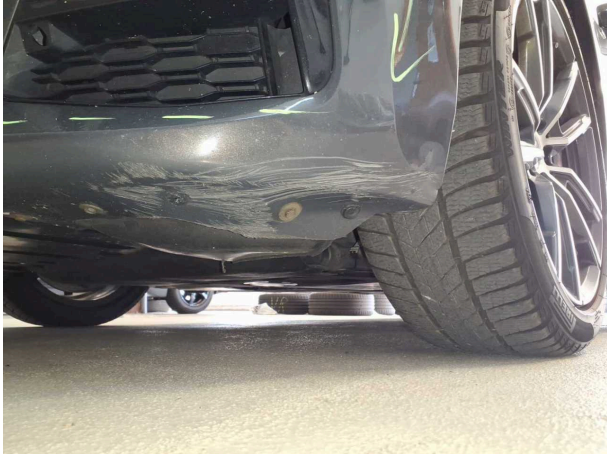
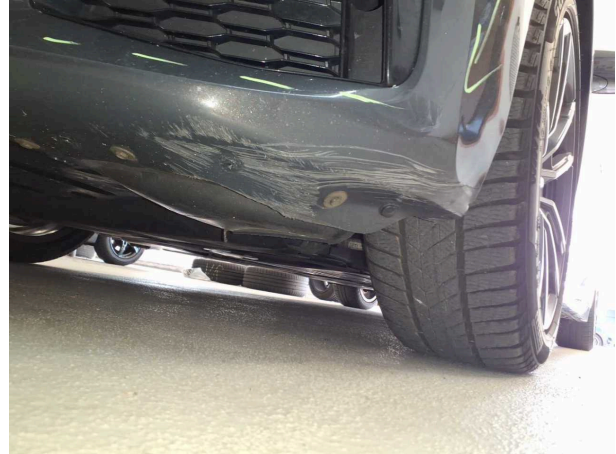
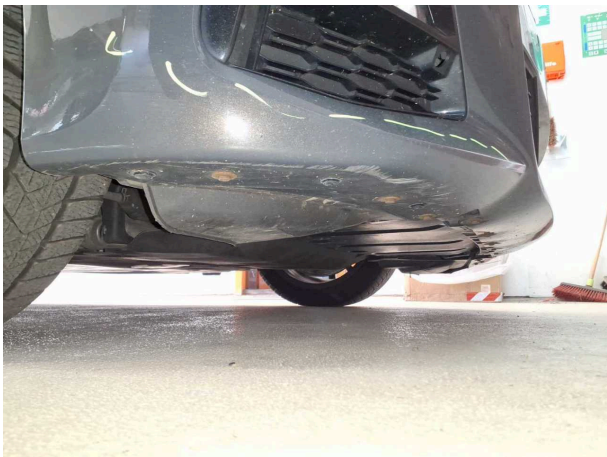
**Damage #13:** Front bumper: Front bumper - Deformed - Replace

| No. | Component group | Description |
|---|---|---|
| 13 | Front bumper | Front bumper - Deformed - Replace |
