WAUZZZFYXL2114222

## Zustandsbericht

Inspection date: 25 Apr 2025  
**Protocol number:** 39467331  
Delivery date: 25 Apr 2025

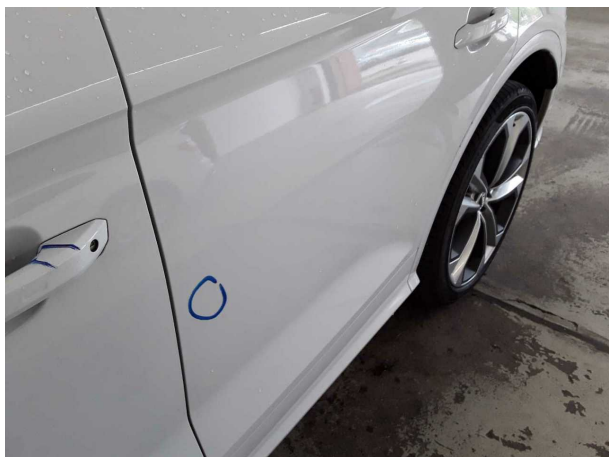
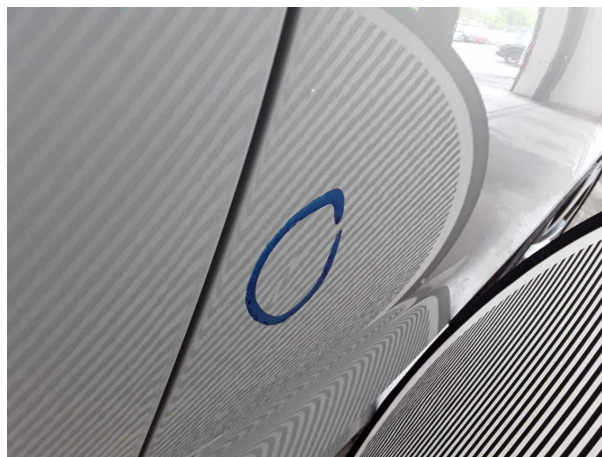
| No. | Component group | Description |
|---|---|---|
| 4 | Door - rear left side | Door - dent(s) - Smooth repair work |

**Damage #4:** Door - rear left side: Door - dent(s) - Smooth repair work

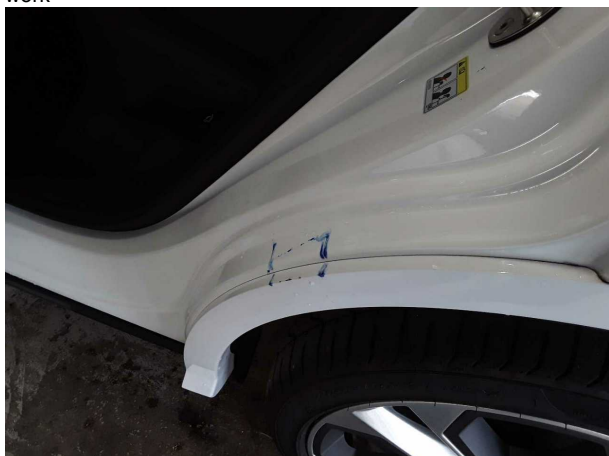
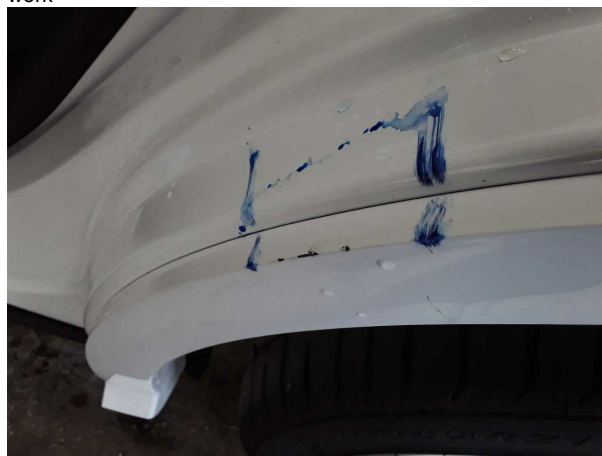
| No. | Component group | Description |
|---|---|---|
| 5 | Side panel - rear left side | Wheel well extension - Scratched - Smart repair |

**Damage #5:** Side panel - rear left side: Wheel well extension - Scratched - Smart repair

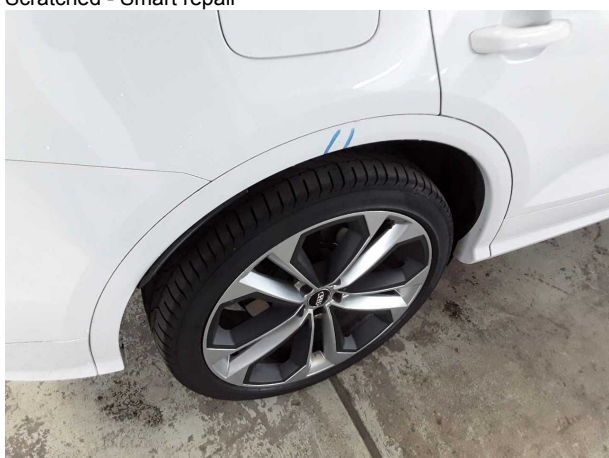
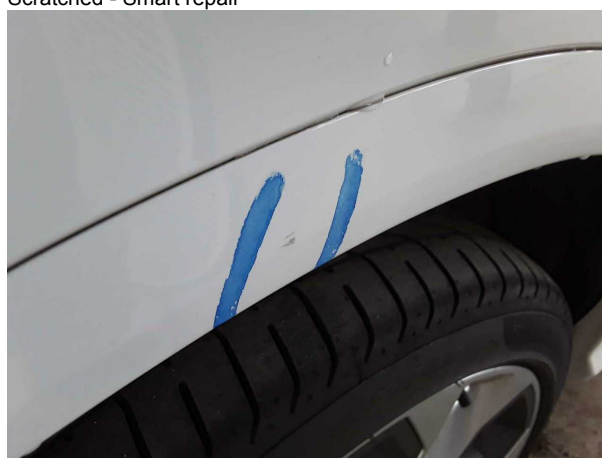
| No. | Component group | Description |
|---|---|---|
| 6 | Side panel - rear right side | Wheel well extension - Scratched - Smart repair |

**Damage #6:** Side panel - rear right side: Wheel well extension - Scratched - Smart repair

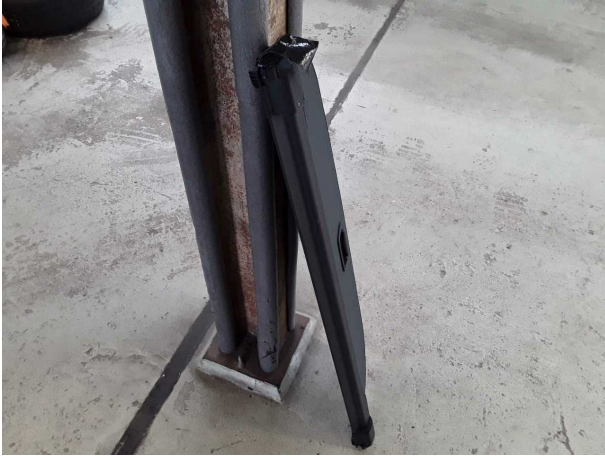
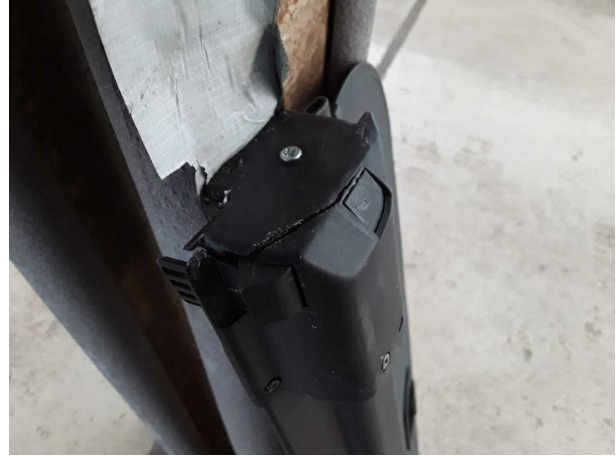
| No. | Component group | Description |
|---|---|---|
| 7 | Interior | Boot cover / roller cover - Broken / torn - Replace |

**Damage #7:** Interior: Boot cover / roller cover - Broken / torn - Replace
