WBA6N31070FL38162

## Vehicle details

Inspection date: 7 May 2025  
**Protocol number:** 39596436  
Delivery date: 7 May 2025

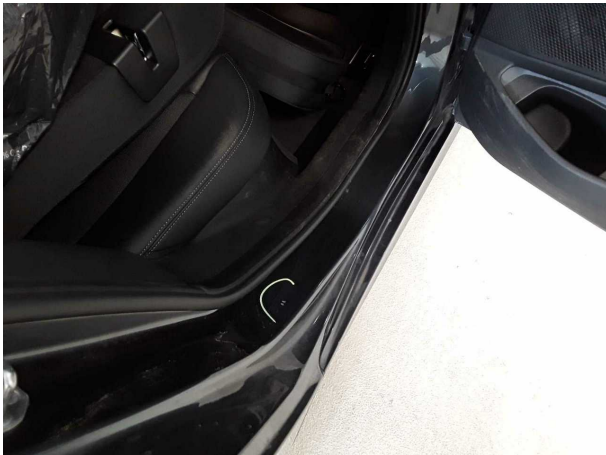
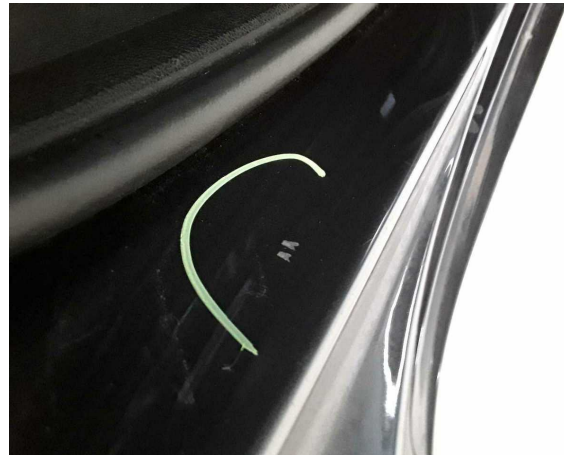
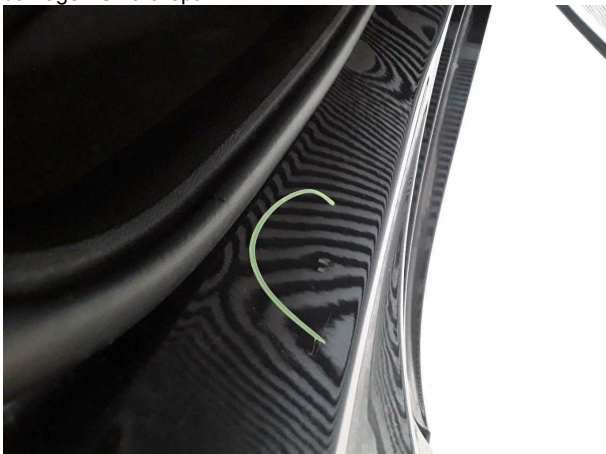
| No. | Component group | Description |
|---|---|---|
| 1 | Side panel - rear right side | Sill - Dent / paintcoat damage - Smart repair |

**Damage #1:** Side panel - rear right side: Sill - Dent / paintcoat damage - Smart repair

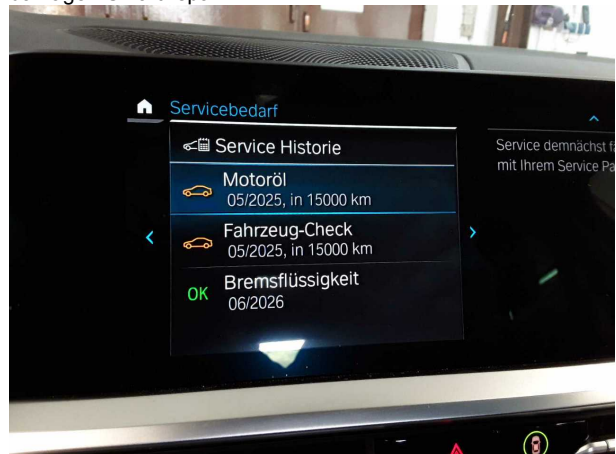
| No. | Component group | Description |
|---|---|---|
| 2 | Misc. | Inspection / maintenance - Due - Replace |

**Damage #2:** Misc.: Inspection / maintenance - Due - Replace

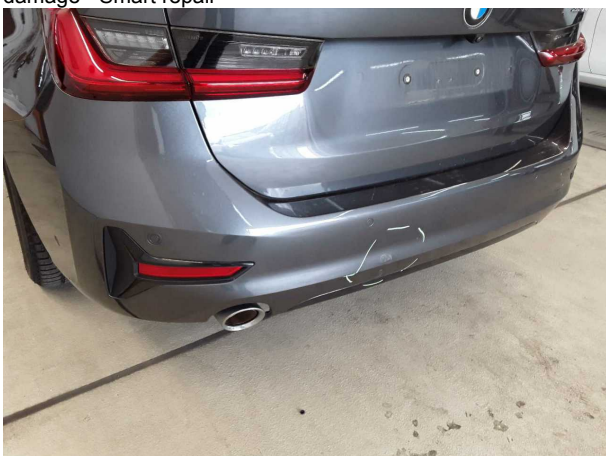
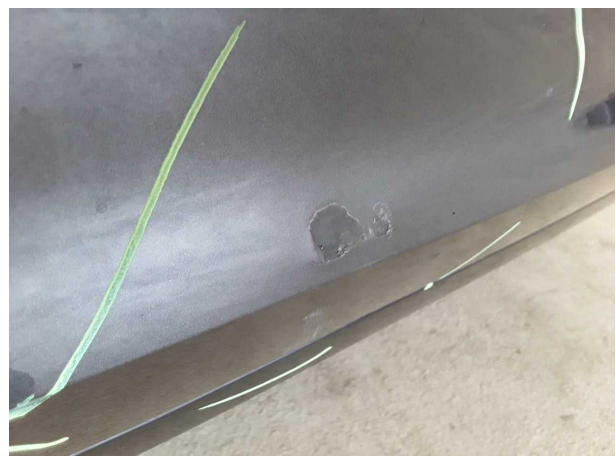
| No. | Component group | Description |
|---|---|---|
| 3 | Rear bumper | Rear bumper (Stark) - Scratched - Replace |

**Damage #3:** Rear bumper: Rear bumper (Stark) - Scratched - Replace
