## Vehicle details

## Zustandsbericht

Inspection date: 7 May 2025  
**Protocol number:** 39597151  
Delivery date: 7 May 2025

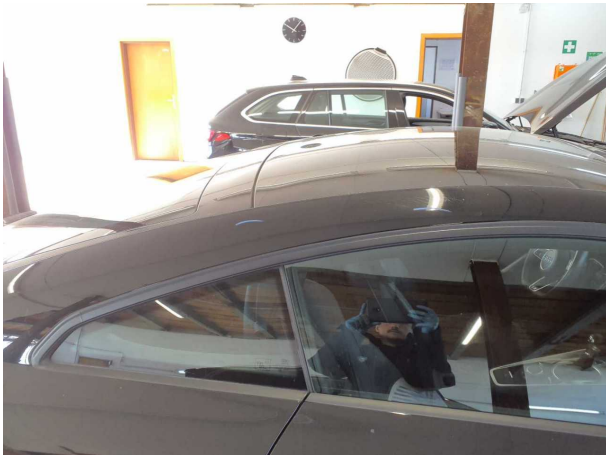
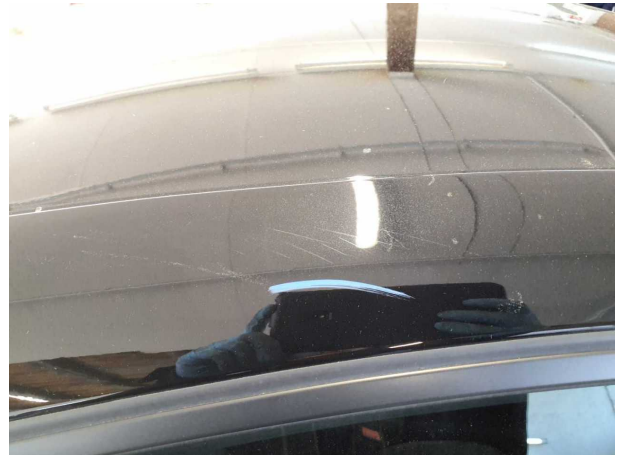
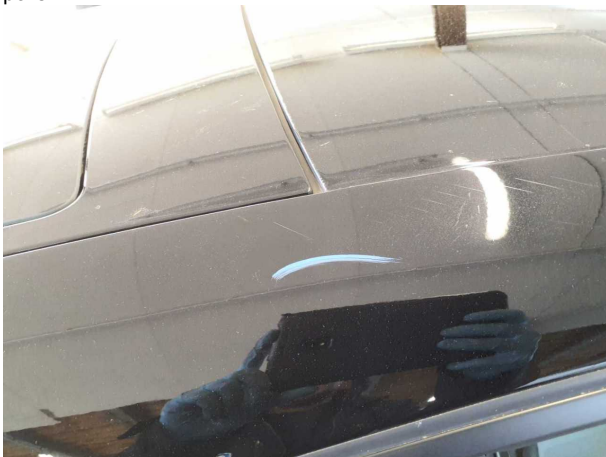
| No. | Component group | Description |
|---|---|---|
| 1 | Roof | Roof rail - right side - Scratch(es) - Cover / polish |

**Damage #1:** Roof: Roof rail - right side - Scratch(es) - Cover / polish

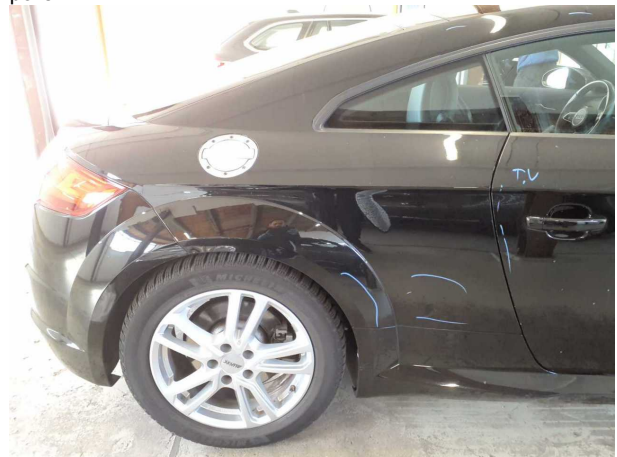
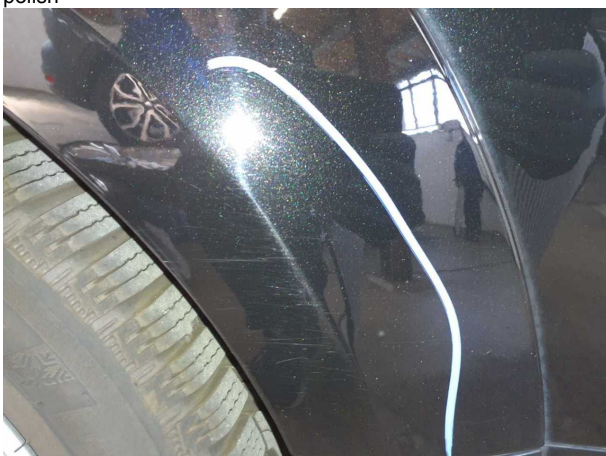
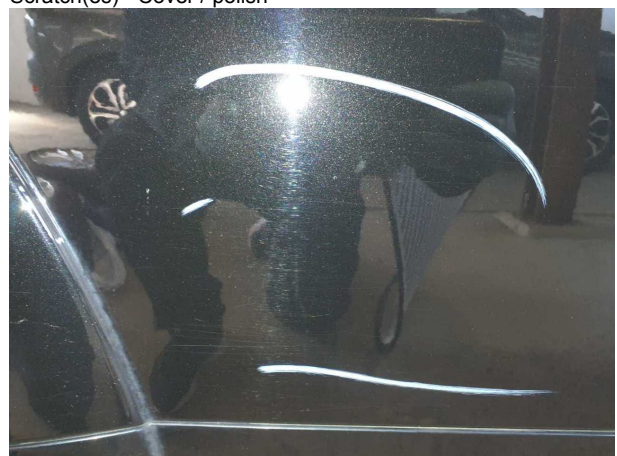
| No. | Component group | Description |
|---|---|---|
| 2 | Side panel - rear right side | Side panel - Scratch(es) - Cover / polish |

**Damage #2:** Side panel - rear right side: Side panel - Scratch(es) - Cover / polish

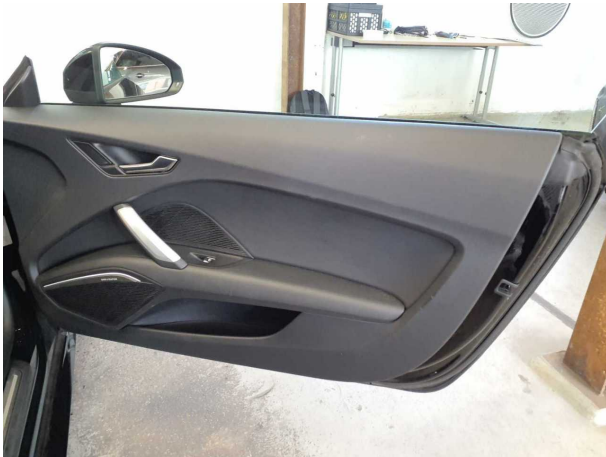
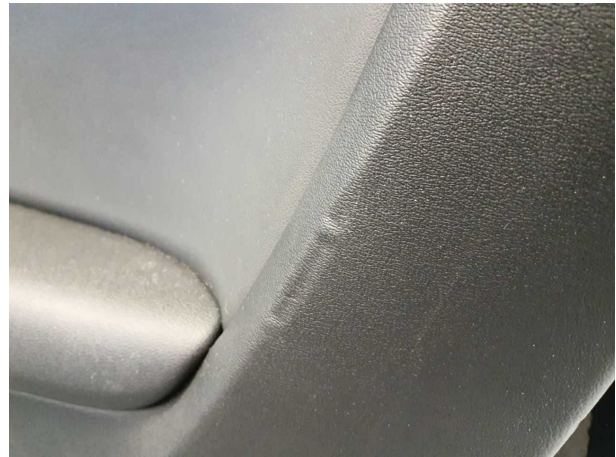
| No. | Component group | Description |
|---|---|---|
| 3 | Trim / covers | Door trim - front right side - Deformed - Loss in value |

**Damage #3:** Trim / covers: Door trim - front right side - Deformed - Loss in value

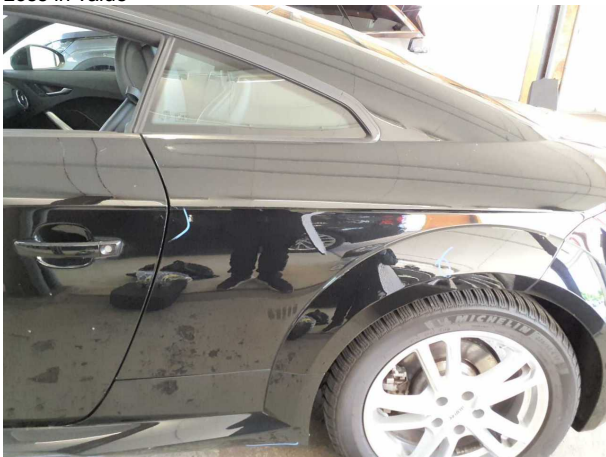
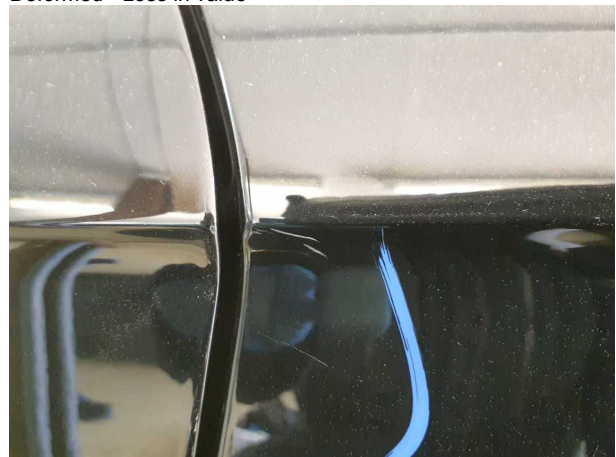
| No. | Component group | Description |
|---|---|---|
| 4 | Side panel - rear left side | Side panel - Scratch(es) - Smart repair |

**Damage #4:** Side panel - rear left side: Side panel - Scratch(es) - Smart repair

**Damage #4:** Side panel - rear left side: Side panel - Scratch(...) - Smart repair

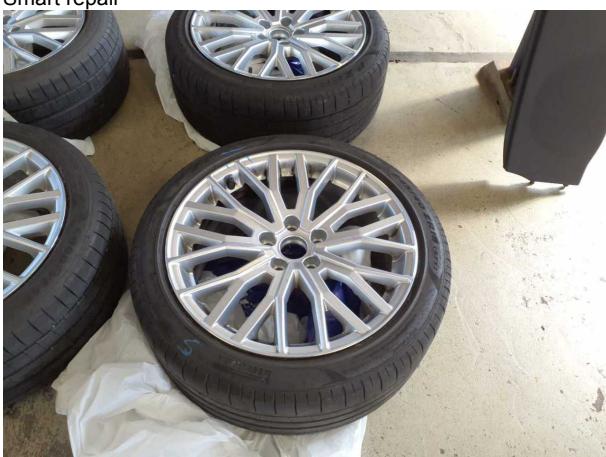
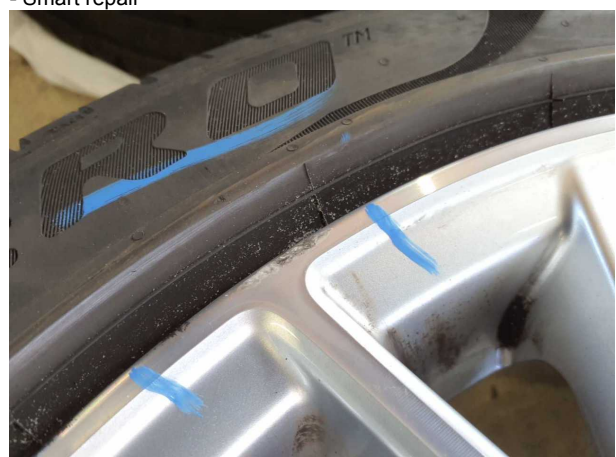
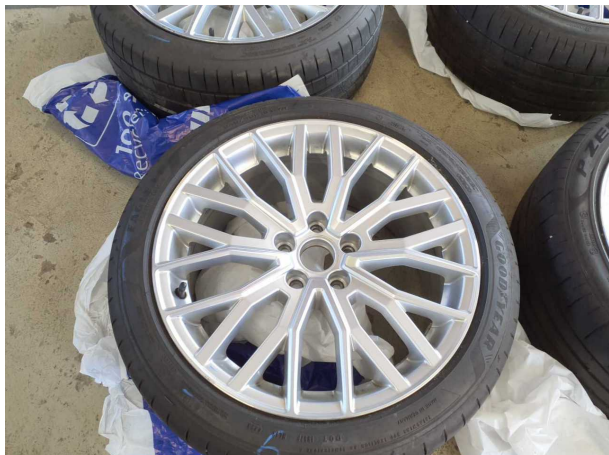
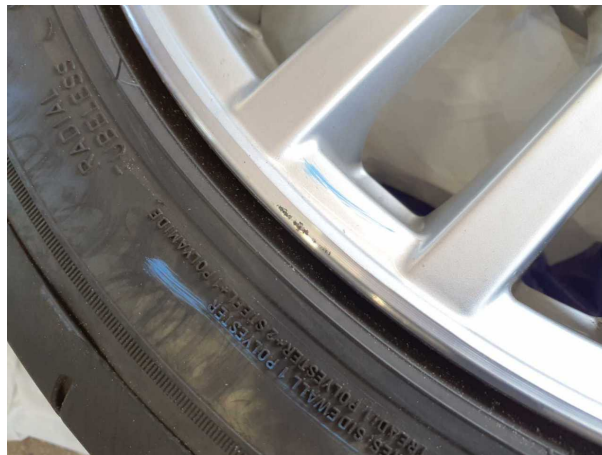
| No. | Component group | Description |
|---|---|---|
| 6 | 2nd wheel set | Alloy rim set - complete - Scratched - Loss in value |

**Damage #6:** 2nd wheel set: Alloy rim set - complete - Scratched - Loss in value

**Damage #6:** 2nd wheel set: Alloy rim set - complete - Scratch... - Loss in value

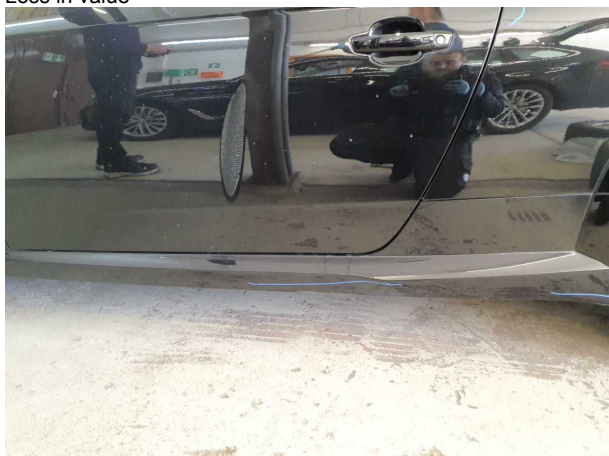
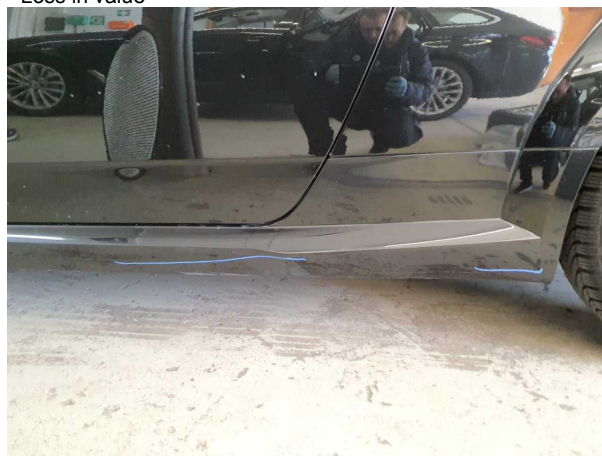
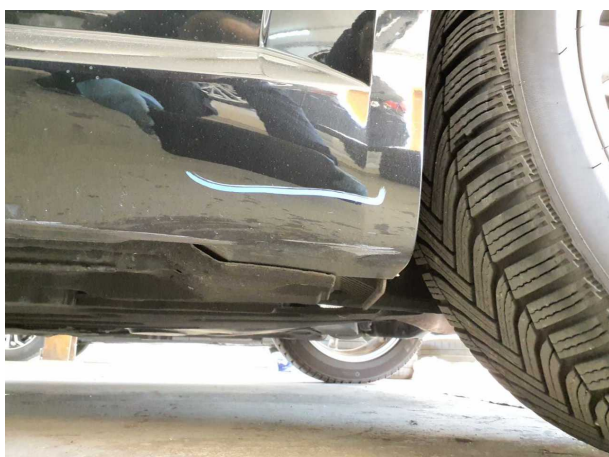
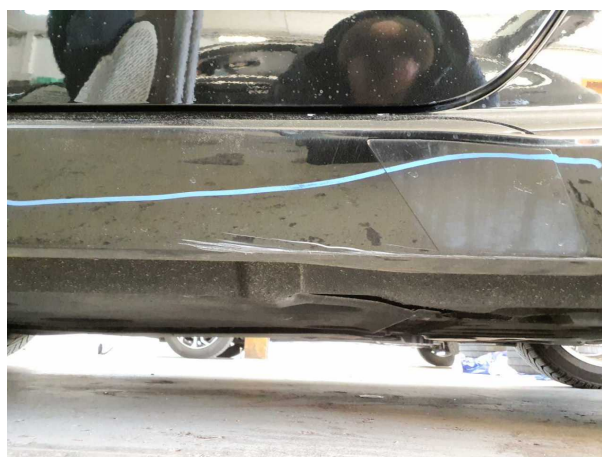
| No. | Component group | Description |
|---|---|---|
| 7 | Sill - left side | Trim - Scratched - Replace |

**Damage #7:** Sill - left side: Trim - Scratched - Replace

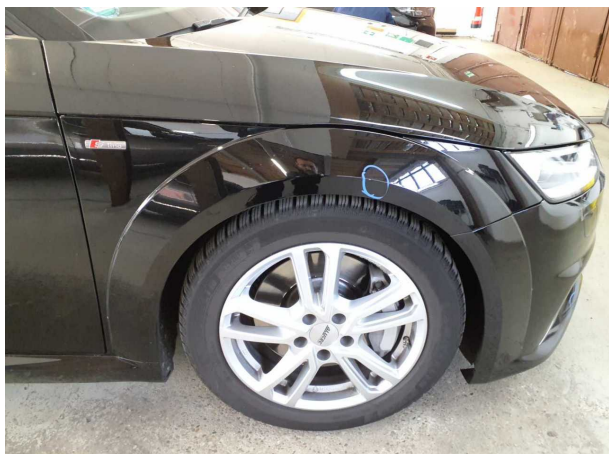
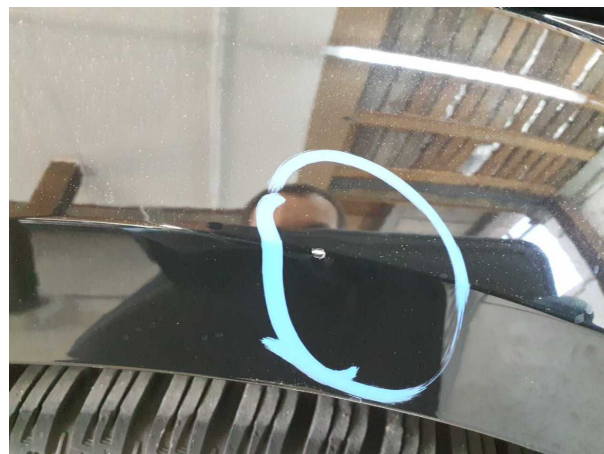
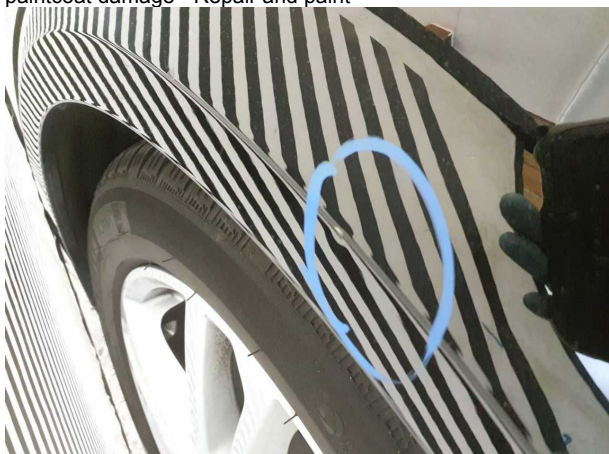
| No. | Component group | Description |
|---|---|---|
| 8 | Mudguard - right side | Mudguard - right side - Dent / paintcoat damage - Repair and paint |

**Damage #8:** Mudguard - right side: Mudguard - right side - Dent / paintcoat damage - Repair and paint

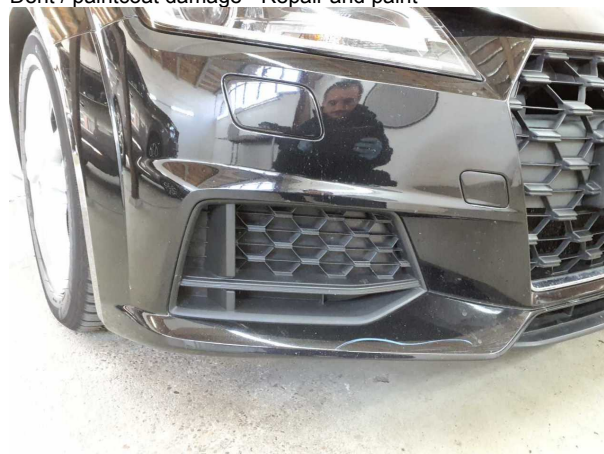
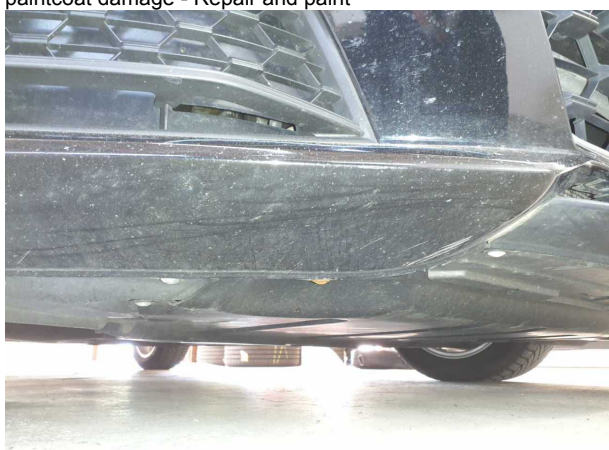
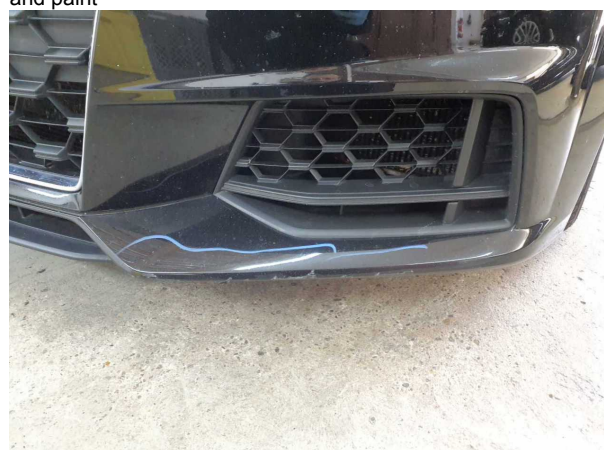
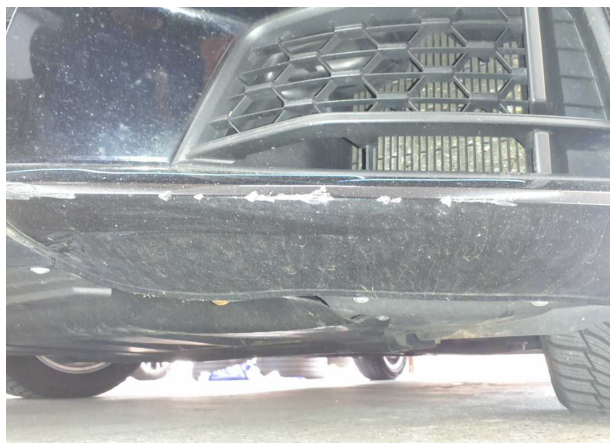
| No. | Component group | Description |
|---|---|---|
| 9 | Front bumper | Front bumper - Scratched - Repair and paint |

**Damage #9:** Front bumper: Front bumper - Scratched - Repair and paint
