**WAUZZZGE8MB034682**

## Zustandsbericht

Inspection date: 23 May 2025  
**Protocol number: 39870247**

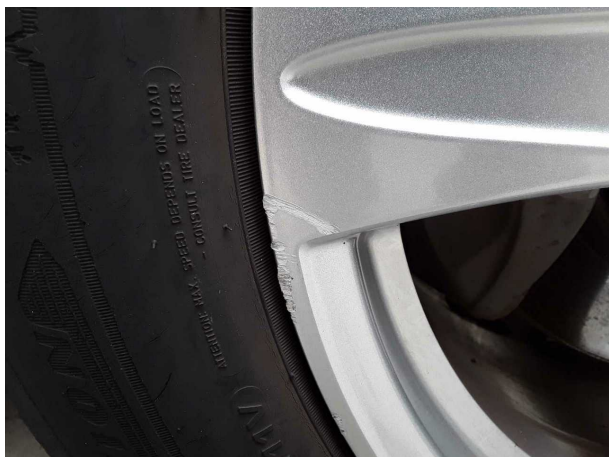
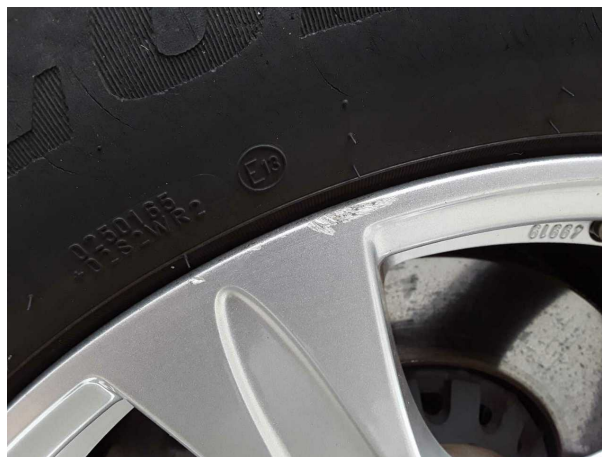
| No. | Component group | Description |
|---|---|---|
| 1 | Wheel / tyres | Alloy rim - front right side (Materialabtrag optisch gering) - Scratched - No deduction |

**Damage #1:** Wheel / tyres: Alloy rim - front right side  
(Materialabtrag optisch gering) - Scratched - No deduction

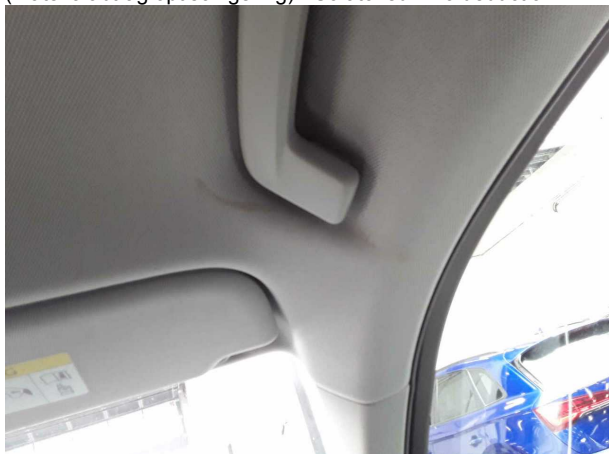
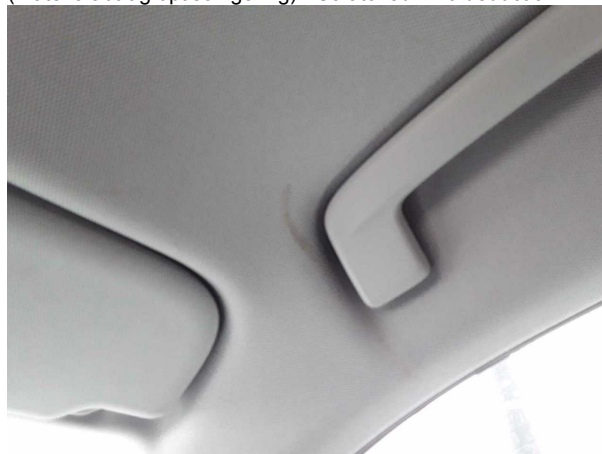
| No. | Component group | Description |
|---|---|---|
| 2 | Trim / covers | Roof lining - Soiled - Clean |

**Damage #2:** Trim / covers: Roof lining - Soiled - Clean

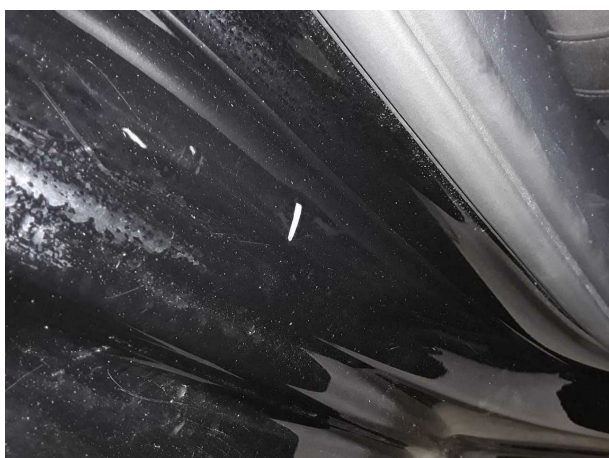
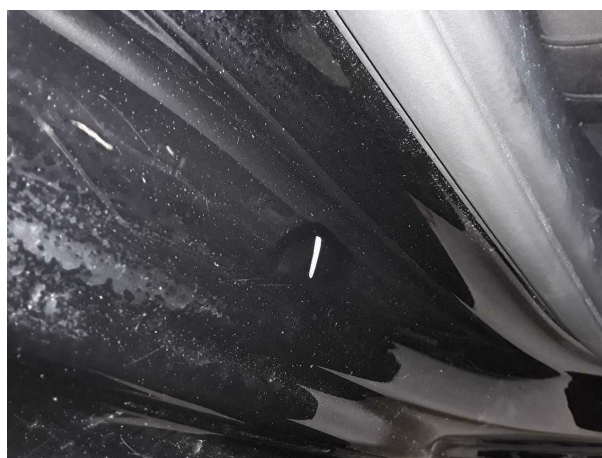
| No. | Component group | Description |
|---|---|---|
| 4 | Side panel - rear right side | Sill - Scratch(es) - Smart repair |

**Damage #4:** Side panel - rear right side: Sill - Scratch(es) - Smart repair

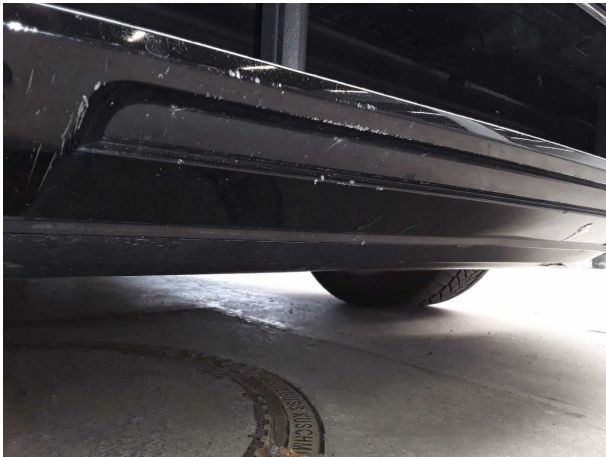
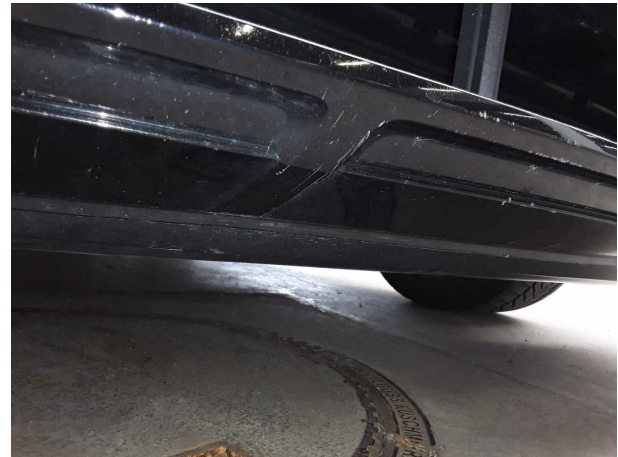
| No. | Component group | Description |
|---|---|---|
| 5 | Front bumper | Spoiler - Scratched - Repair and paint |

**Damage #5:** Front bumper: Spoiler - Scratched - Repair and paint

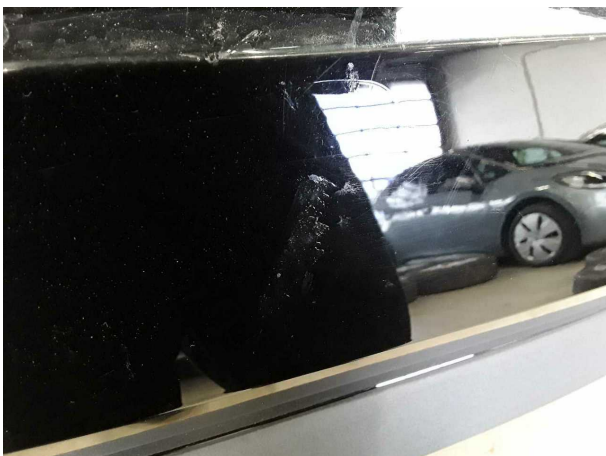
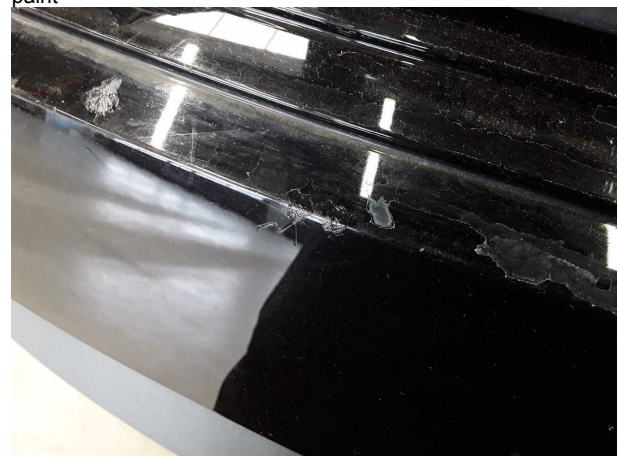
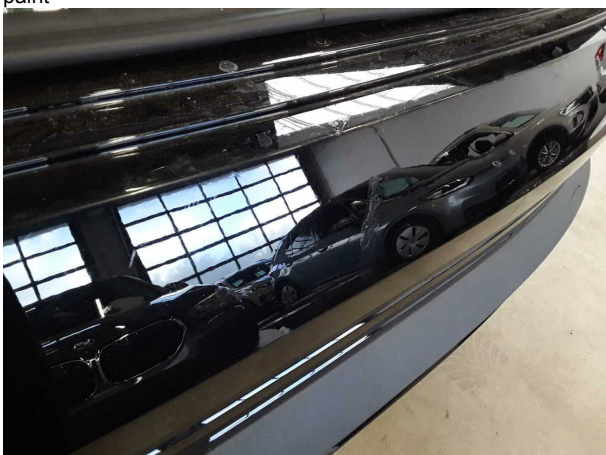
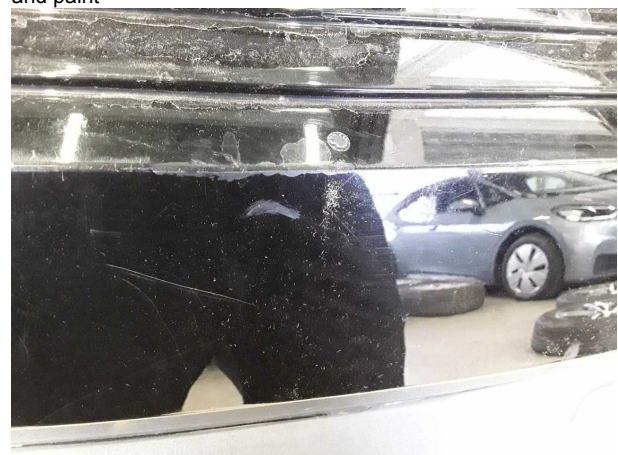
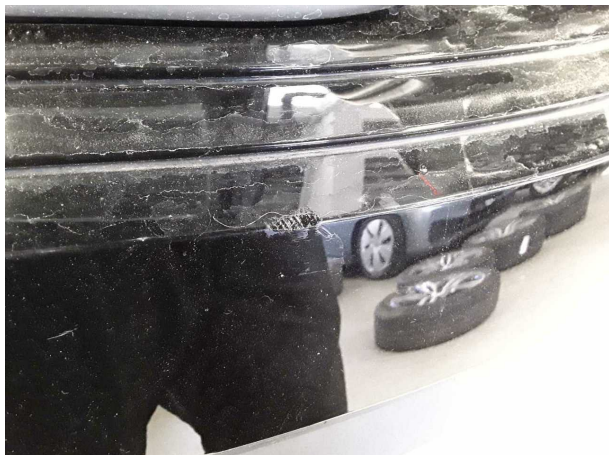
| No. | Component group | Description |
|---|---|---|
| 7 | Rear bumper | Rear bumper - Scratched - Repair and paint |

**Damage #7:** Rear bumper: Rear bumper - Scratched - Repair and paint
