WBA11DZ080FL99150

## Zustandsbericht

**TÜV SÜD Auto Partner GmbH**  
Gutenbergstr. 13  
70771 Leinfelden-Echterdingen

**Protocol number:** 39800796

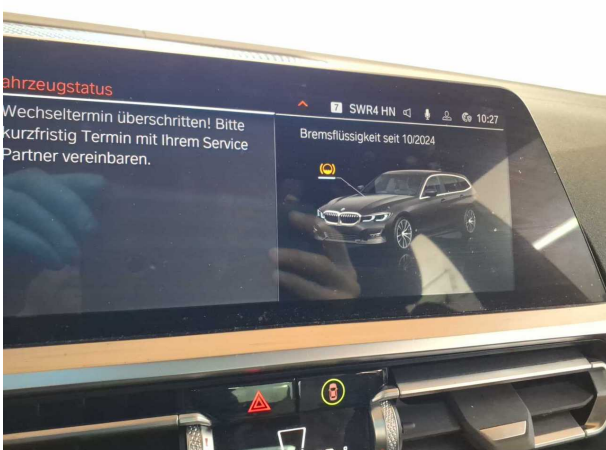
| No. | Component group | Description |
|---|---|---|
| 2 | Braking system | Brake fluid - Due - Replace |

**Damage #2:** Braking system: Brake fluid - Due - Replace

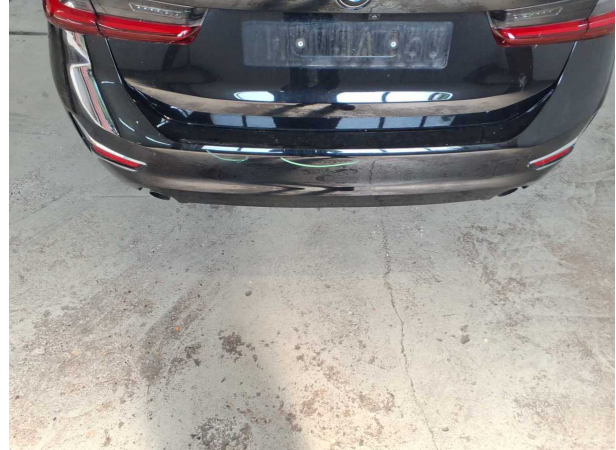
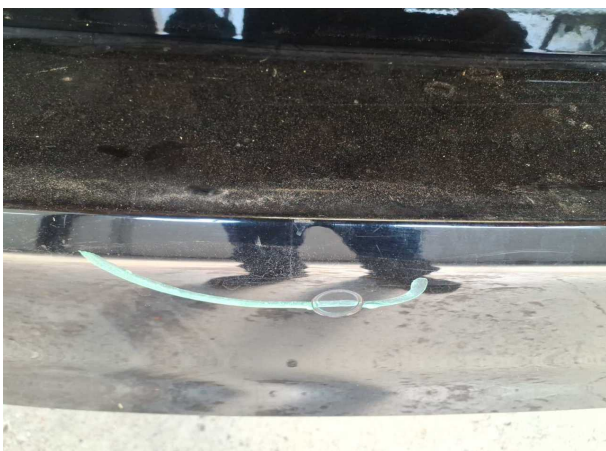
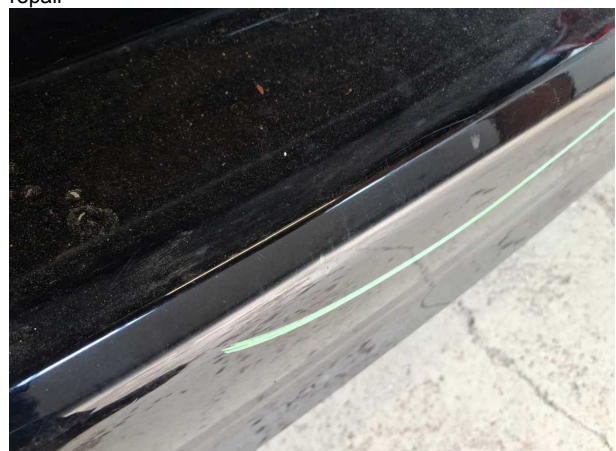
| No. | Component group | Description |
|---|---|---|
| 4 | Rear bumper | Rear bumper - Scratched - Smart repair |

**Damage #4:** Rear bumper: Rear bumper - Scratched - Smart repair

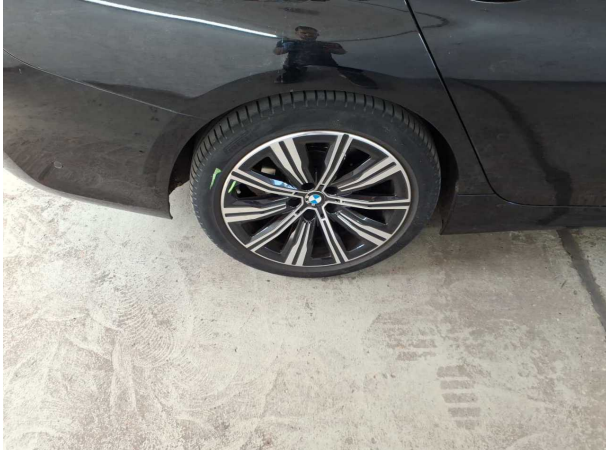
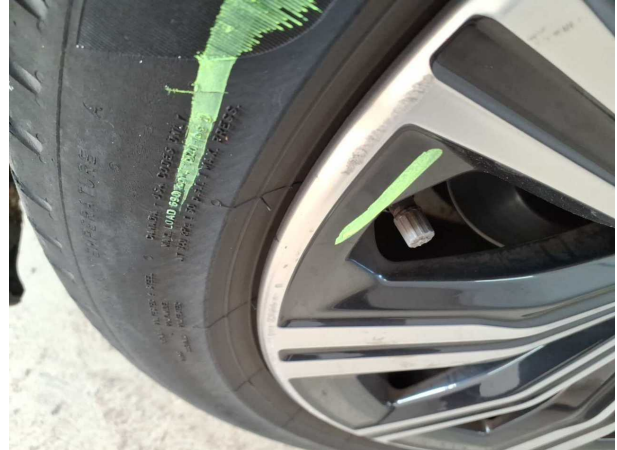
| No. | Component group | Description |
|---|---|---|
| 5 | Wheel / tyres | Alloy rim - rear right side - Scratched - Loss in value |

**Damage #5:** Wheel / tyres: Alloy rim - rear right side - Scratched - Loss in value

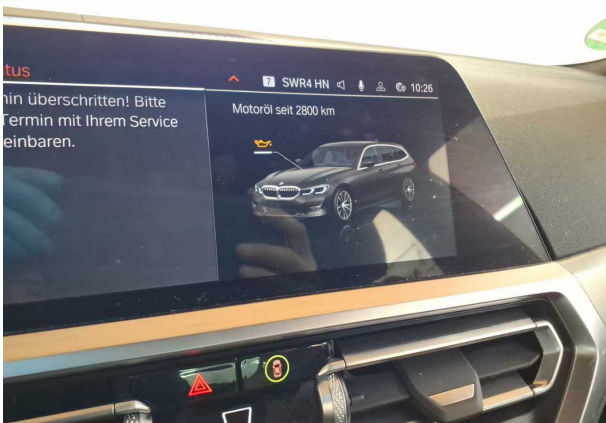
| No. | Component group | Description |
|---|---|---|
| 6 | Misc. | Inspection / maintenance - Due - Replace |

**Damage #6:** Misc.: Inspection / maintenance - Due - Replace

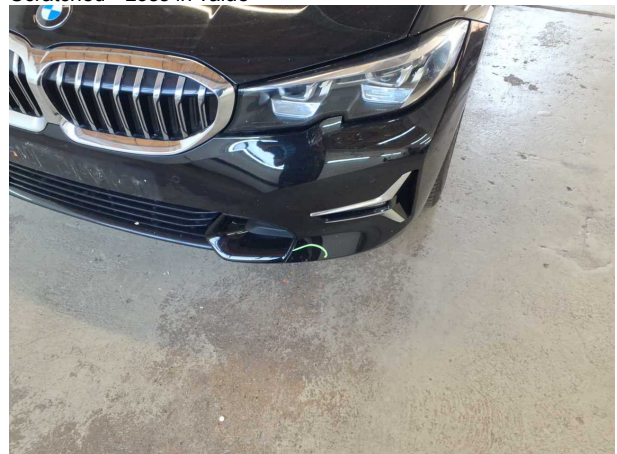
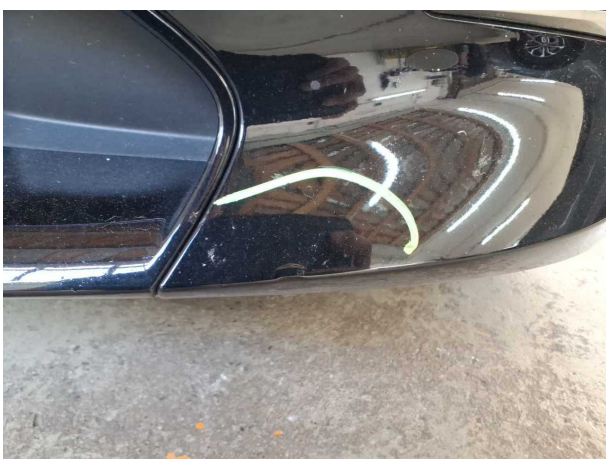
| No. | Component group | Description |
|---|---|---|
| 7 | Front bumper | Front bumper - Scratched - Smart repair |

**Damage #7:** Front bumper: Front bumper - Scratched - Smart repair
