**WBA5P51030FK28016**

## Vehicle details

Inspection date: 14 May 2025  
**Protocol number: 39731509**  
Delivery date: 14 May 2025

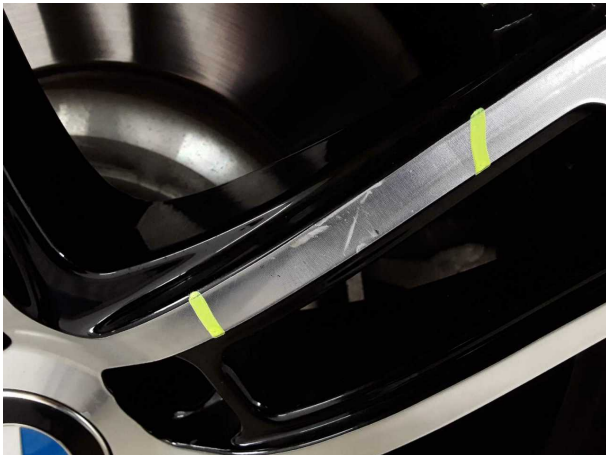
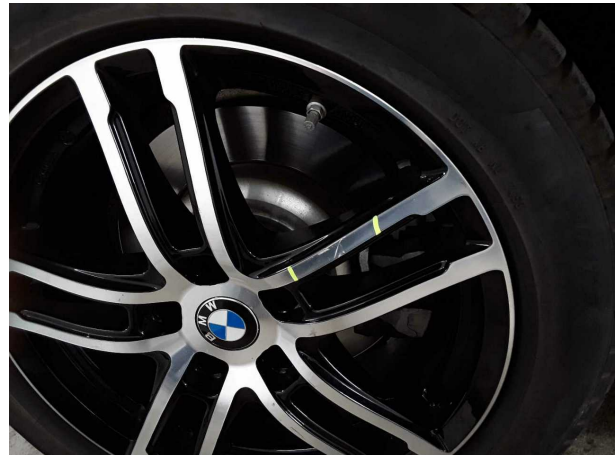
| No. | Component group | Description |
|---|---|---|
| 1 | Wheel / tyres | Alloy rim - rear right side - Scratched |

**Damage #1:** Wheel / tyres: Alloy rim - rear right side - Scratched

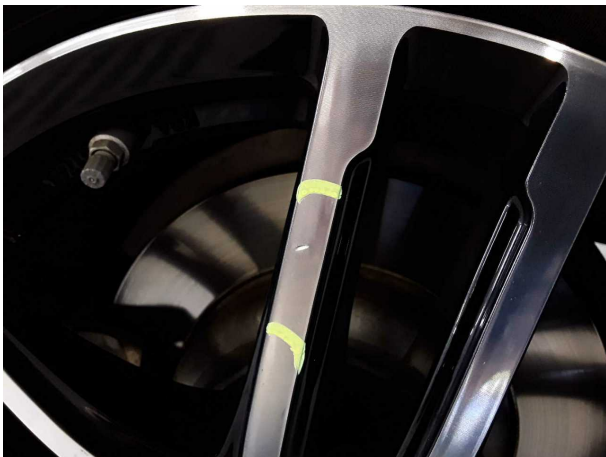
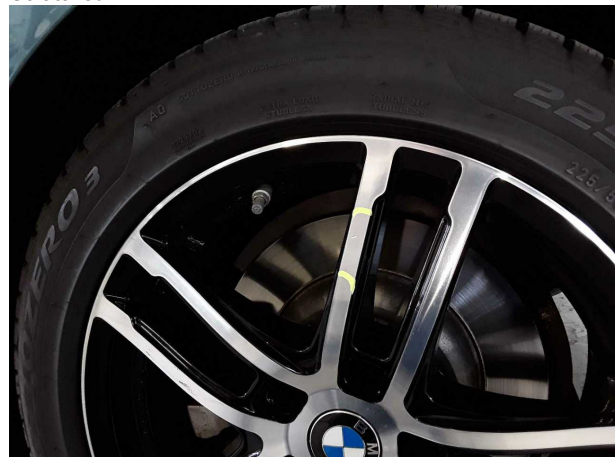
| No. | Component group | Description |
|---|---|---|
| 2 | Wheel / tyres | Alloy rim - rear left side - Scratched |

**Damage #2:** Wheel / tyres: Alloy rim - rear left side - Scratched

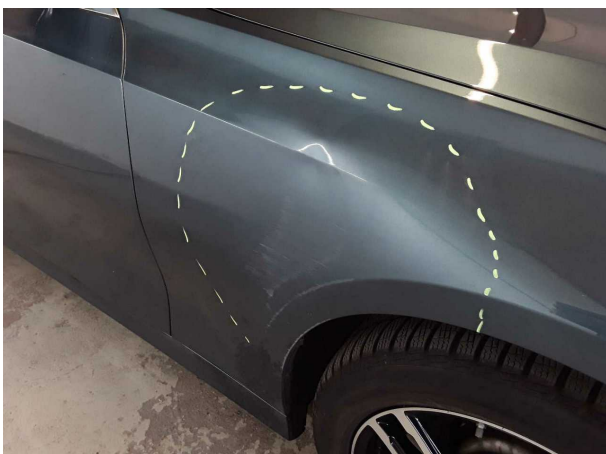
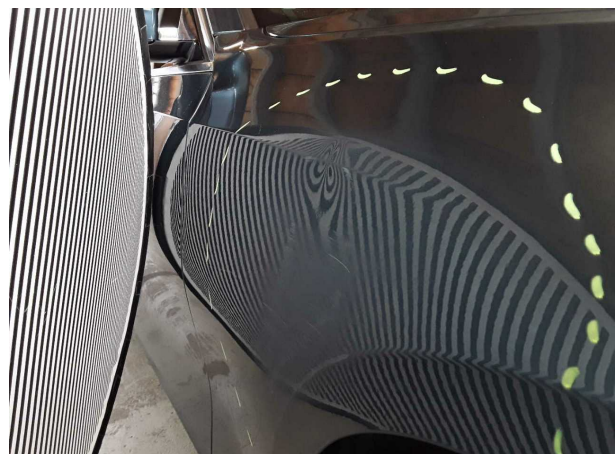
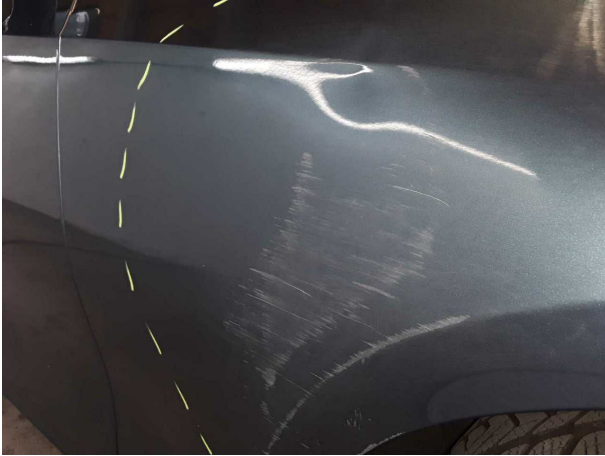
| No. | Component group | Description |
|---|---|---|
| 5 | Mudguard - right side | Mudguard - right side - Dent / paintcoat damage - Repair and paint |

**Damage #5:** Mudguard - right side: Mudguard - right side - Dent / paintcoat damage - Repair and paint
