**WBA2N510807G59800**

## Zustandsbericht

Inspection date: 20 May 2025

**Protocol number:** 39800611

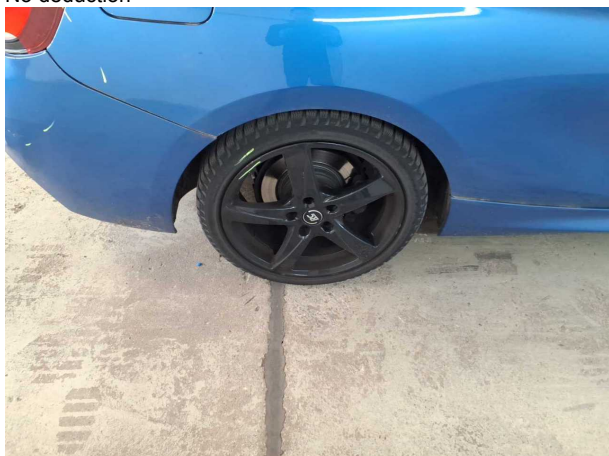
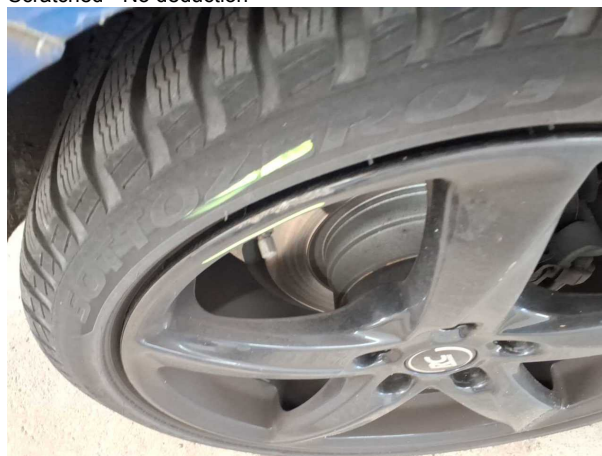
| No. | Component group | Description |
|---|---|---|
| 2 | Wheel / tyres | Alloy rim - rear right side - Scratched - No deduction |

**Damage #2:** Wheel / tyres: Alloy rim - rear right side - Scratched - No deduction

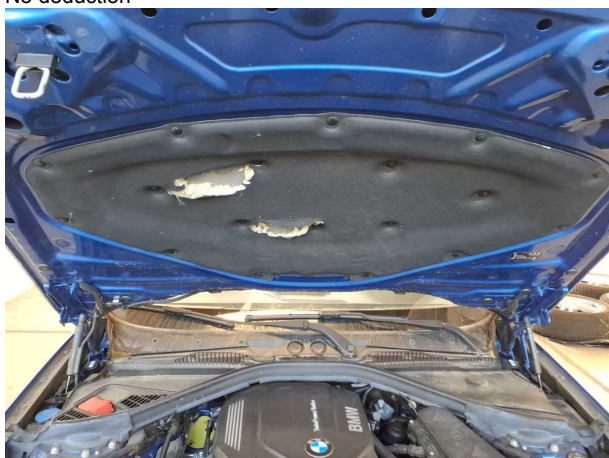
| No. | Component group | Description |
|---|---|---|
| 4 | Bonnet | Insulation lining - Damage caused by marten / rodent - Replace |

**Damage #4:** Bonnet: Insulation lining - Damage caused by marte... rodent - Replace

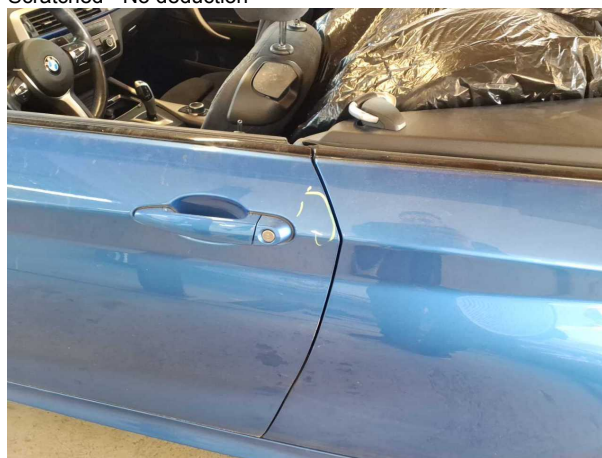
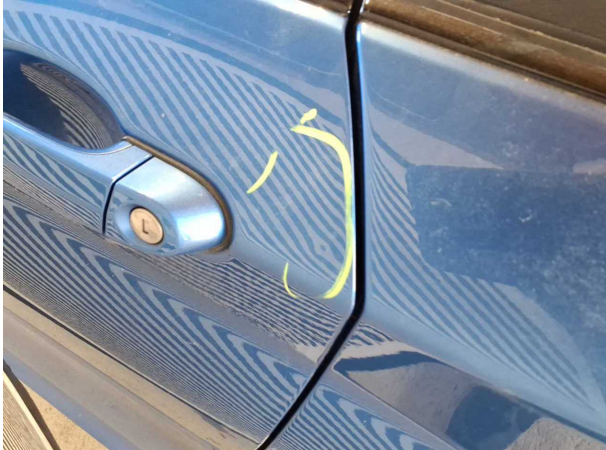
| No. | Component group | Description |
|---|---|---|
| 5 | Door - front left side | Door - dent(s) - Smooth repair work |

**Damage #5:** Door - front left side: Door - dent(s) - Smooth repair work

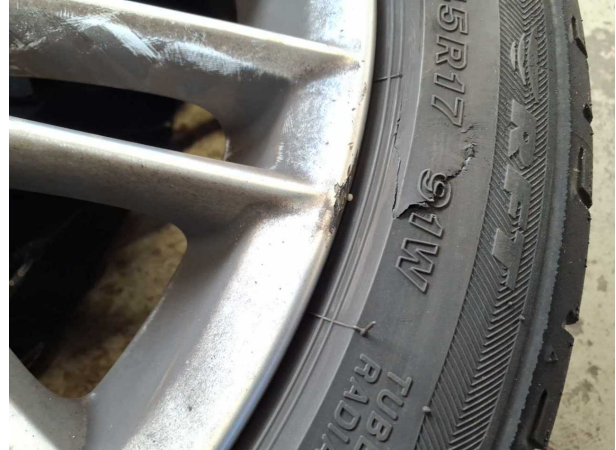
| No. | Component group | Description |
|---|---|---|
| 6 | 2nd wheel set | 1 alloy rim - Scratched - Loss in value |

**Damage #6:** 2nd wheel set: 1 alloy rim - Scratched - Loss in value

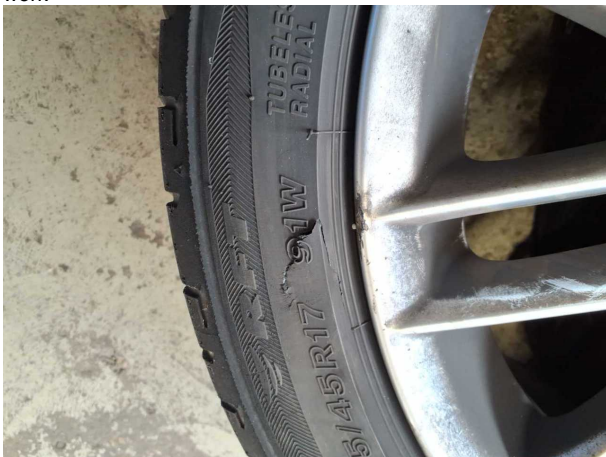
| No. | Component group | Description |
|---|---|---|
| 7 | 2nd wheel set | 1 tyre - Damaged - Replace |

| Axle | Tyre size | Manufacturer | Type of tyre | Tread depth | Roadworthy | Permissibility |
|---|---|---|---|---|---|---|
| 1 | 225/45 R17 91W | Bridgestone | Summer tyres | 6mm - 6mm | Not o.k. | |

**Damage #7:** 2nd wheel set: 1 tyre - Damaged - Replace

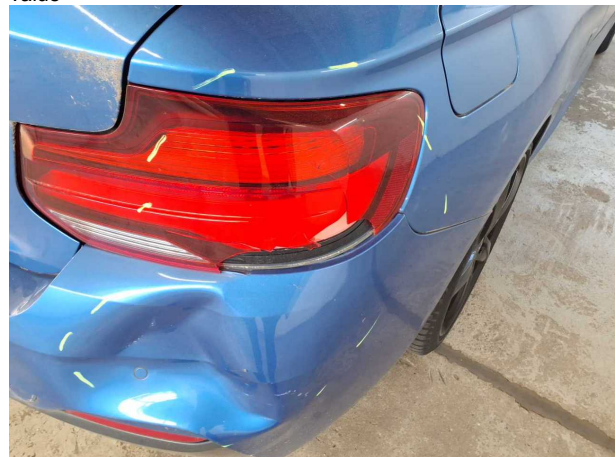
| No. | Component group | Description |
|---|---|---|
| 8 | Tail light | Tail lamp - right side - Damaged - Replace |

**Damage #8:** Tail light: Tail lamp - right side - Damaged - Replace

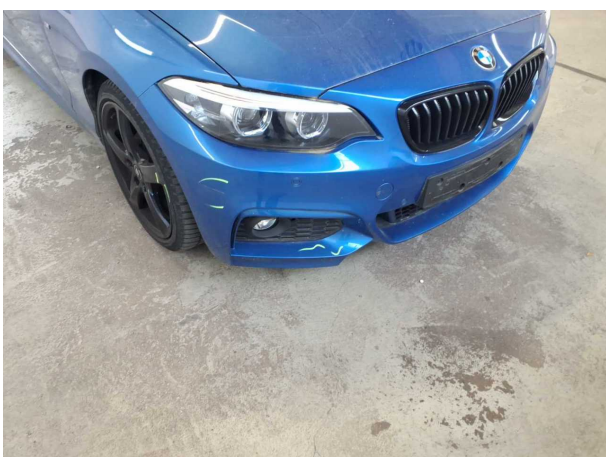
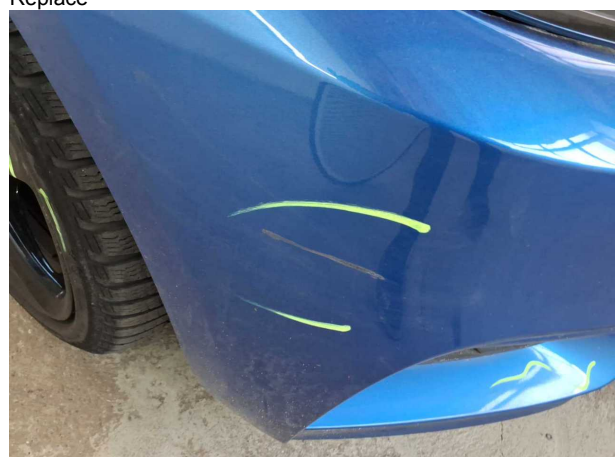
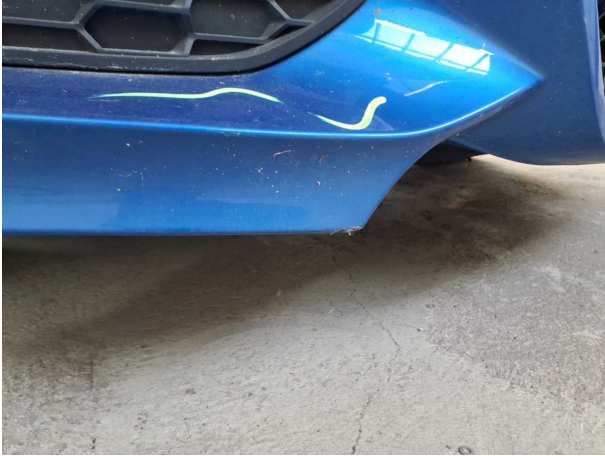
| No. | Component group | Description |
|---|---|---|
| 9 | Front bumper | Front bumper - Scratched - Repair and paint |

**Damage #9:** Front bumper: Front bumper - Scratched - Repair and paint

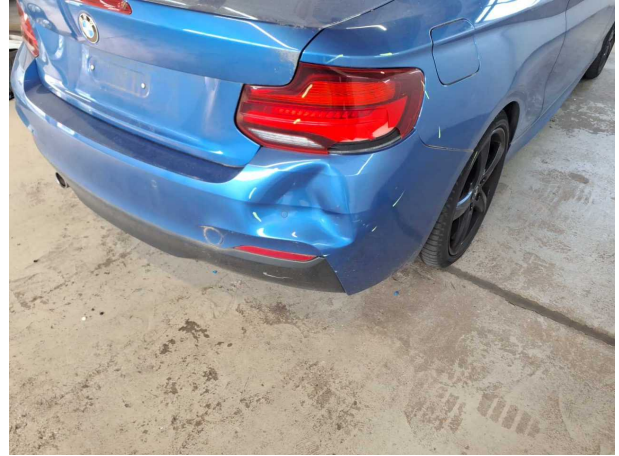
| No. | Component group | Description |
|---|---|---|
| 10 | Rear bumper | Rear bumper - Damaged - Replace |

**Damage #10:** Rear bumper: Rear bumper - Damaged - Replace
