**WBA7K310005T26244**

## Zustandsbericht

**TÜV SÜD Auto Plus GmbH**  
Gutenbergstr. 13  
70771 Leinfelden-Echterdingen

Inspection date: 25 Mar 2025  
**Protocol number: 39050998**

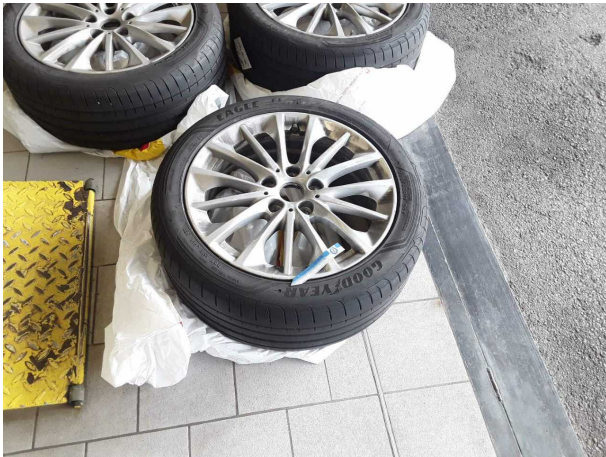
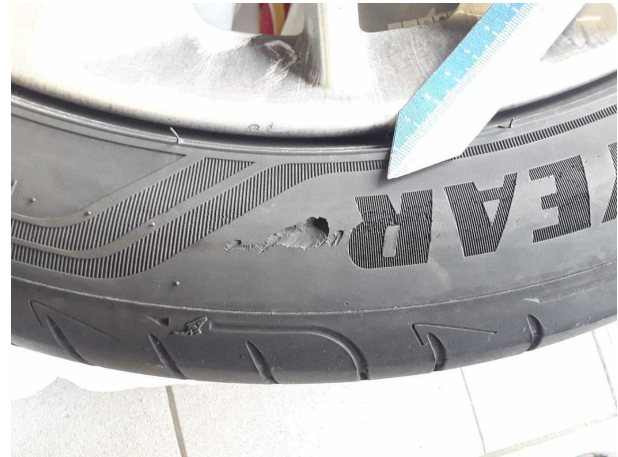
| No. | Component group | Description |
|---|---|---|
| 1 | 2nd wheel set | 1 tyre - Damaged - Replace |

**Damage #1:** 2nd wheel set: 1 tyre - Damaged - Replace

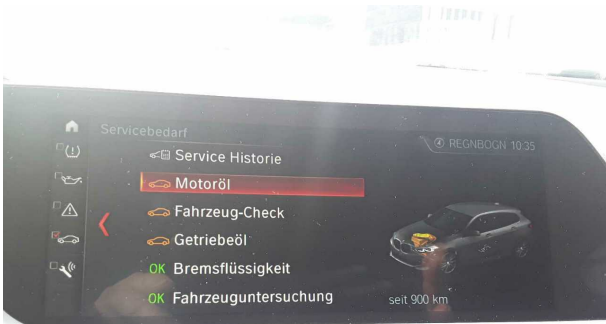
| No. | Component group | Description |
|---|---|---|
| 2 | Misc. | Inspection / maintenance - Due - Perform |

**Damage #2:** Misc.: Inspection / maintenance - Due - Perform

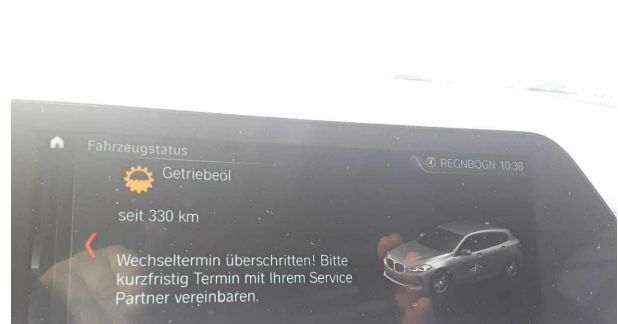
| No. | Component group | Description |
|---|---|---|
| 3 | Gearbox | Gearbox (Ölwechsel überfällig) - Due - Replace |

**Damage #3:** Gearbox: Gearbox (Ölwechsel überfällig) - Due - Replace

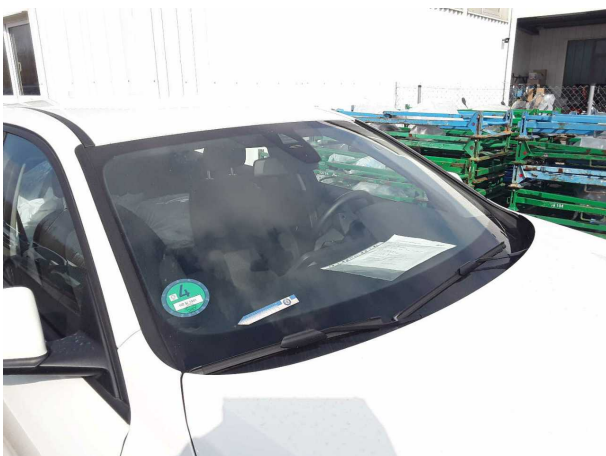
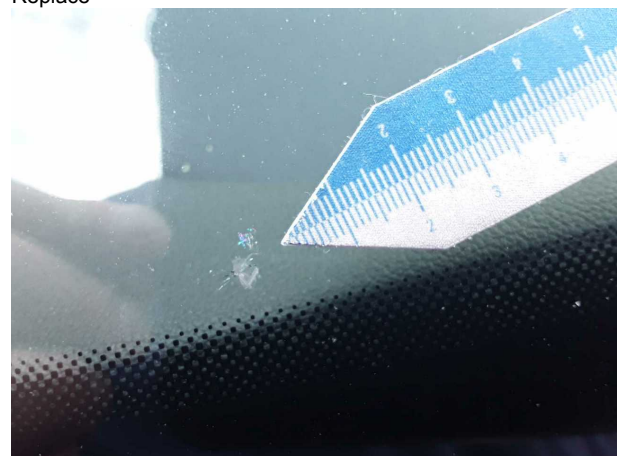
| No. | Component group | Description |
|---|---|---|
| 4 | Vehicle glazing | Windscreen - Stone chips - Replace |

**Damage #4:** Vehicle glazing: Windscreen - Stone chips - Replace
