WBA11AJ030CG64359

## Zustandsbericht

**TÜV SÜD Auto Partner GmbH**  
Gutenbergstr. 13  
70771 Leinfelden-Echterdingen

Inspection date: 28 Apr 2025  
**Protocol number: 39677755**

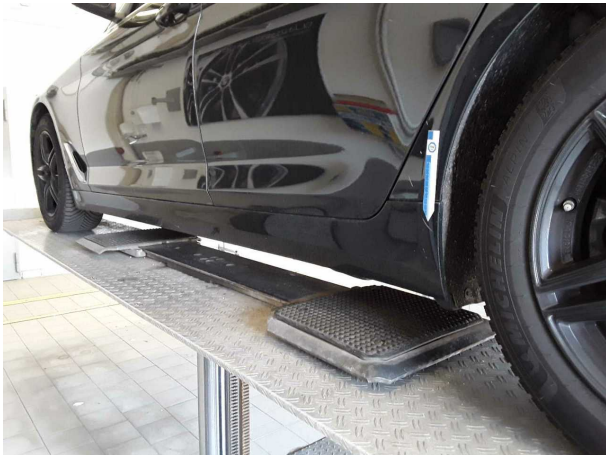
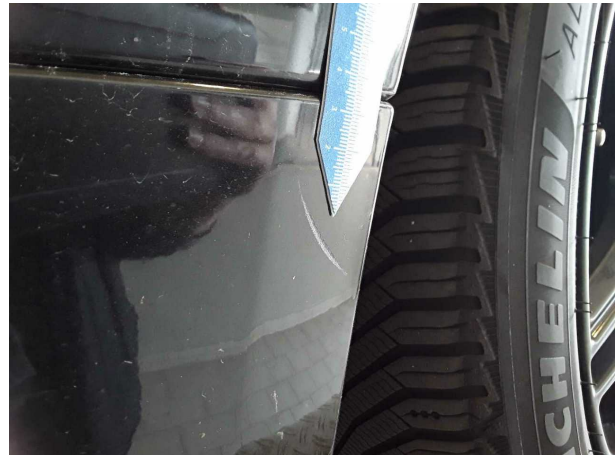
| No. | Component group | Description |
|---|---|---|
| 1 | Sill - left side | Trim - Scratched - Smart repair |

**Damage #1:** Sill - left side: Trim - Scratched - Smart repair

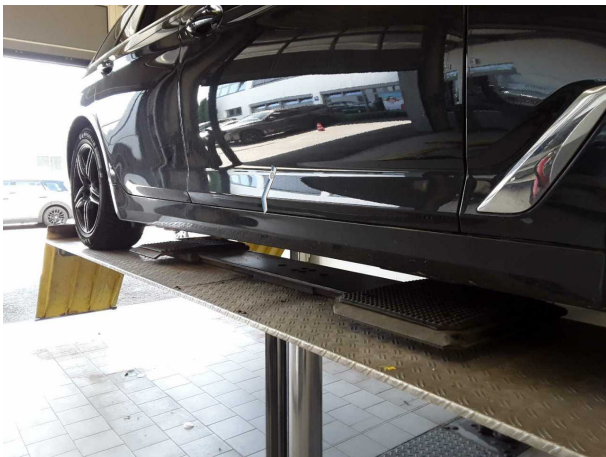
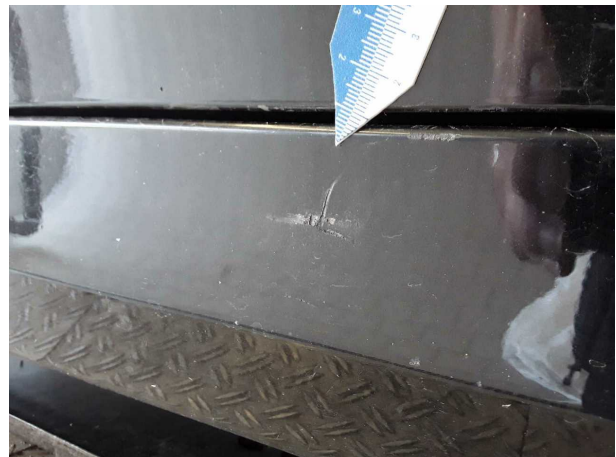
| No. | Component group | Description |
|---|---|---|
| 2 | Sill - right side | Trim - Scratched - Smart repair |

**Damage #2:** Sill - right side: Trim - Scratched - Smart repair

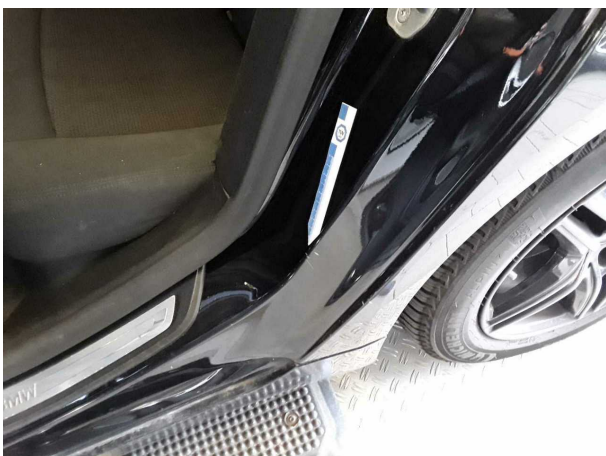
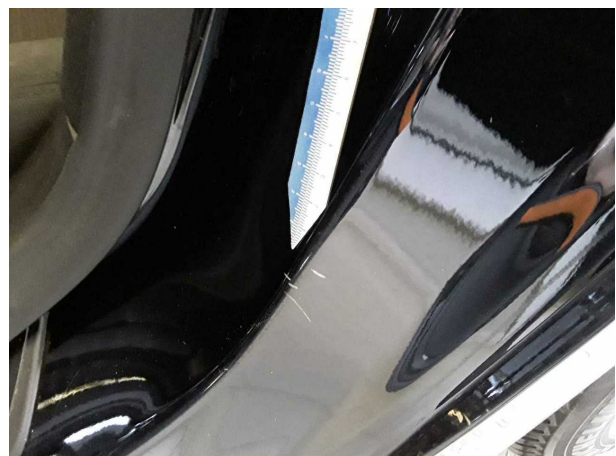
| No. | Component group | Description |
|---|---|---|
| 3 | Side panel - rear left side | Sill - Scratched - Smart repair |

**Damage #3:** Side panel - rear left side: Sill - Scratched - Smart repair

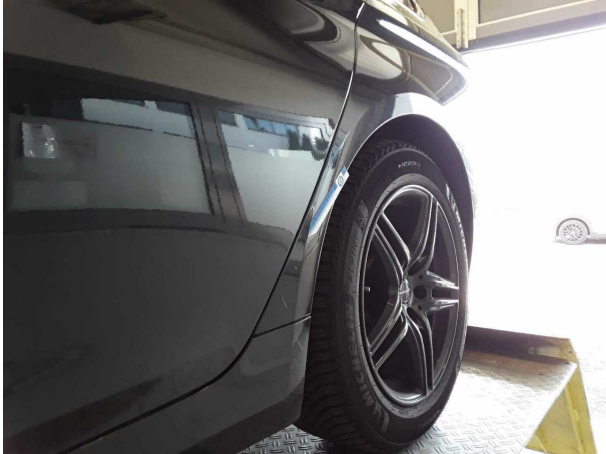
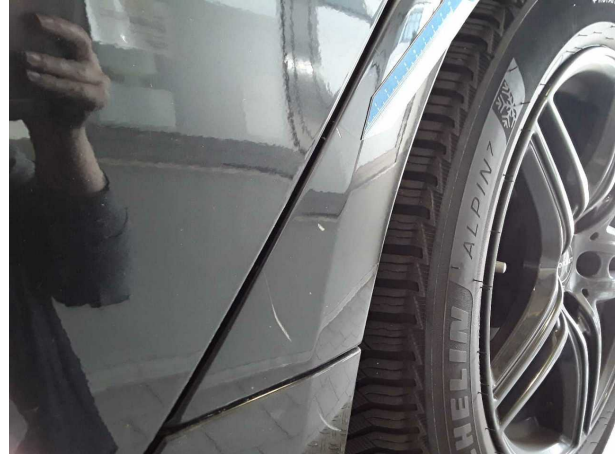
| No. | Component group | Description |
|---|---|---|
| 4 | Side panel - rear left side | Elbow - Scratched - Smart repair |

**Damage #4:** Side panel - rear left side: Elbow - Scratched - Smart repair

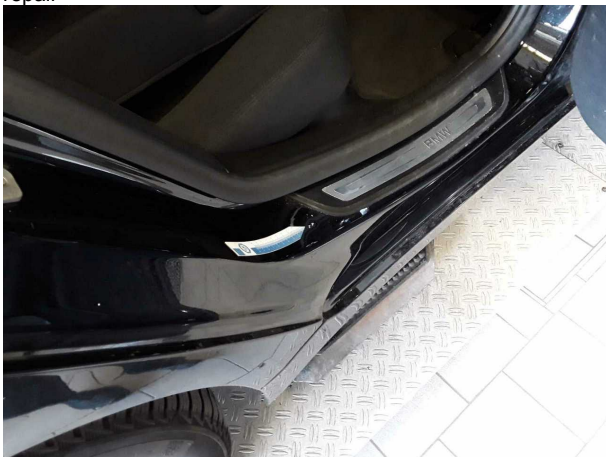
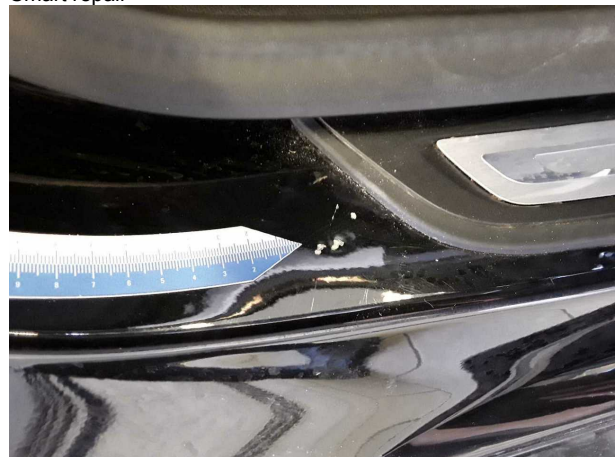
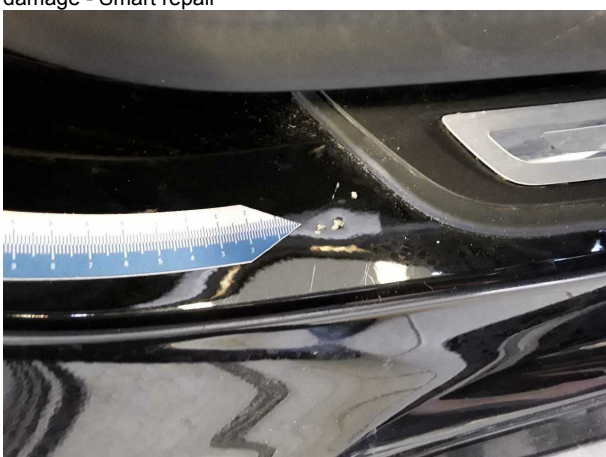
| No. | Component group | Description |
|---|---|---|
| 5 | Side panel - rear right side | Sill - Dent / paintcoat damage - Smart repair |

**Damage #5:** Side panel - rear right side: Sill - Dent / paintcoat damage - Smart repair

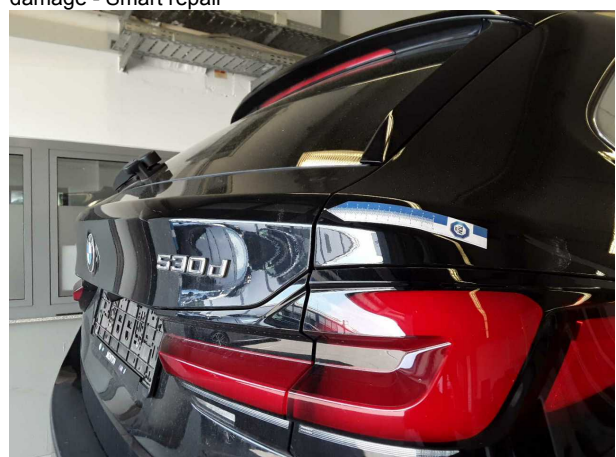
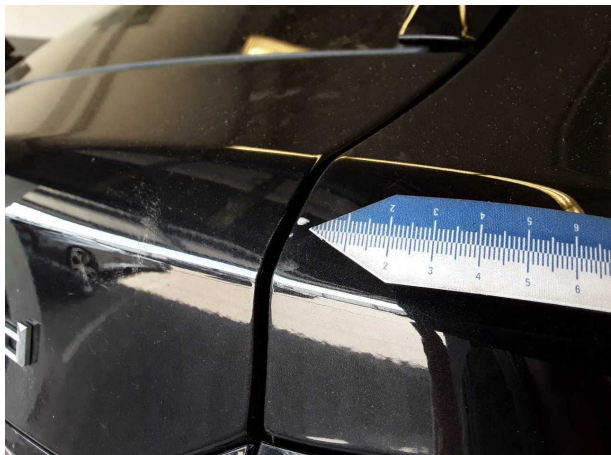
| No. | Component group | Description |
|---|---|---|
| 6 | Side panel - rear right side | Side panel - Scratched - Smart repair |

**Damage #6:** Side panel - rear right side: Side panel - Scratch... - Smart repair

**Damage #6:** Side panel - rear right side: Side panel - Scratched - Smart repair

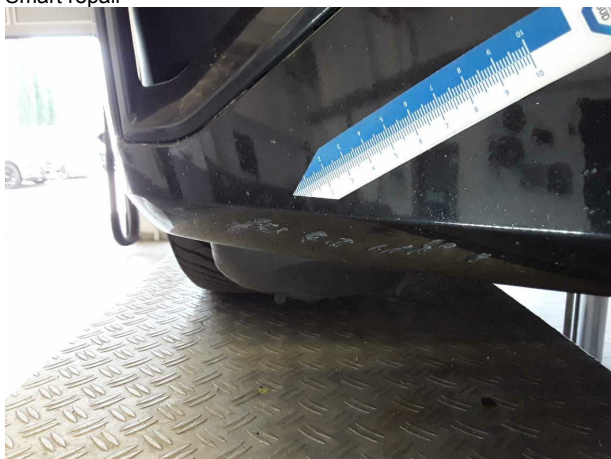
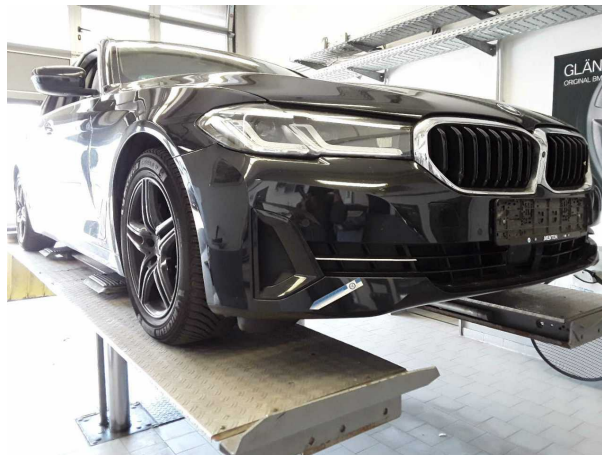
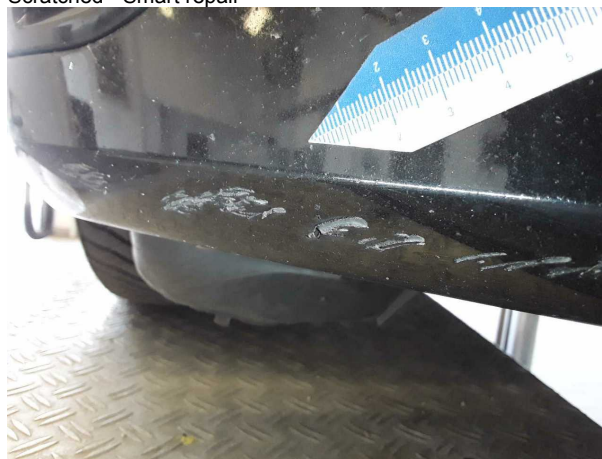
| No. | Component group | Description |
|---|---|---|
| 7 | Front bumper | Front bumper (unterhalb) - Scratched - Smart repair |

**Damage #7:** Front bumper: Front bumper (unterhalb) - Scratched - Smart repair

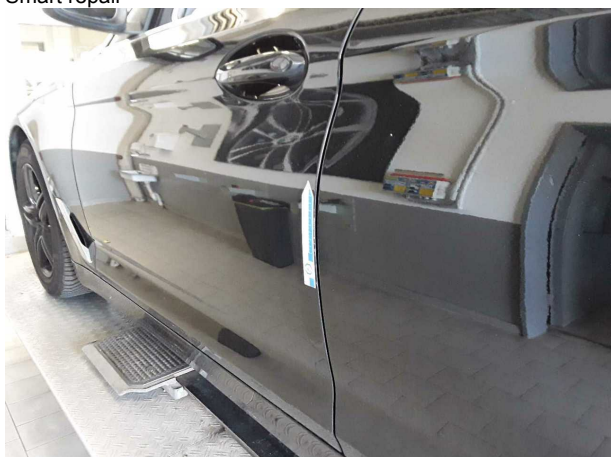
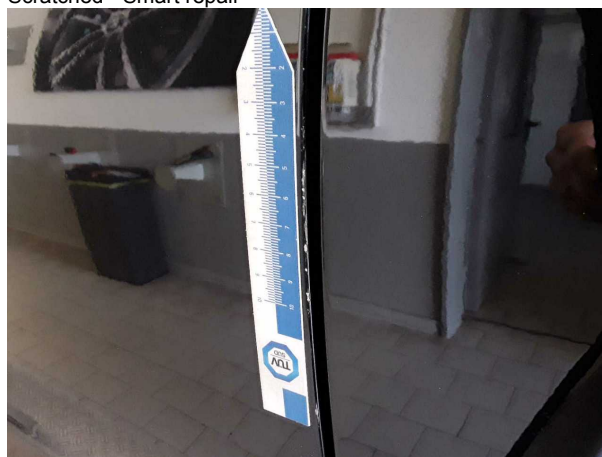
| No. | Component group | Description |
|---|---|---|
| 8 | Door - front left side | Door edge - Scratched - Smart repair |

**Damage #8:** Door - front left side: Door edge - Scratched - Smart repair

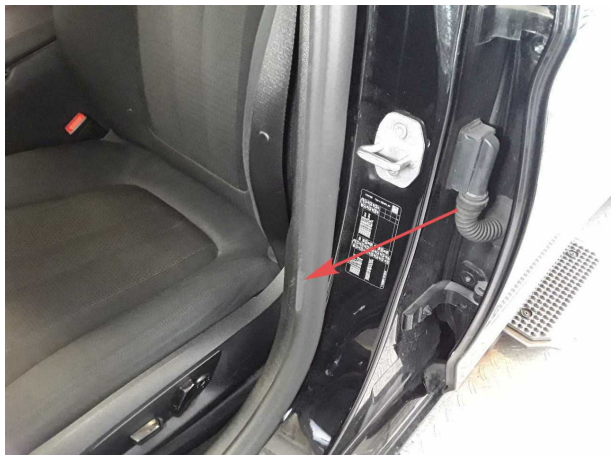
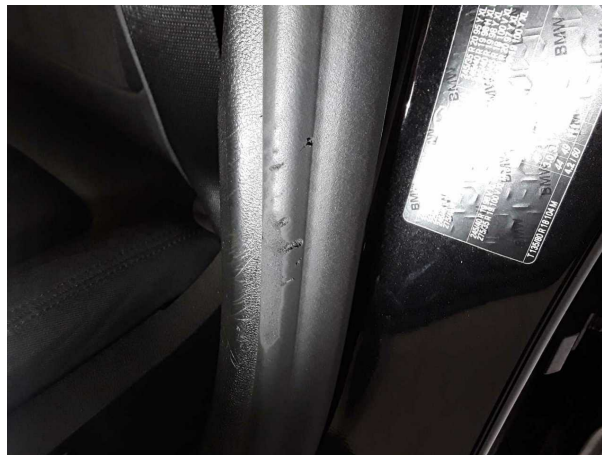
| No. | Component group | Description |
|---|---|---|
| 10 | Body | Door seal - front left side - Damaged - Replace |

**Damage #10:** Body: Door seal - front left side - Damaged - Replace

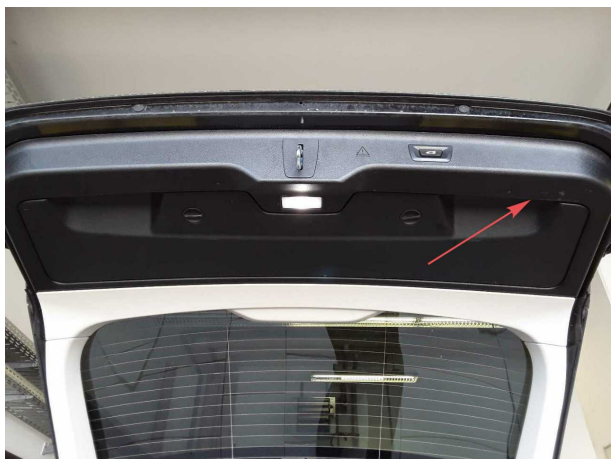
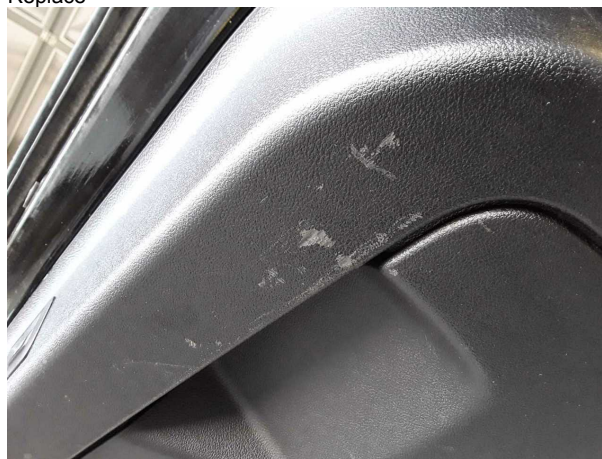
| No. | Component group | Description |
|---|---|---|
| 11 | Boot lid / rear door | Trim - standard - lower - Scratched - Replace |

**Damage #11:** Boot lid / rear door: Trim - standard - lower - Scratched - Replace

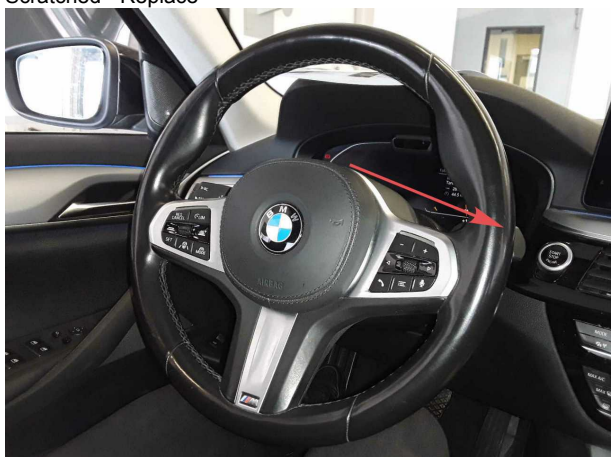
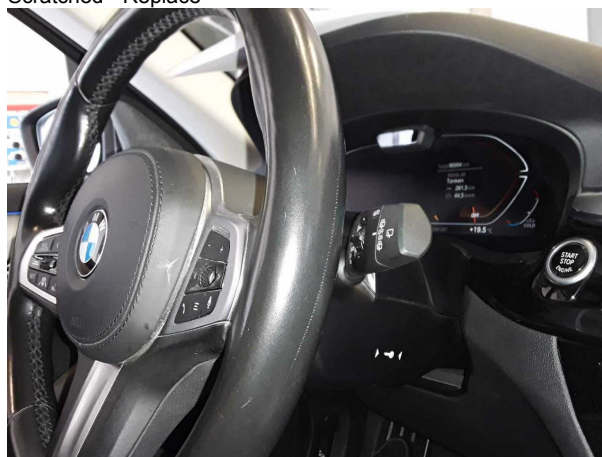
| No. | Component group | Description |
|---|---|---|
| 12 | Steering system | Steering wheel sheath - Scratched - Loss in value |

**Damage #12:** Steering system: Steering wheel sheath - Scratched... Loss in value

**Damage #12:** Steering system: Steering wheel sheath - Scratched - Loss in value

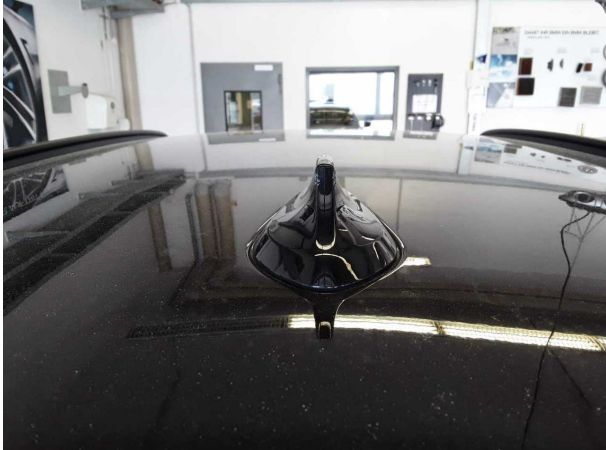
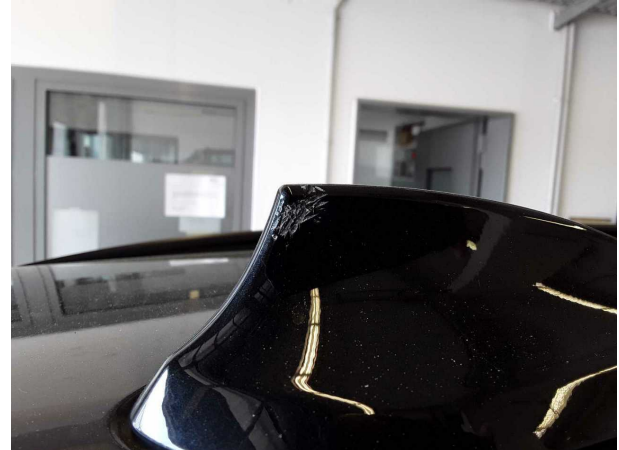
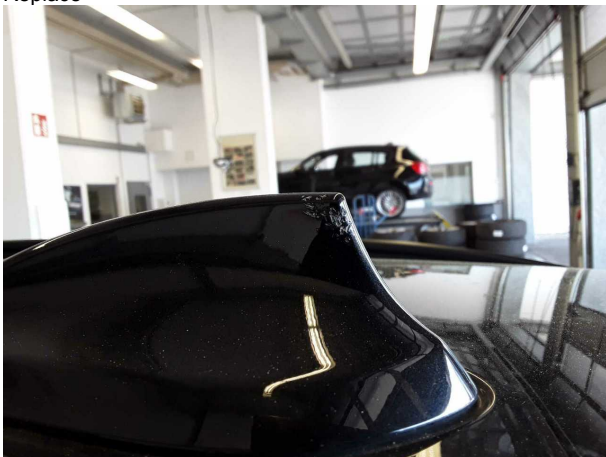
| No. | Component group | Description |
|---|---|---|
| 13 | Roof | Aerial - Damage caused by marten / rodent - Replace |

**Damage #13:** Roof: Aerial - Damage caused by marten / rodent - Replace

**Damage #13:** Roof: Aerial - Damage caused by marten / rode... - Replace

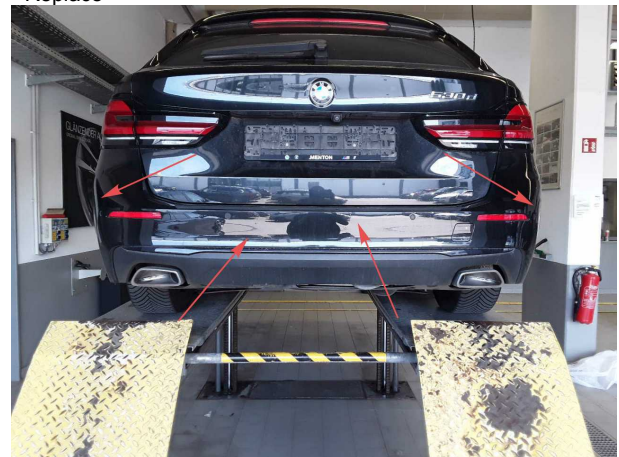
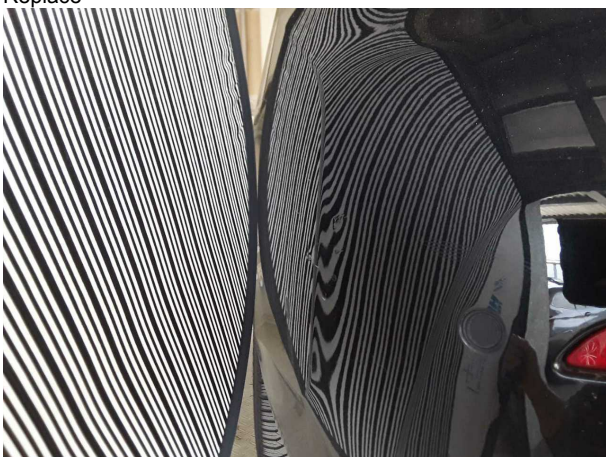
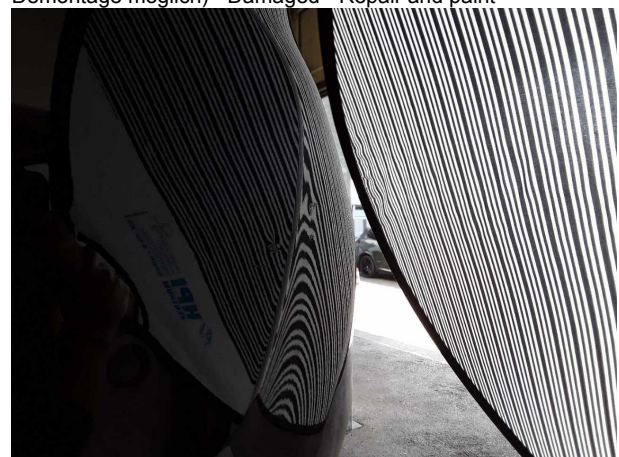
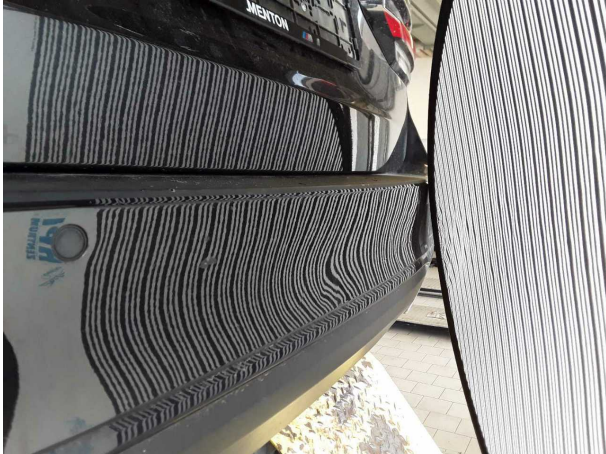
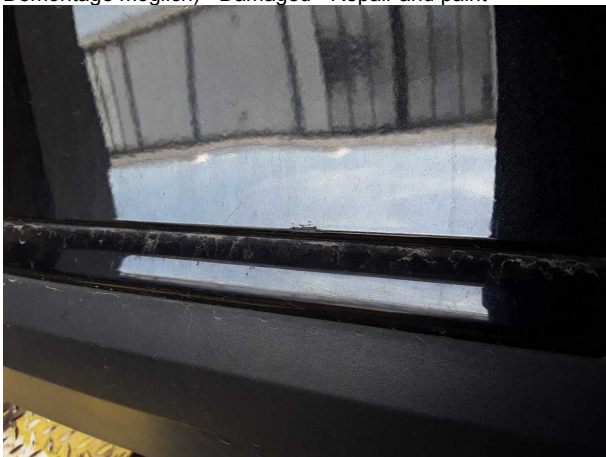
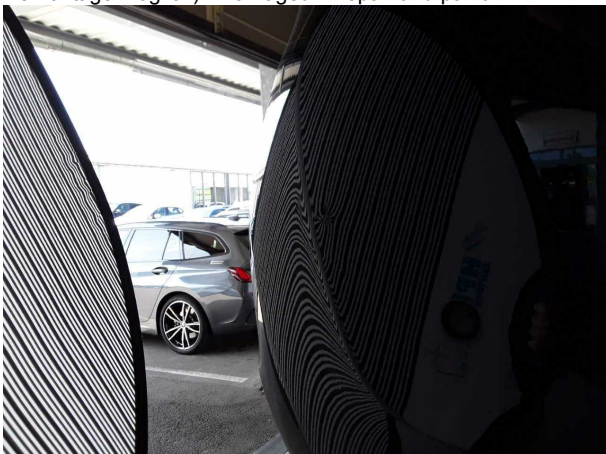
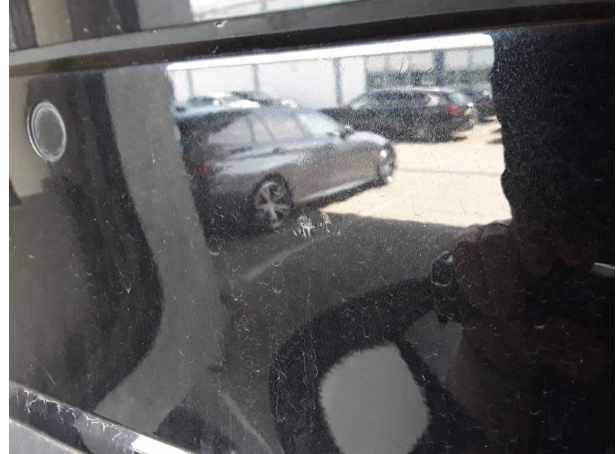
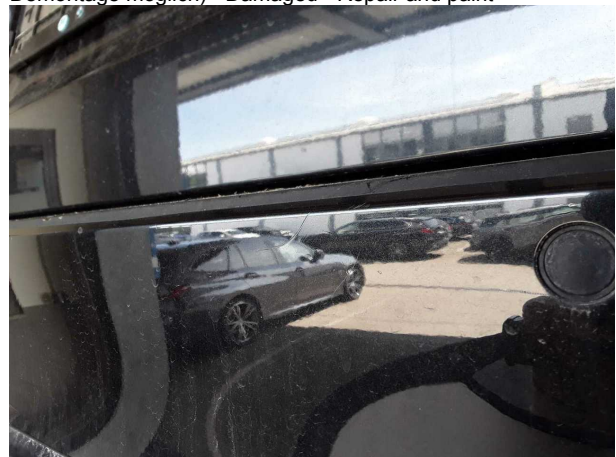
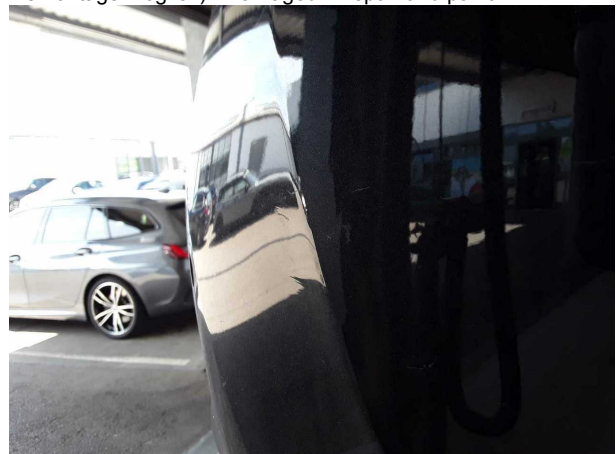
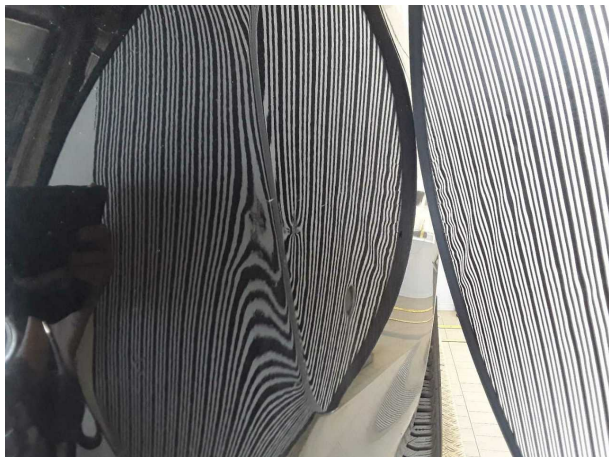
| No. | Component group | Description |
|---|---|---|
| 14 | Rear bumper | Rear bumper (Mehrkosten nach Demontage möglich) - Damaged - Repair and paint |

**Damage #14:** Rear bumper: Rear bumper (Mehrkosten nach Demontage möglich) - Damaged - Repair and paint

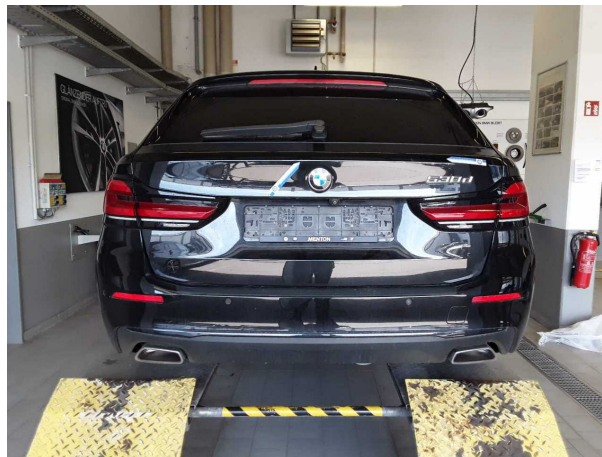
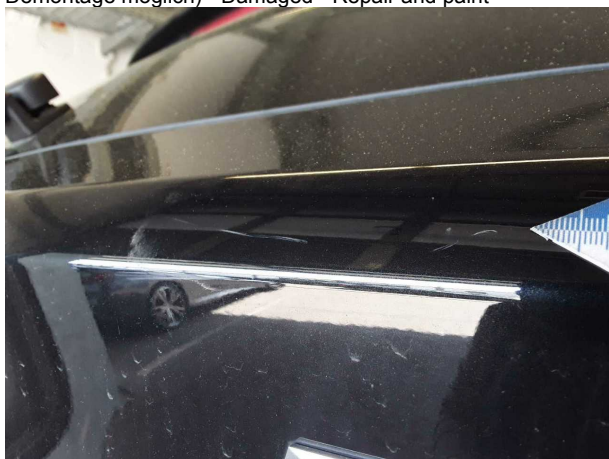
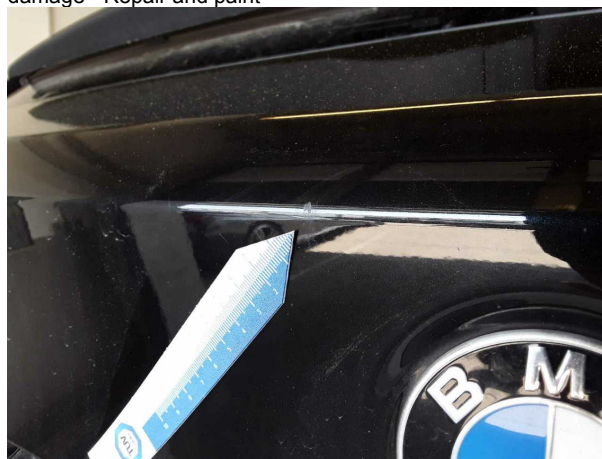
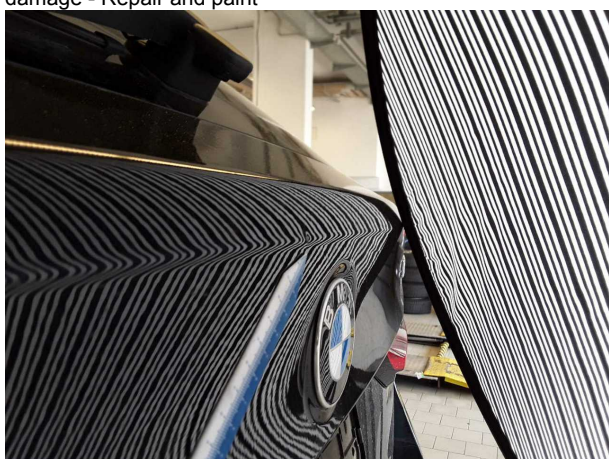
| No. | Component group | Description |
|---|---|---|
| 15 | Boot lid / rear door | Boot lid - Dent / paintcoat damage - Repair and paint |

**Damage #15:** Boot lid / rear door: Boot lid - Dent / paintcoat damage - Repair and paint

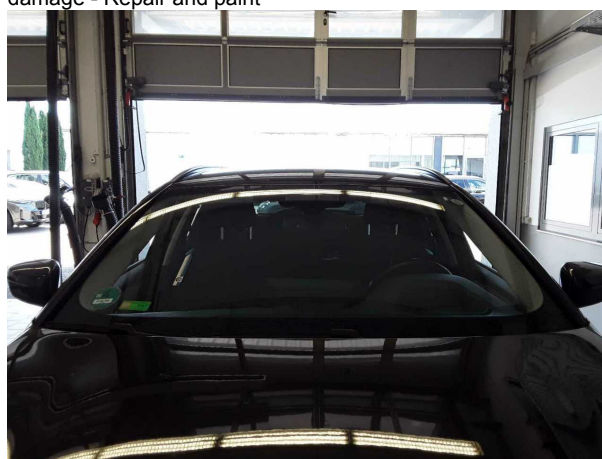
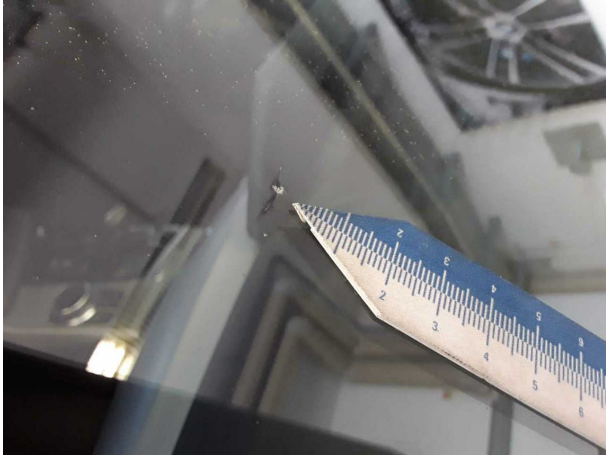
| No. | Component group | Description |
|---|---|---|
| 17 | Vehicle glazing | Windscreen - Stone chips - Replace |

**Damage #17:** Vehicle glazing: Windscreen - Stone chips - Replace
