**WBA7M910805T25890**

## Zustandsbericht

Inspection date: 26 May 2025  
**Protocol number:** 39893412  
Delivery date: 26 May 2025

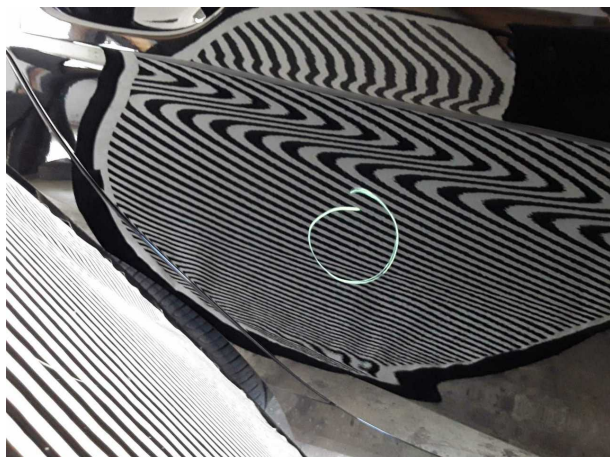
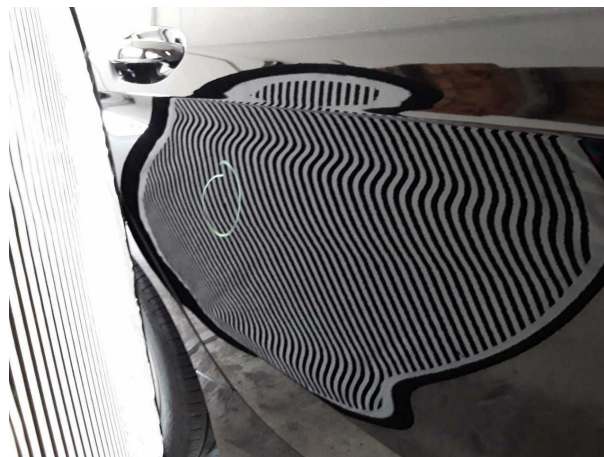
| No. | Component group | Description |
|---|---|---|
| 1 | Door - rear right side | Door - dent(s) - Smooth repair work |

**Damage #1:** Door - rear right side: Door - dent(s) - Smooth repair work

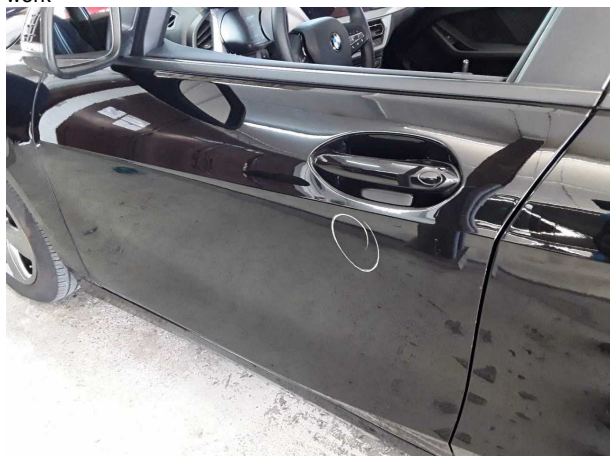
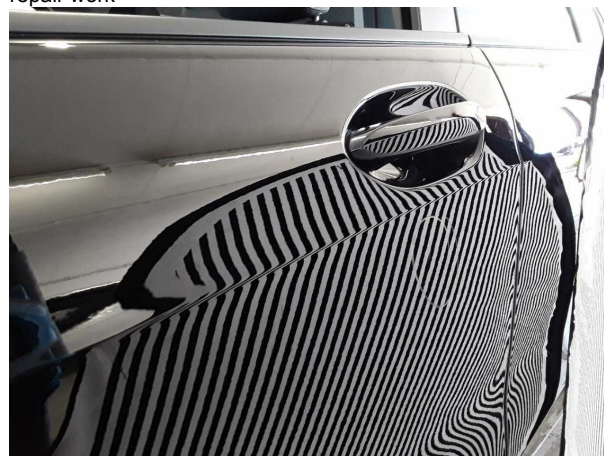
| No. | Component group | Description |
|---|---|---|
| 2 | Door - front left side | Door - dent(s) - Smooth repair work |

**Damage #2:** Door - front left side: Door - dent(s) - Smooth repair work

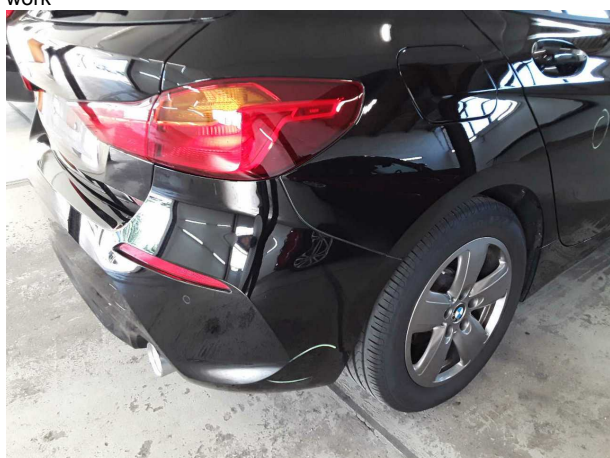
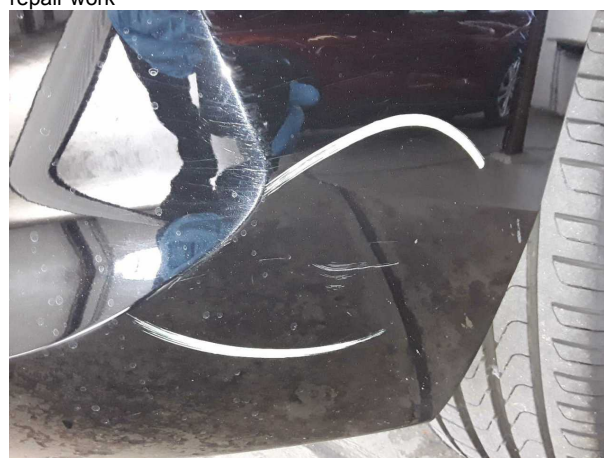
| No. | Component group | Description |
|---|---|---|
| 3 | Rear bumper | Rear bumper - Scratched - Smart repair |

**Damage #3:** Rear bumper: Rear bumper - Scratched - Smart repair work

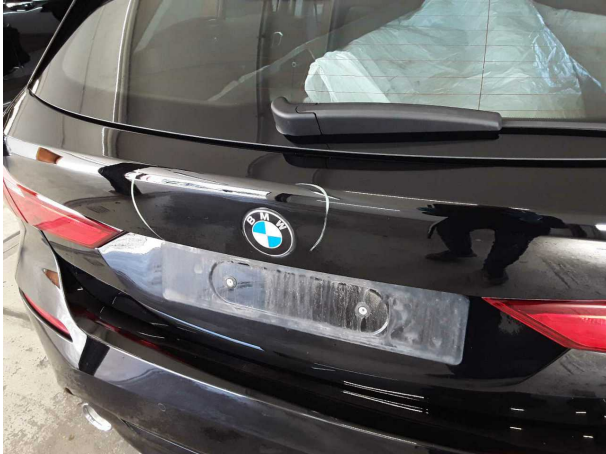
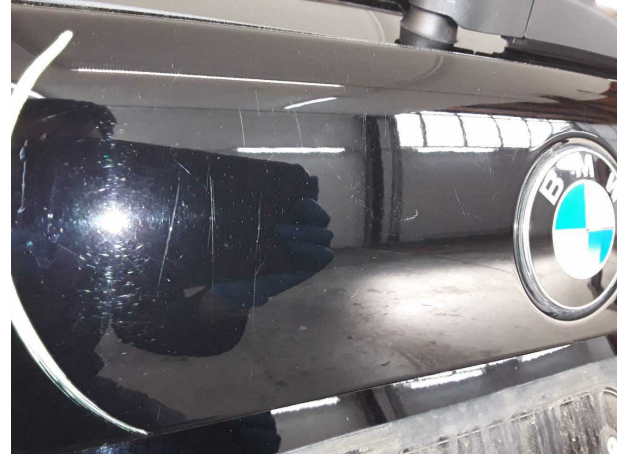
| No. | Component group | Description |
|---|---|---|
| 4 | Boot lid / rear door | Boot lid - Scratched - Paint |

**Damage #4:** Boot lid / rear door: Boot lid - Scratched - Paint

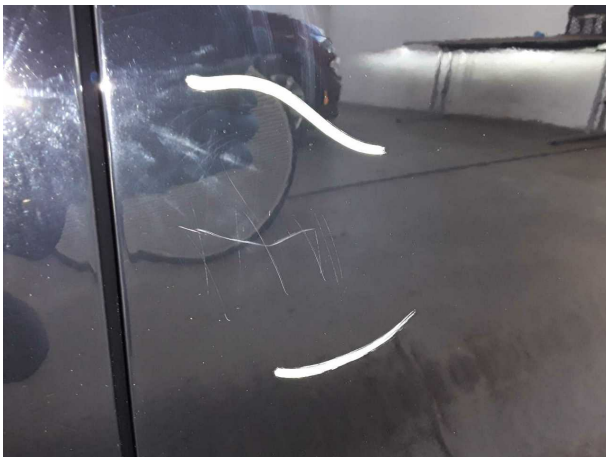
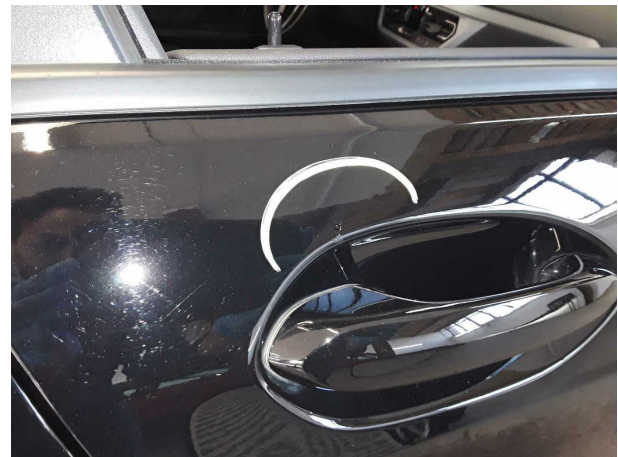
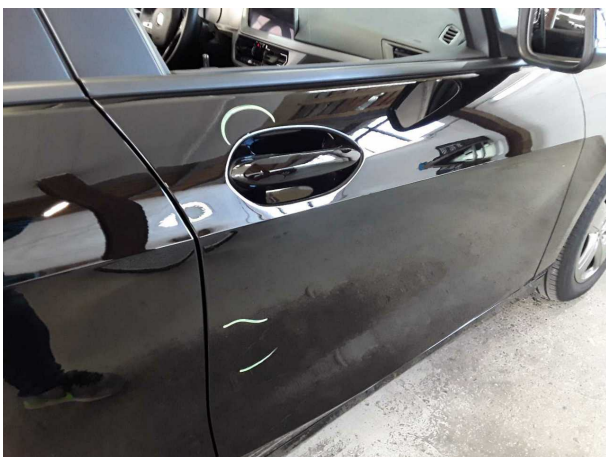
| No. | Component group | Description |
|---|---|---|
| 5 | Door - front right side | Door - Scratched - Paint |

**Damage #5:** Door - front right side: Door - Scratched - Paint

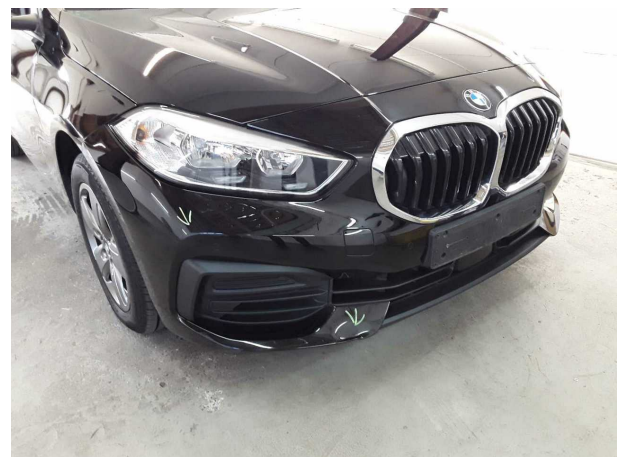
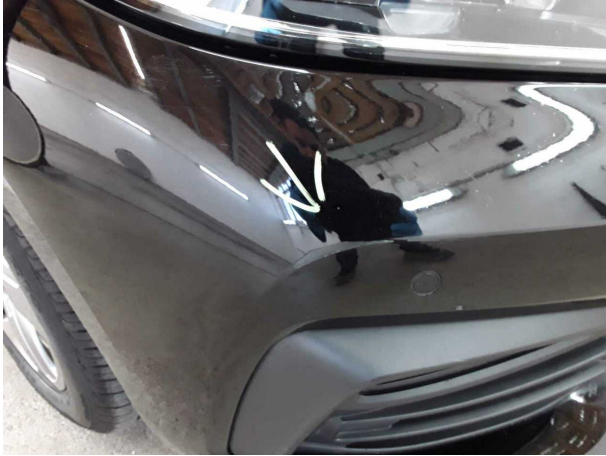
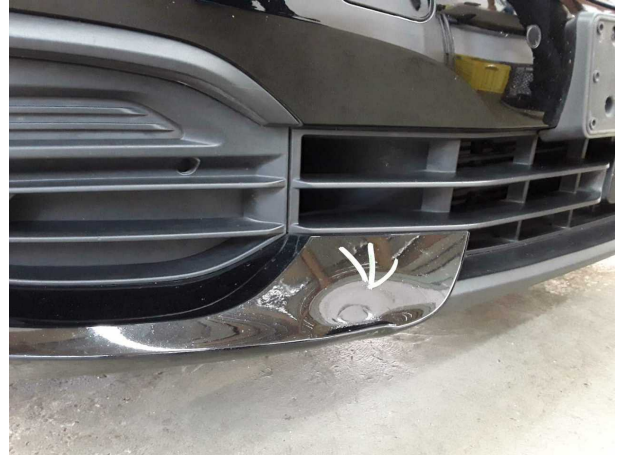
| No. | Component group | Description |
|---|---|---|
| 6 | Front bumper | Front bumper - Deformed - Replace |

**Damage #6:** Front bumper: Front bumper - Deformed - Replace
