WBY11CF010CK58955

| Manufacturer | BMW | Next maintenance in | 14 Tag(e) |

## Zustandsbericht

**Protocol number:** 39909935

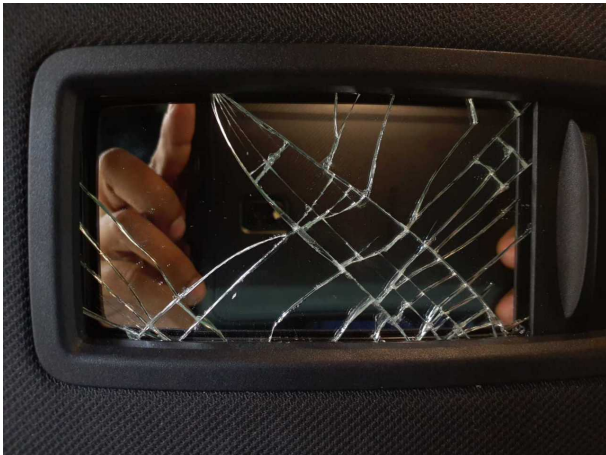
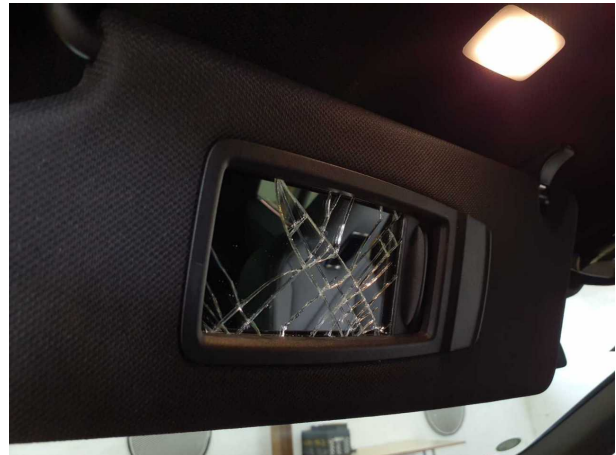
| No. | Component group | Description |
|---|---|---|
| 1 | Interior | Sun visor - left side - Damaged - Replace |

**Damage #1:** Interior: Sun visor - left side - Damaged - Replace

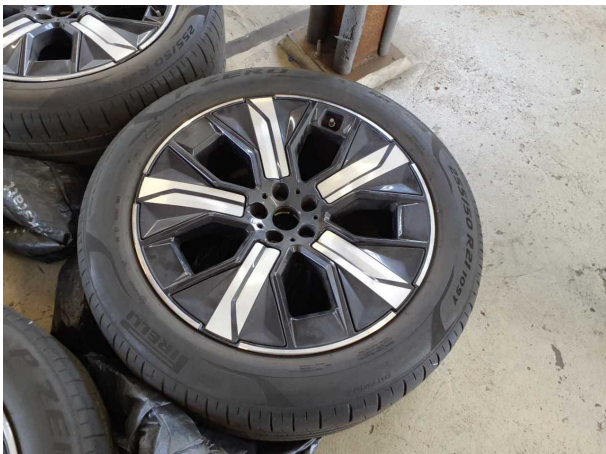
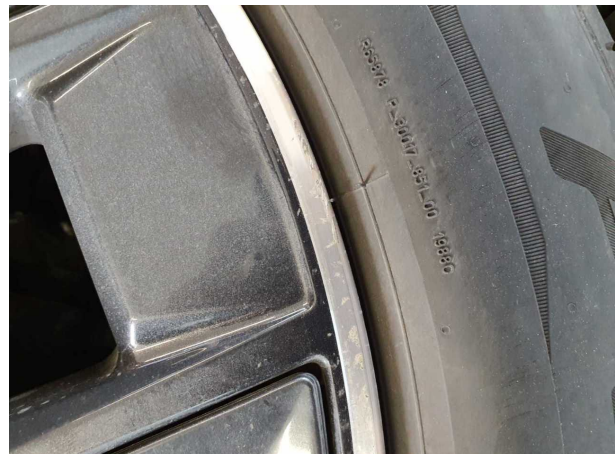
| No. | Component group | Description |
|---|---|---|
| 2 | 2nd wheel set | 1 alloy rim - Scratched - Loss in value |

**Damage #2:** 2nd wheel set: 1 alloy rim - Scratched - Loss in value

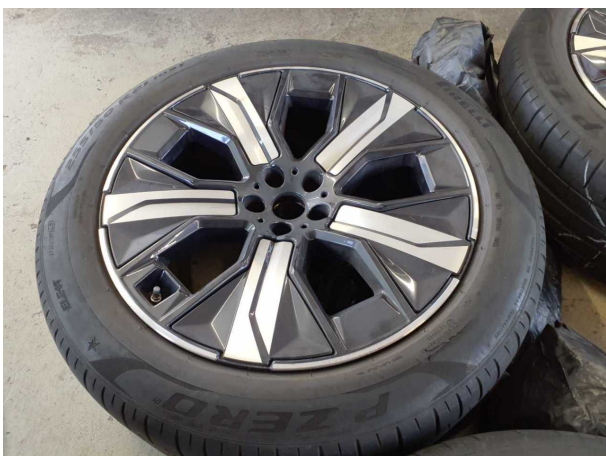
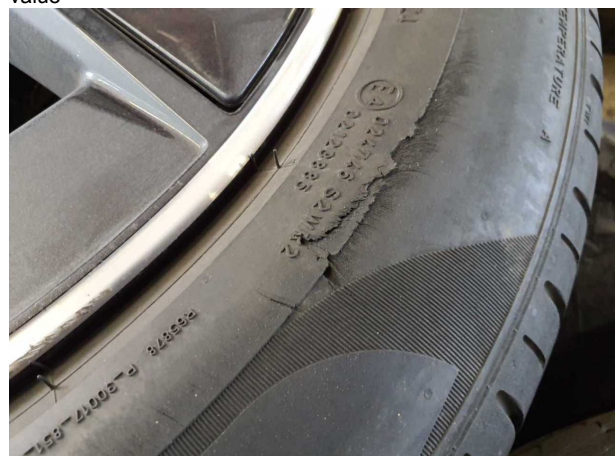
| No. | Component group | Description |
|---|---|---|
| 3 | 2nd wheel set | 1 tyre - Damaged - Replace |

**Damage #3:** 2nd wheel set: 1 tyre - Damaged - Replace

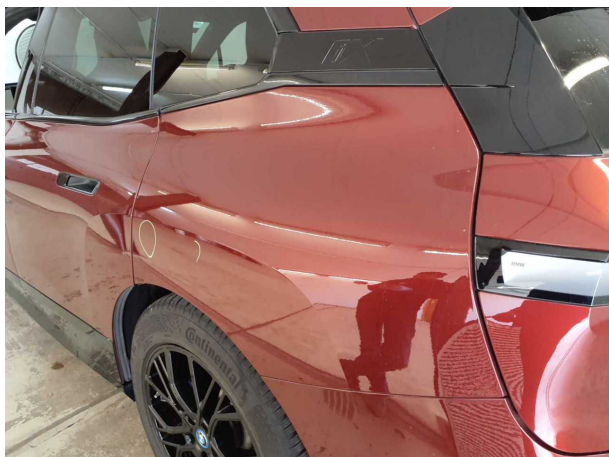
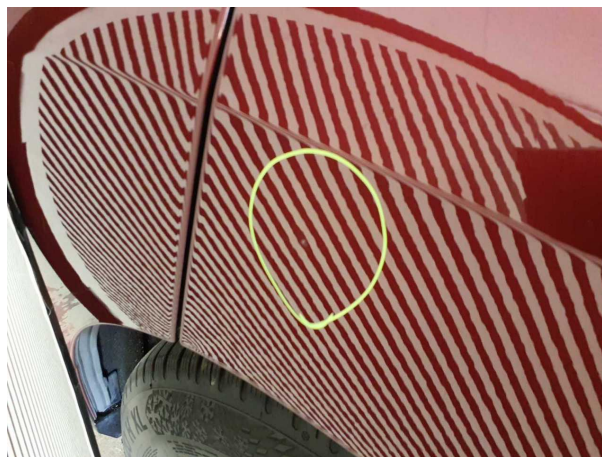
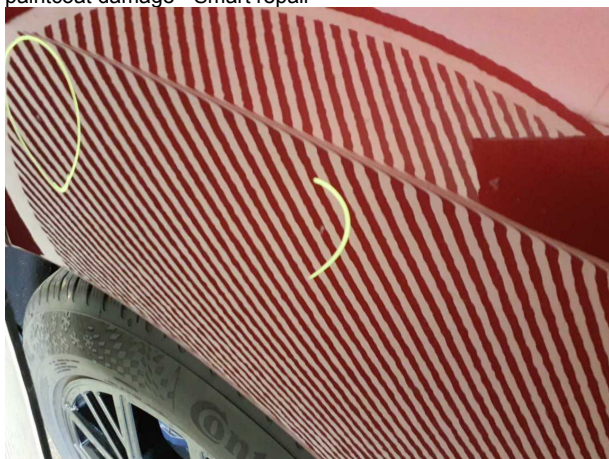
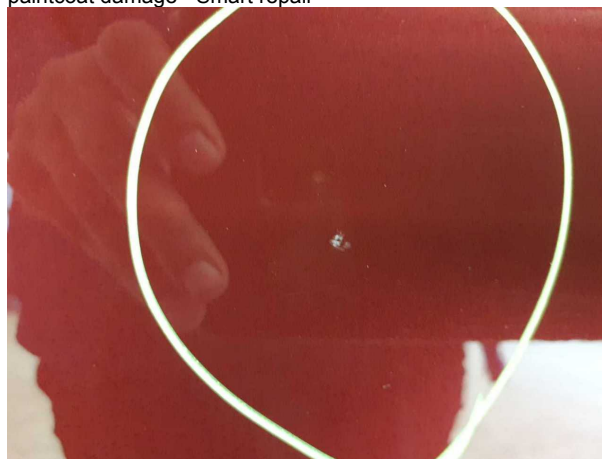
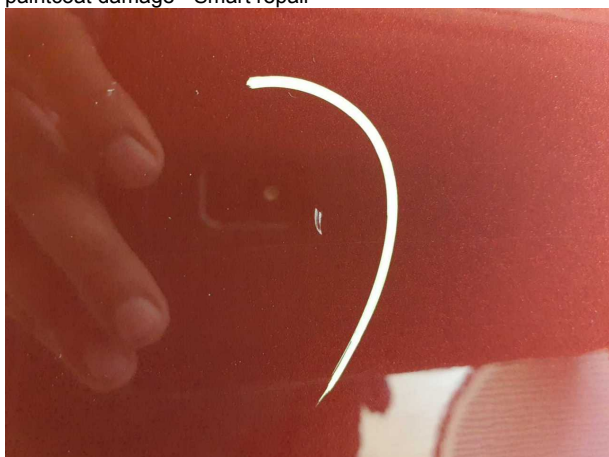
| No. | Component group | Description |
|---|---|---|
| 4 | Side panel - rear left side | Side panel - Dent / paintcoat damage - Smart repair |

**Damage #4:** Side panel - rear left side: Side panel - Dent / paintcoat damage - Smart repair

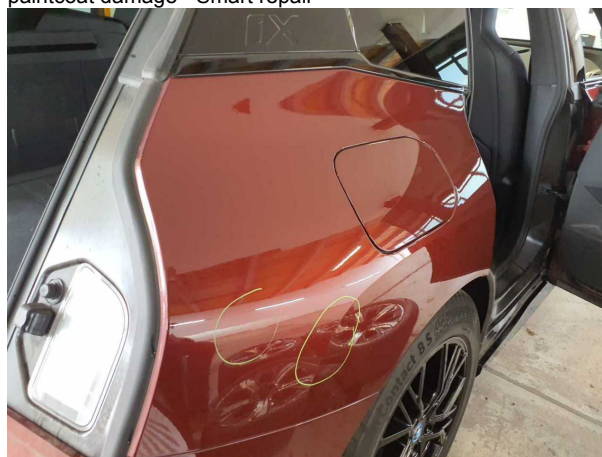
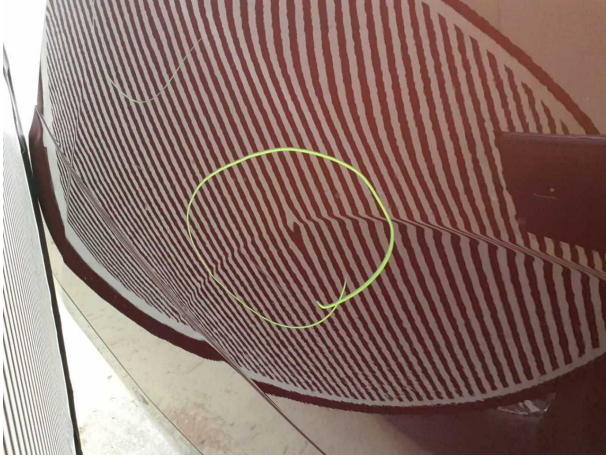
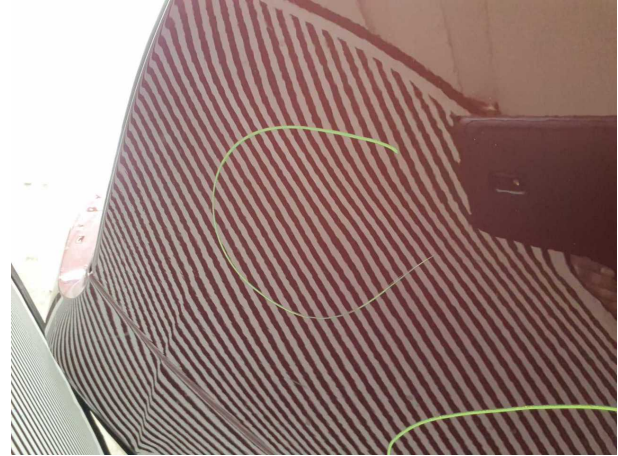
| No. | Component group | Description |
|---|---|---|
| 5 | Side panel - rear right side | Side panel - dent(s) - Smooth repair work |

**Damage #5:** Side panel - rear right side: Side panel - dent(s) - Smooth repair work

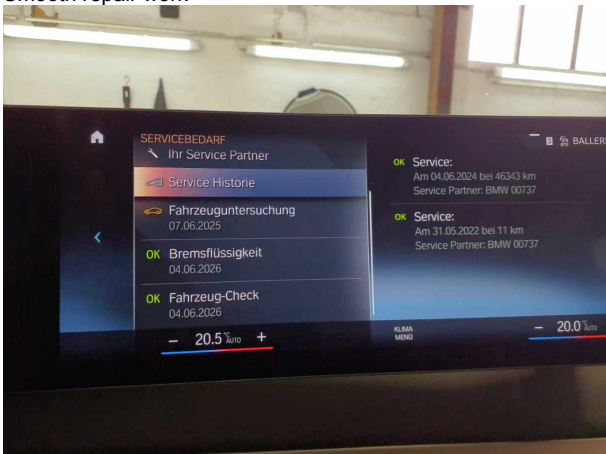
| No. | Component group | Description |
|---|---|---|
| 6 | Misc. | Inspection / maintenance - Due - Replace |

**Damage #6:** Misc.: Inspection / maintenance - Due - Replace

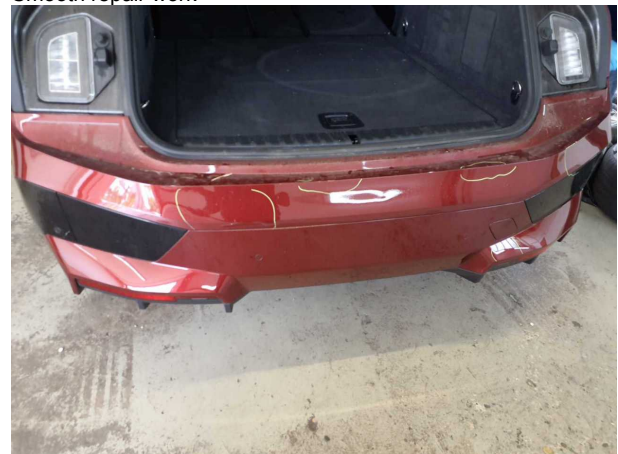
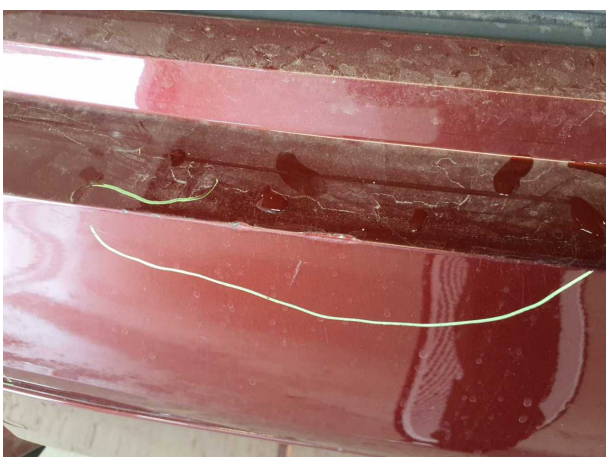
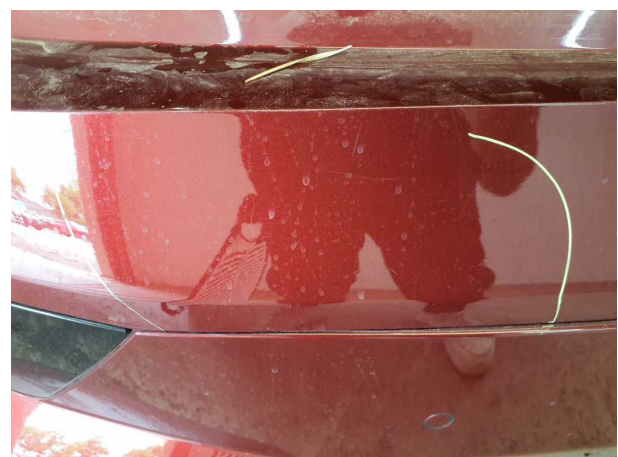
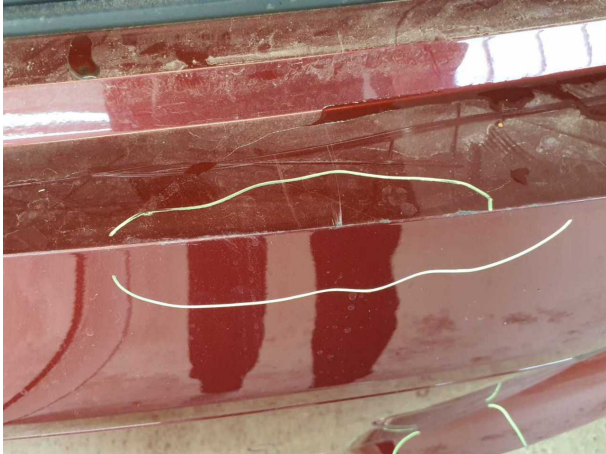
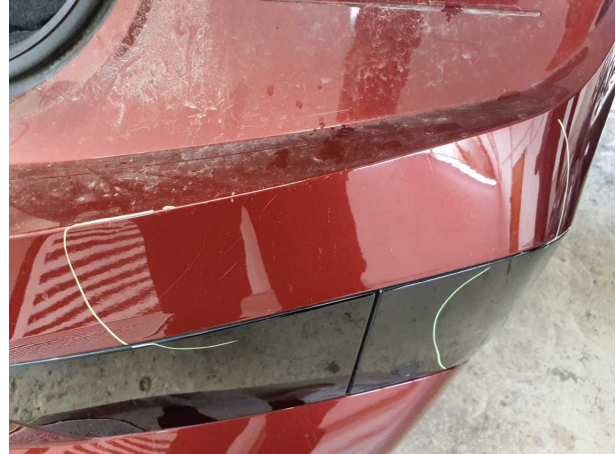
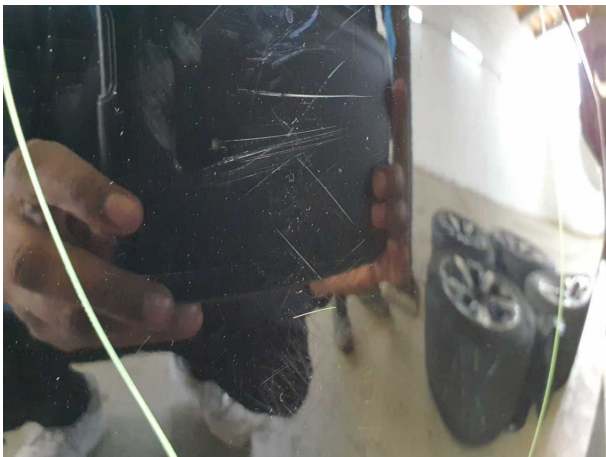
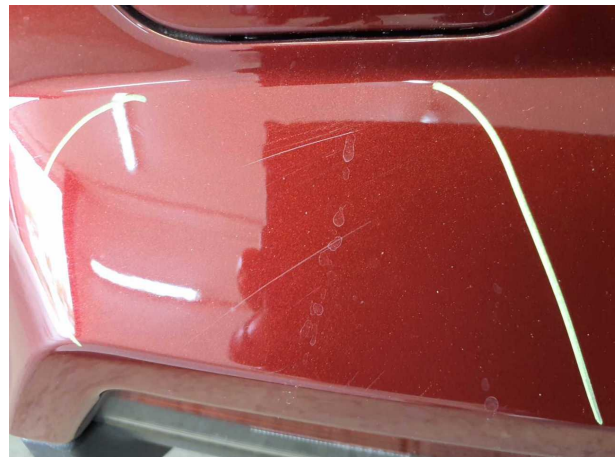
| No. | Component group | Description |
|---|---|---|
| 7 | Rear bumper | Rear bumper - Scratched - Paint |

**Damage #7:** Rear bumper: Rear bumper - Scratched - Paint

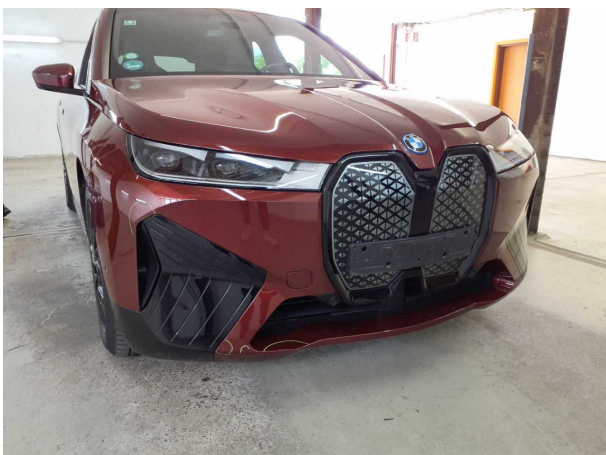
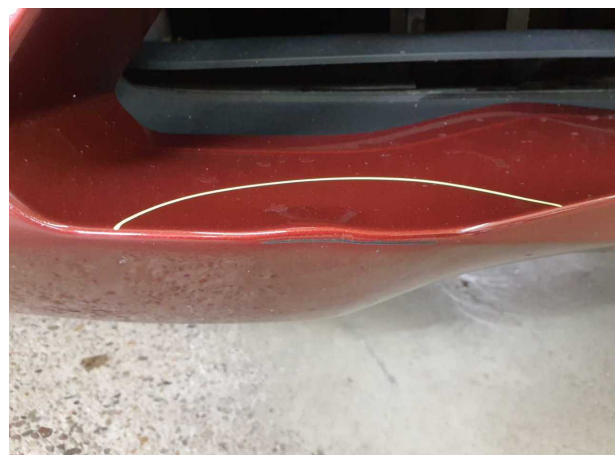
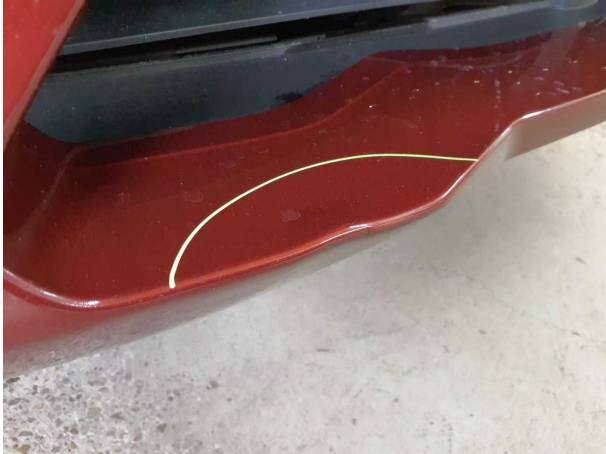
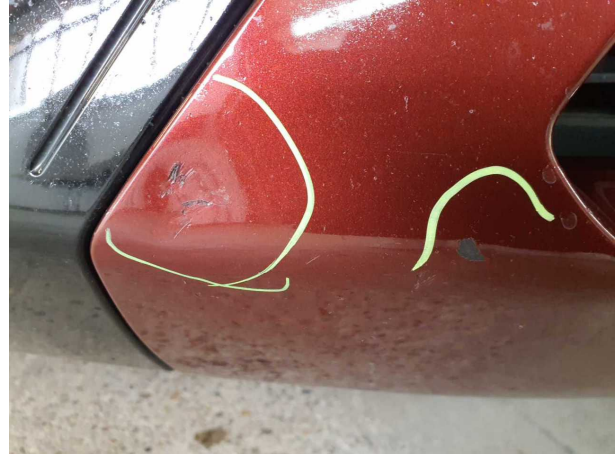
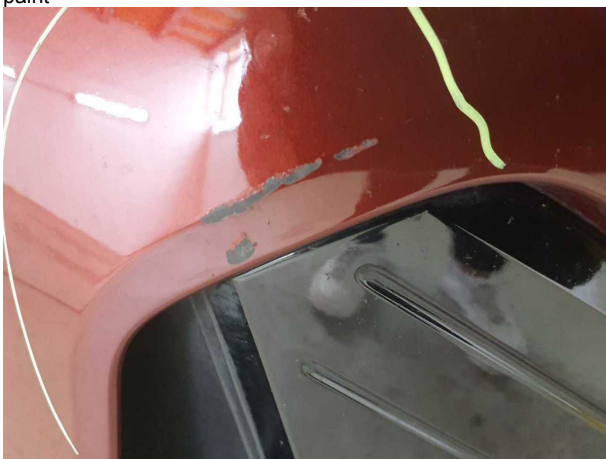
| No. | Component group | Description |
|---|---|---|
| 8 | Front bumper | Front bumper - Deformed - Repair and paint |

**Damage #8:** Front bumper: Front bumper - Deformed - Repair and paint

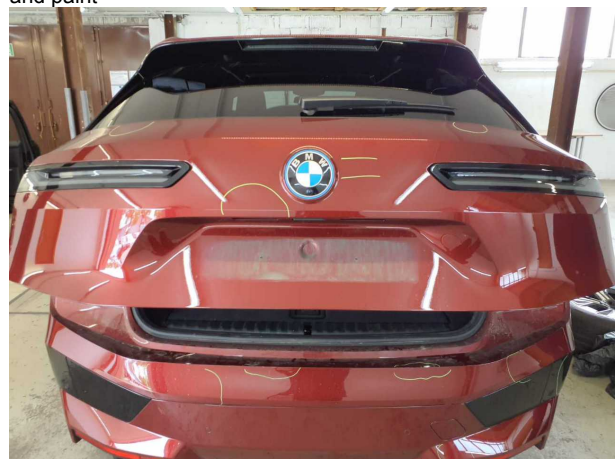
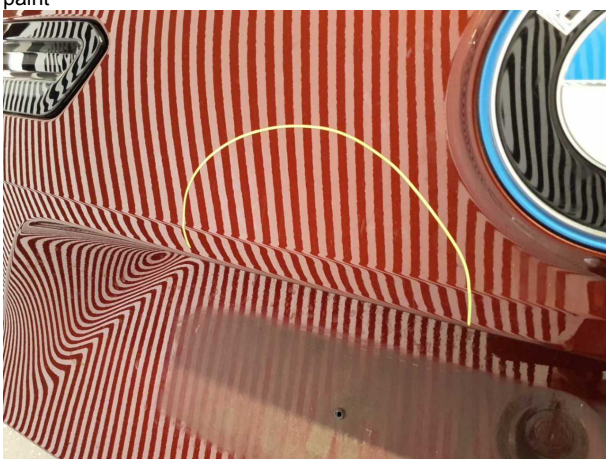
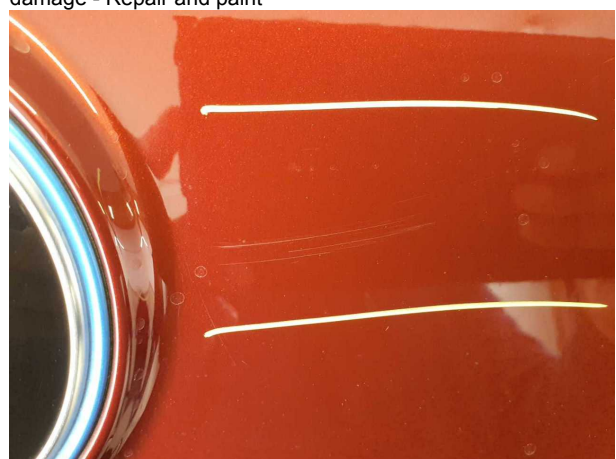
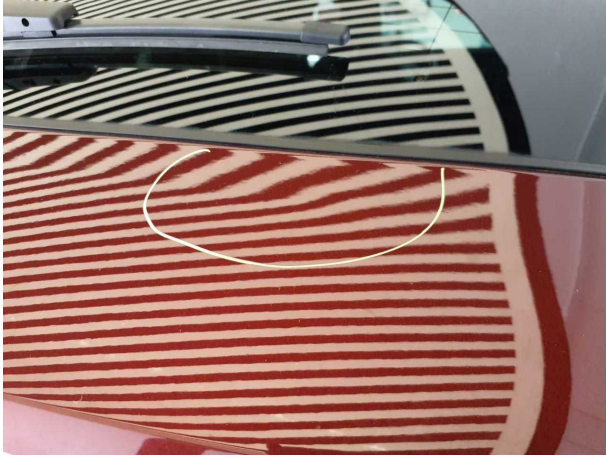
| No. | Component group | Description |
|---|---|---|
| 9 | Boot lid / rear door | Boot lid - Dent / paintcoat damage - Repair and paint |

**Damage #9:** Boot lid / rear door: Boot lid - Dent / paintcoat damage - Repair and paint

**Damage #9:** Boot lid / rear door: Boot lid - Dent / paintcoat damage  
- Repair and paint
