WBA11AJ000CH06535

## Zustandsbericht

Inspection date: 12 May 2025  
**Protocol number: 39930026**

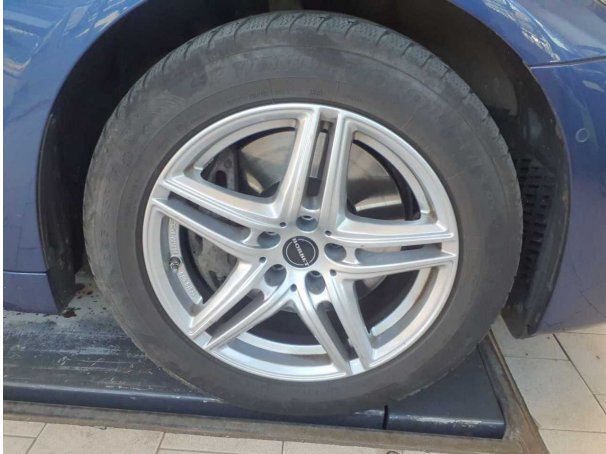
**Figure 31:** Mounted tyres

| No. | Component group | Description |
|---|---|---|
| 1 | Wheel / tyres | Tyre - front (Verschleißgrenze beachten) - No deduction |

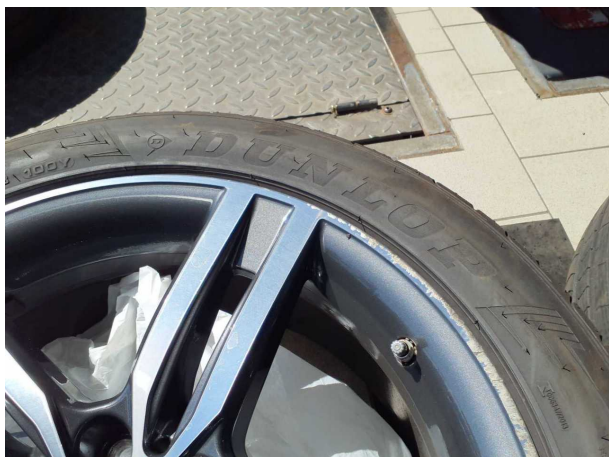
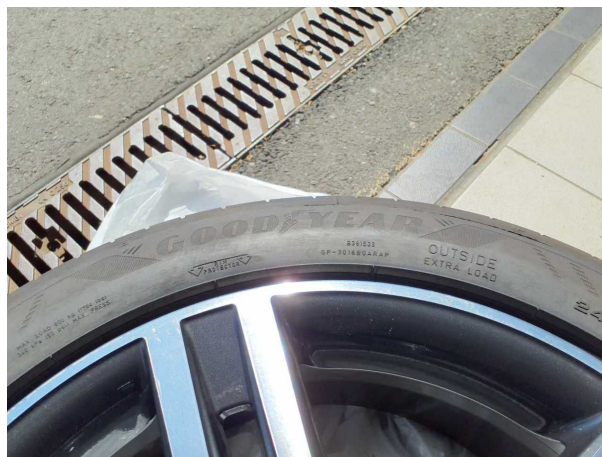
| No. | Component group | Description |
|---|---|---|
| 3 | 2nd wheel set | 2 tyres (Reifen HA Mischbereifung) - Differs from the original configuration - No deduction |

**Damage #3:** 2nd wheel set: 2 tyres (Reifen HA Mischbereifung) - Differs from the original configuration - No deduction

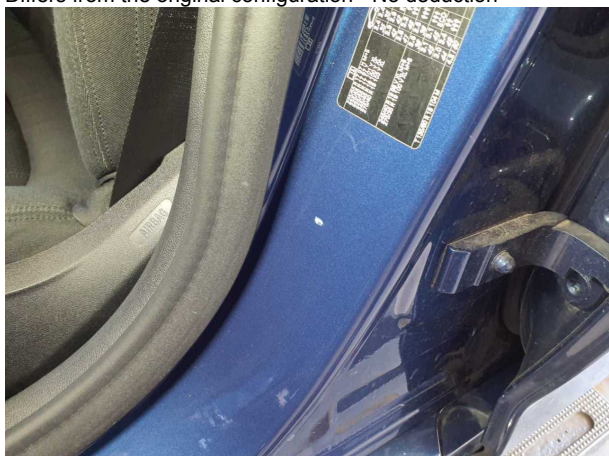
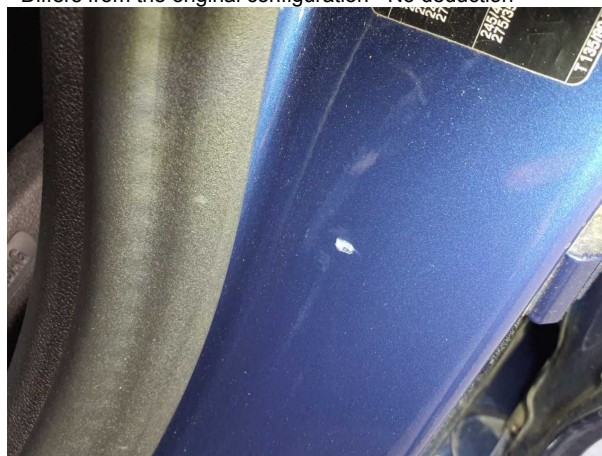
| No. | Component group | Description |
|---|---|---|
| 4 | Sill - left side | Sill - Scratch(es) - Smart repair |

**Damage #4:** Sill - left side: Sill - Scratch(es) - Smart repair

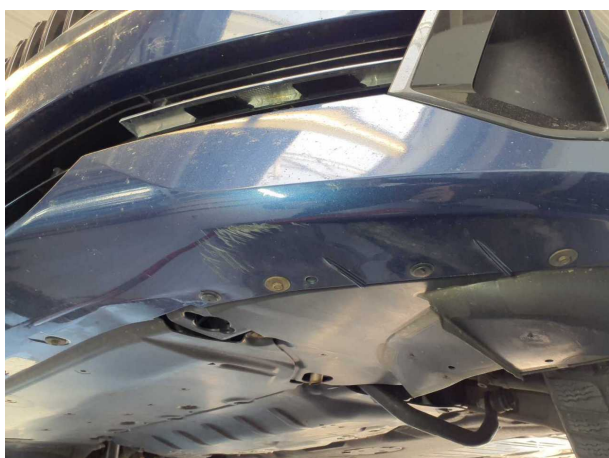
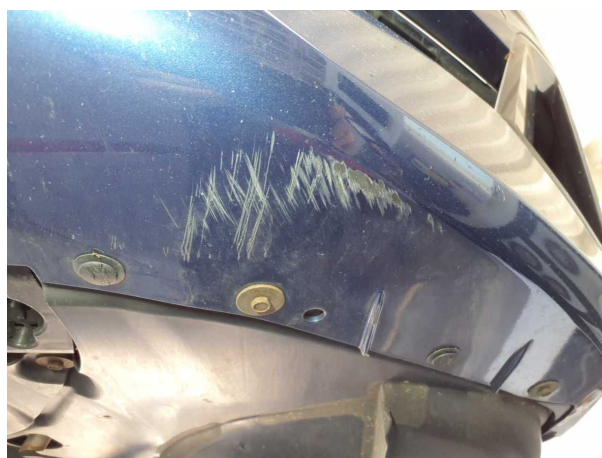
| No. | Component group | Description |
|---|---|---|
| 5 | Front bumper | Front bumper - Scratched - Smart repair |

**Damage #5:** Front bumper: Front bumper - Scratched - Smart repair

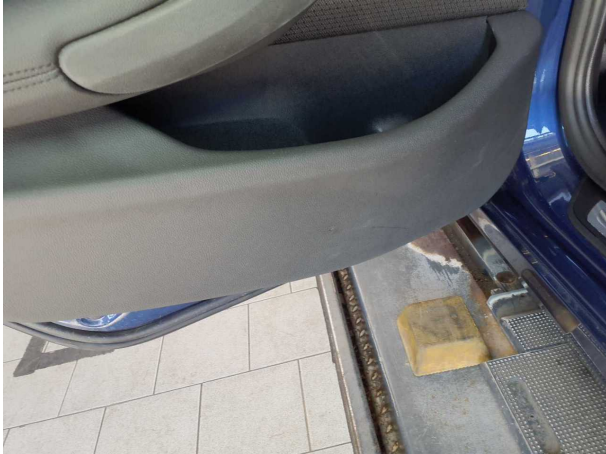
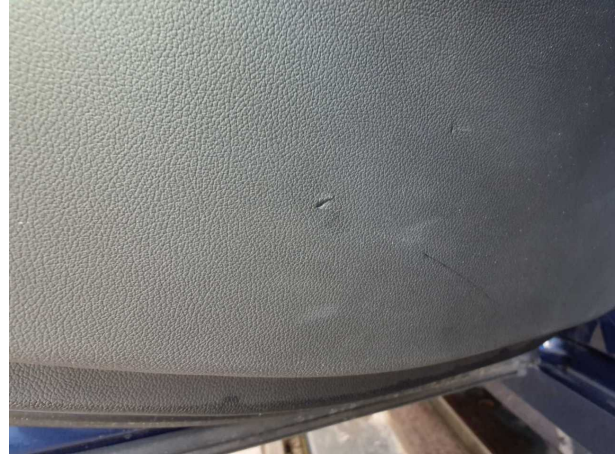
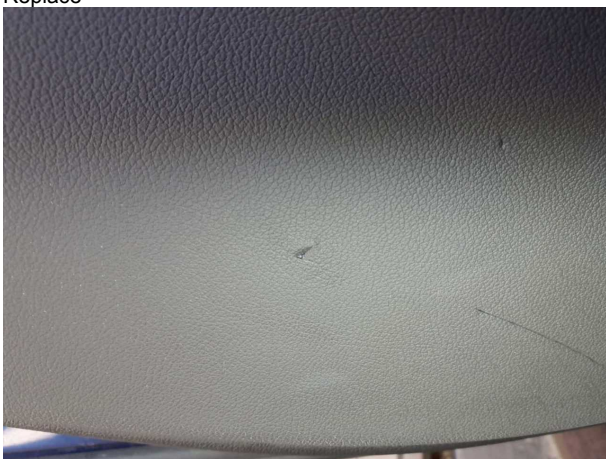
| No. | Component group | Description |
|---|---|---|
| 6 | Trim / covers | Door trim - rear left side - Broken / torn - Replace |

**Damage #6:** Trim / covers: Door trim - rear left side - Broken / torn - Replace

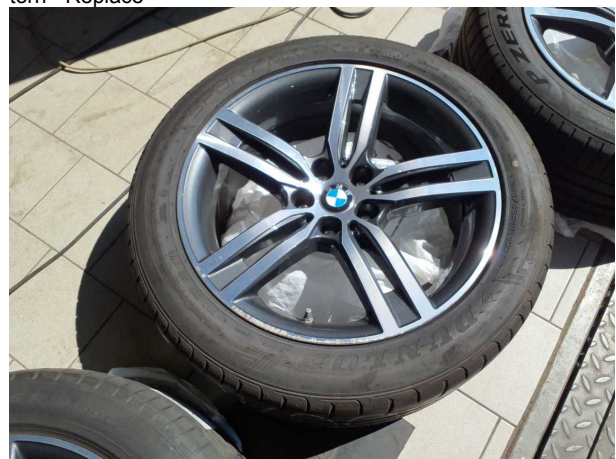
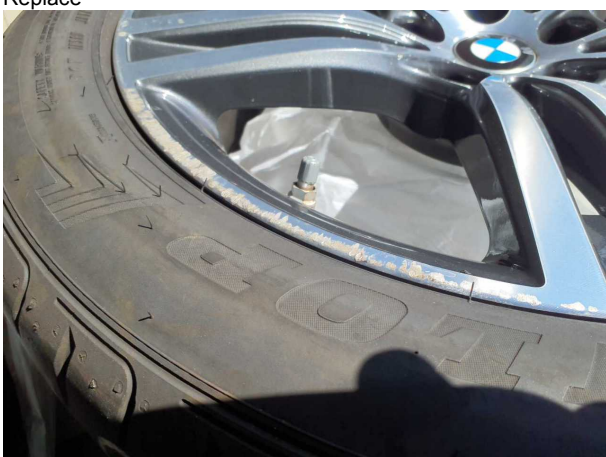
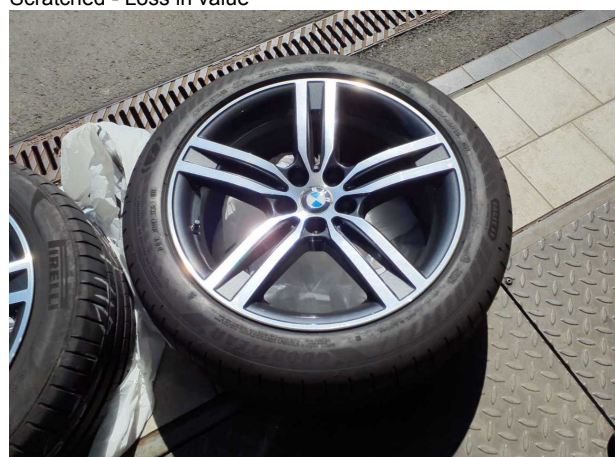
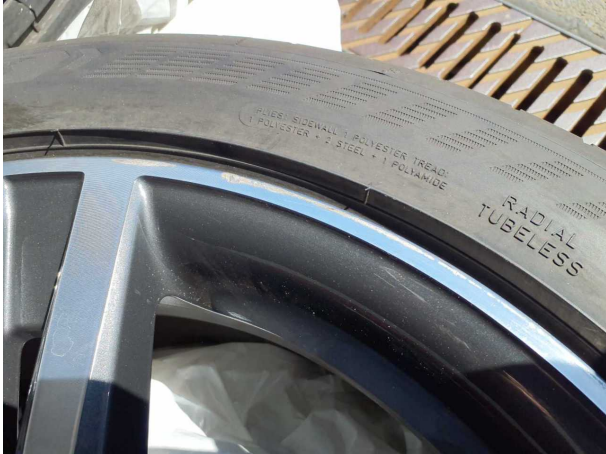
| No. | Component group | Description |
|---|---|---|
| 7 | 2nd wheel set | 2 alloy rims (Glanzgedreht) - Scratched - Loss in value |

**Damage #7:** 2nd wheel set: 2 alloy rims (Glanzgedreht) - Scratched - Loss in value

**Damage #7:** 2nd wheel set: 2 alloy rims (Glanzgedreht) - Scratch...  
- Loss in value
